**AIR, NOISE AND VIBRATION
MONTHLY MONITORING REPORT
Number 001**

DDC. Project ID:	BBJ K-DSS	Period Start: 12/01/23 End 12/31/23
Project Name:	NYC Borough Based Jails System – Brooklyn Dismantle and Swing Space Project	
DDC Pin No.:	8502020CR0043P

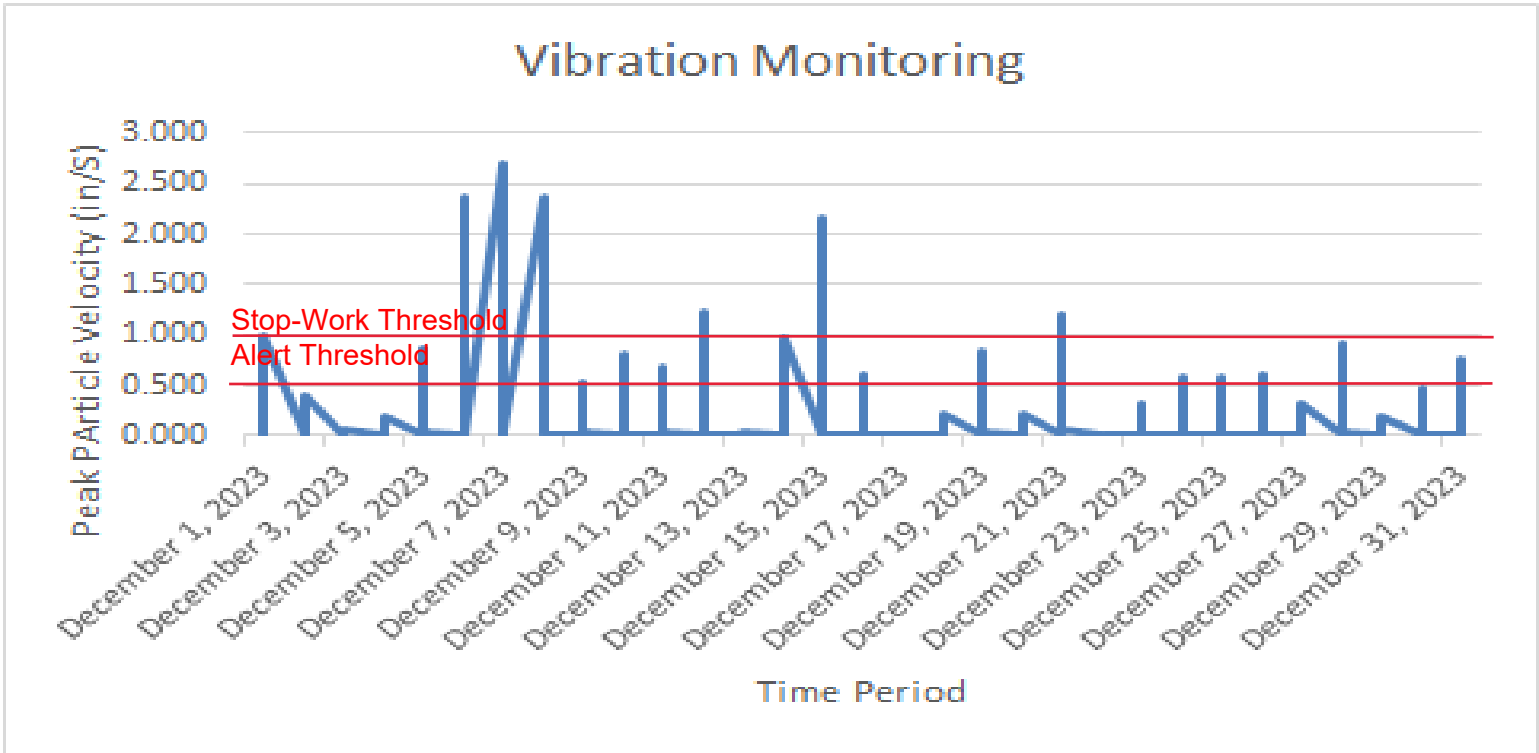
Vibration Monitor – VM-01 – December 2023:

Number of Workdays in a Month	Number of Vibration Monitoring Days in a Month	Number of Days with Vibration Levels above Action Levels by Month	Comments
20	31	19	No mitigation actions were required. Alerts triggered manually during off hours as well as during working hours.

Vibration monitors were installed within the MTA subway tunnel and in front of the Brooklyn Criminal Courthouse on State Street, to monitor vibrations during the dismantling of the Brooklyn Detention Center. The monitors in the subway tunnels were not activated, as the vibrations from train movements were determined to overwhelm or obscure the vibrations from the dismantling work. The monitor in front of the Courthouse was located in an access shaft in the sidewalk, under 2 metal hatch doors. The monitor is a highly sensitive instrument, so it records vibrations from heavy impact from footsteps, scooters, etc. on the metal access shaft cover plates, bits of debris dropped down the shaftway, rainfall, etc. as well as potential vibrations from the deconstruction across the street. Furthermore, the deconstruction work is greater than 90' away from the monitor, so allowing for dissipation of any vibration over distance, the source of the exceedances is more likely to be local than from that distance. Therefore, many of the exceedances recorded are discounted as being due to other factors than the dismantling. During the month of December 2023, vibration monitoring was ongoing throughout the entire month at the project site and vibration monitoring devices were in continuous operation at the project site recording construction-related vibration levels measured in inches per second (in/sec) or IPS. Throughout the month of November, action-level vibration threshold exceedances and stop-work level vibration exceedances were recorded above the Daily Permissible Exposure Limits (DPEL) during this month as set by Action Levels = 0.5 in/sec above backgrounds and Stop Work Levels = 1.0 in/sec above backgrounds. These alerts were recorded during off hours when no work was taking place on site. No work was taking place within 90-feet of the vibration monitoring equipment when action level and stop-work level exceedances were recorded. The contractor, NorthStar Contracting Group, Inc. in conjunction with their environmental specialist, will implement mitigation techniques at Action Levels as well as Exceedances to suppress construction activity effects that causes Vibration when warranted throughout the Project work-zone.

No corrective actions or mitigations measures were required this month as the alerts were triggered due to manual disturbance of the sensor during off hours as well as during work hours.
