**AIR, NOISE AND VIBRATION
MONTHLY MONITORING REPORT**

Prepared By: PSI Agency, Inc.

DDC. Project ID:	BBJ K-DSS	Period Start: 11/01/23 End 11/30/23
Project Name:	NYC Borough Based Jails System – Brooklyn Dismantle and Swing Space Project	
DDC Pin No.:	8502020CR0043P

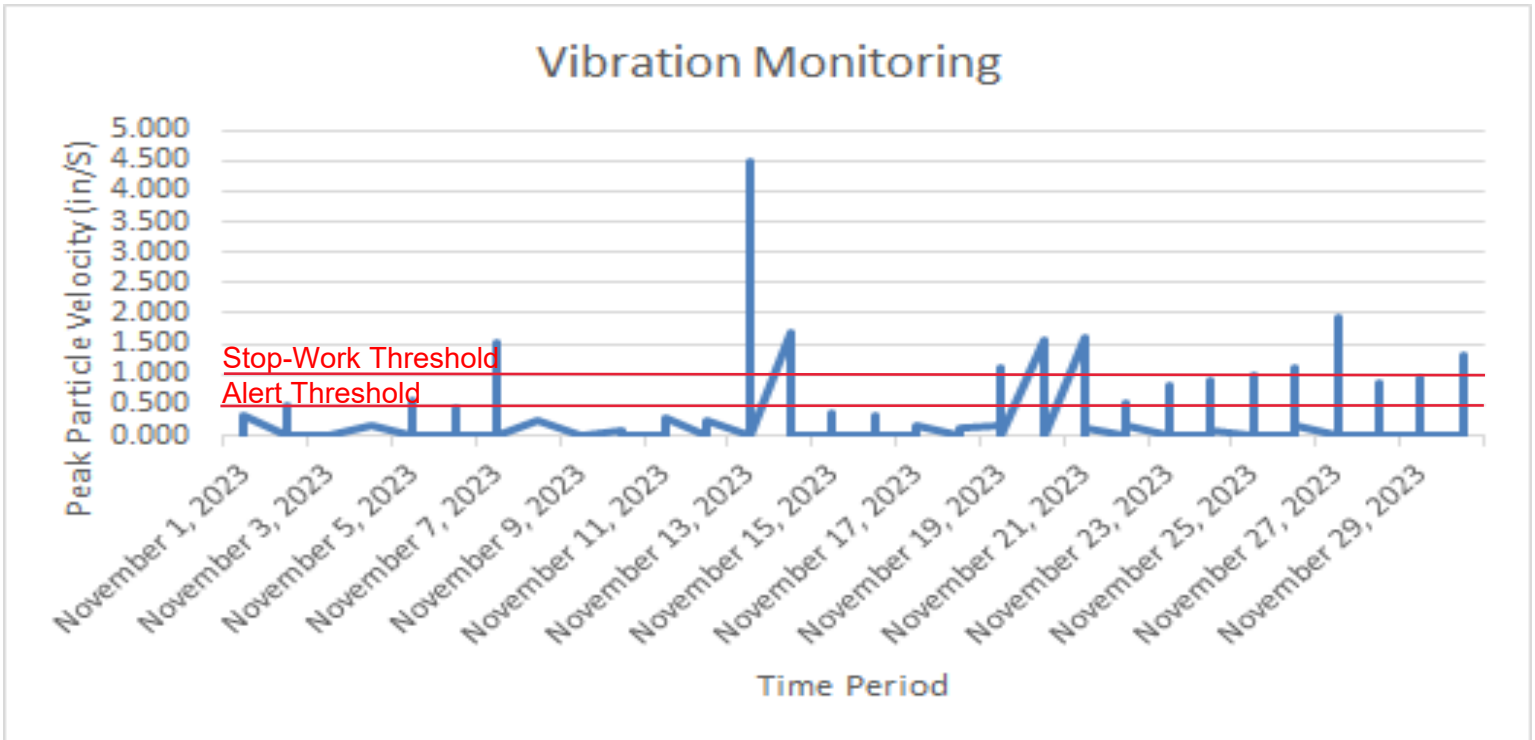
Vibration Monitor – VM-01 – November 2023:

Number of Workdays in a Month	Number of Vibration Monitoring Days in a Month	Number of Days with Vibration Levels above Action Levels by Month	Comments
23	30	21	Please see details below.

Date: Time	Exceedance Level Recorded (in/sec)	Ambient Vibration Level after Exceedance Recorded (in/sec)	Corrective Action
November 5, 2023; 06:16:11	0.529	0.014	No significant vibration-causing work taking place during this time (before start of workday, during lunch break, after end of work day)
November 5, 2023; 13:37:26	0.542	0.014	No deconstruction work taking place within 90' of sensor, trigger could have been rodents, heavy footsteps on metal cover plates, or debris from street falling into shaftway.
November 5, 2023; 14:56:26	0.578	0.014	No deconstruction work taking place within 90' of sensor, trigger could have been rodents, heavy footsteps on metal cover plates, or debris from street falling into shaftway.
November 7, 2023; 06:22:17	1.224	0.012	No significant vibration-causing work taking place during this time (before start of workday, during lunch break, after end of work day)
November 7, 2023; 06:23:38	1.444	0.012	No significant vibration-causing work taking place during this time (before start of workday, during lunch break, after end of work day)

November 7, 2023; 12:29:49	1.512	0.012	No deconstruction work taking place within 90' of sensor, trigger could have been rodents, heavy footsteps on metal cover plates, or debris from street falling into shaftway.
November 7, 2023; 17:40:57	1.124	0.012	No deconstruction work taking place within 90' of sensor, trigger could have been rodents, heavy footsteps on metal cover plates, or debris from street falling into shaftway.
November 13, 2023; 08:38:58	1.348	0.315	No deconstruction work taking place within 90' of sensor, trigger could have been rodents, heavy footsteps on metal cover plates, or debris from street falling into shaftway.
November 13, 2023; 10:47:54	4.419	0.315	No deconstruction work taking place within 90' of sensor, trigger could have been rodents, heavy footsteps on metal cover plates, or debris from street falling into shaftway.
November 13, 2023; 10:49:18	4.497	0.315	No deconstruction work taking place within 90' of sensor, trigger could have been rodents, heavy footsteps on metal cover

plates, or debris from street falling into shaftway.
November 14, 2023; 06:00:14	1.678	0.350	No significant vibration-causing work taking place during this time (before start of workday, during lunch break, after end of work day)
November 14, 2023; 14:13:55	1.087	0.350	No deconstruction work taking place within 90' of sensor, trigger could have been rodents, heavy footsteps on metal cover plates, or debris from street falling into shaftway.
November 19, 2023; 06:16:19	1.120	0.497	No significant vibration-causing work taking place during this time (before start of workday, during lunch break, after end of work day)
November 20, 2023; 06:00:14	1.552	0.012	No significant vibration-causing work taking place during this time (before start of workday, during lunch break, after end of work day)
November 21, 2023; 06:01:53	1.601	0.125	No significant vibration-causing work taking place during this time (before start of workday, during lunch break, after end of work day)

November 22, 2023; 06:18:45	0.550	0.162	No significant vibration-causing work taking place during this time (before start of workday, during lunch break, after end of work day)
November 23, 2023; 08:57:55	0.810	0.270	No deconstruction work taking place within 90' of sensor, trigger could have been rodents, heavy footsteps on metal cover plates, or debris from street falling into shaftway.
November 24, 2023; 08:01:02	0.818	0.070	No deconstruction work taking place within 90' of sensor, trigger could have been rodents, heavy footsteps on metal cover plates, or debris from street falling into shaftway.
November 24, 2023; 08:34:19	0.908	0.070	No deconstruction work taking place within 90' of sensor, trigger could have been rodents, heavy footsteps on metal cover plates, or debris from street falling into shaftway.
November 25, 2023; 08:06:48	0.995	0.480	No deconstruction work taking place within 90' of sensor, trigger could have been rodents, heavy footsteps on metal cover plates, or debris from street falling into shaftway.

November 26, 2023; 11:33:49	1.121	0.150	No deconstruction work taking place within 90' of sensor, trigger could have been rodents, heavy footsteps on metal cover plates, or debris from street falling into shaftway.
November 26, 2023; 12:51:45	0.582	0.150	No deconstruction work taking place within 90' of sensor, trigger could have been rodents, heavy footsteps on metal cover plates, or debris from street falling into shaftway.
November 27, 2023; 14:58:31	1.926	0.014	No deconstruction work taking place within 90' of sensor, trigger could have been rodents, heavy footsteps on metal cover plates, or debris from street falling into shaftway.
November 28, 2023; 06:16:21	0.881	0.015	No significant vibration-causing work taking place during this time (before start of workday, during lunch break, after end of work day)

November 29, 2023; 06:24:49	0.947	0.297	No significant vibration-causing work taking place during this time (before start of workday, during lunch break, after end of work day)
November 29, 2023; 10:27:55	0.929	0.297	No deconstruction work taking place within 90' of sensor, trigger could have been rodents, heavy footsteps on metal cover plates, or debris from street falling into shaftway.
November 30, 2023; 14:26:03	1.305	0.015	No deconstruction work taking place within 90' of sensor, trigger could have been rodents, heavy footsteps on metal cover plates, or debris from street falling into shaftway.

No corrective actions or mitigations measures were required this month as the alerts were triggered due to manual disturbance of the sensor during off hours as well as during work hours.
