**AIR, NOISE AND VIBRATION
MONTHLY MONITORING REPORT
Number 013 – August 2023**

Prepared By:
Gramercy
Group Inc.

DDC. Project ID:	BBJ M DSS	Period Start: 8/01/23 End 8/31/23	
Project Name:	NYC Borough Based Jails System – Manhattan Dismantle and Swing Space		
DDC Pin No.:	8502021CR0004P-06P

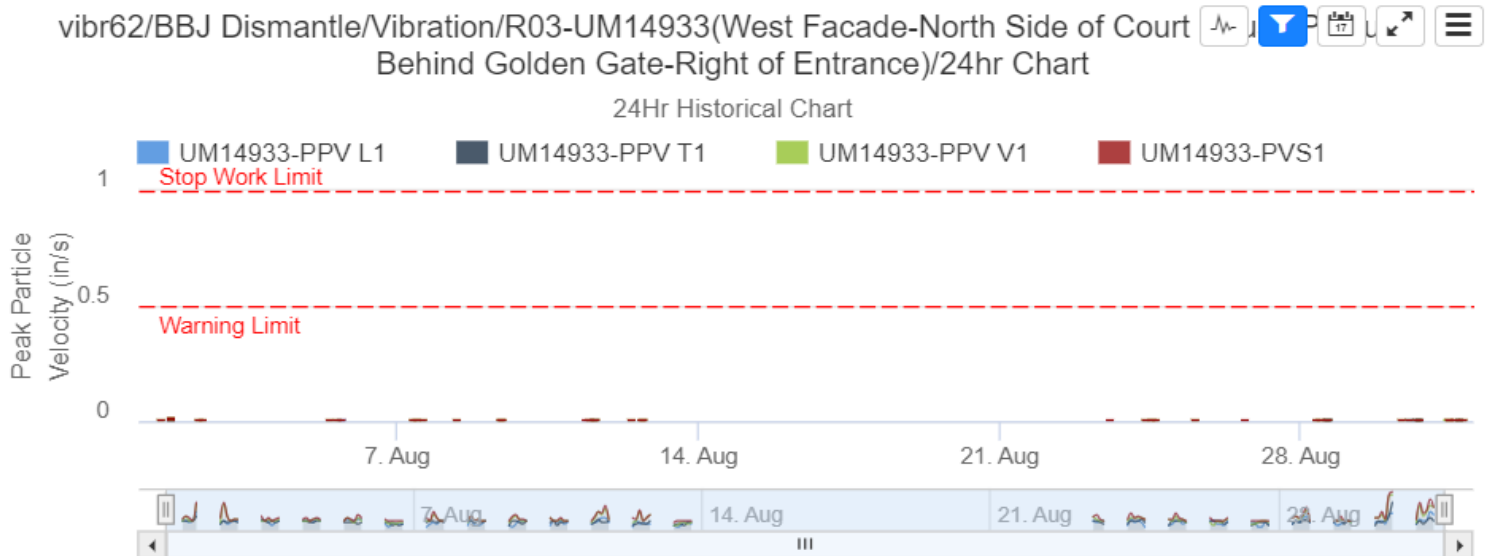
Vibration Monitor – (R03) August 23:

- R03 (the furthest monitor from the site) was down for the period shown below. This was due to one of the components needing to be replaced. Vibranalysis ordered the new part and serviced the unit and was functioning properly again. We would like to reiterate that even though the monitor was down, the other vibration monitors in this area serve as coverage to ensure that vibration from the site is still below threshold.

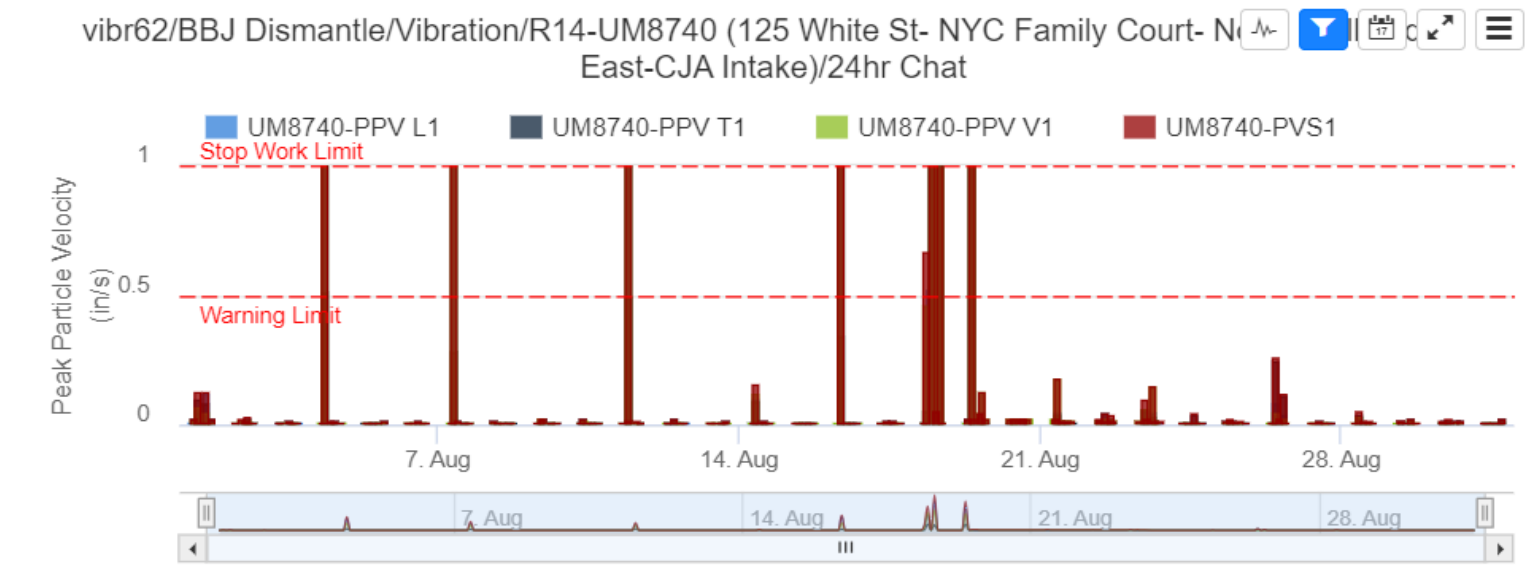
Vibration Monitor – (R14) August 23:

Number of Workdays in a Month	Number of Vibration Monitoring Days in a Month	Number of Days with Vibration Levels above Action Levels by Month (in/sec)	Comments
22	31	8	All Vibration alerts were from R14 located in the CJA intake area. This is the monitor that gets knocked / bumped into by either officer or inmates during their processing procedures. R11 also had 2 warnings during the month of August which are below the limit. We took every alert seriously and made sure it was not caused by our operations. We are in the process of relocating this monitor to a place in that area that will be more out of their way so we can stop having these false alarms.

During the Month of August 2023, there were 6 vibration monitor exceedances shown above, and 2 warnings. When we got these alerts, they were investigated immediately..), I also want to reiterate that Vibration Monitor R14 located in the CJA Intake area that goes off multiple times every month due to all the foot traffic in this space and people physically hitting into the monitor. We still investigate this every time it happens, and we continue to remind the personnel in this area to be mindful of the monitor. None of the exceedances from R14 are related to construction activity. Vibration monitors R01 and R02 were off during 08/13 – 08/22 due to connection issues. Both monitors had the antennas swapped for larger ones that hold a better connection and since then the issue has been resolved. Vibration monitor R03 (the furthest monitor from the site) was down due to component needing to be replaced within the modem. Vibrabalysis ordered the new part and serviced the unit and was functioning properly again. We would like to reiterate that even though the monitor was down, the other vibration monitors in this area serve as coverage to ensure that vibration from the site is still below the threshold.

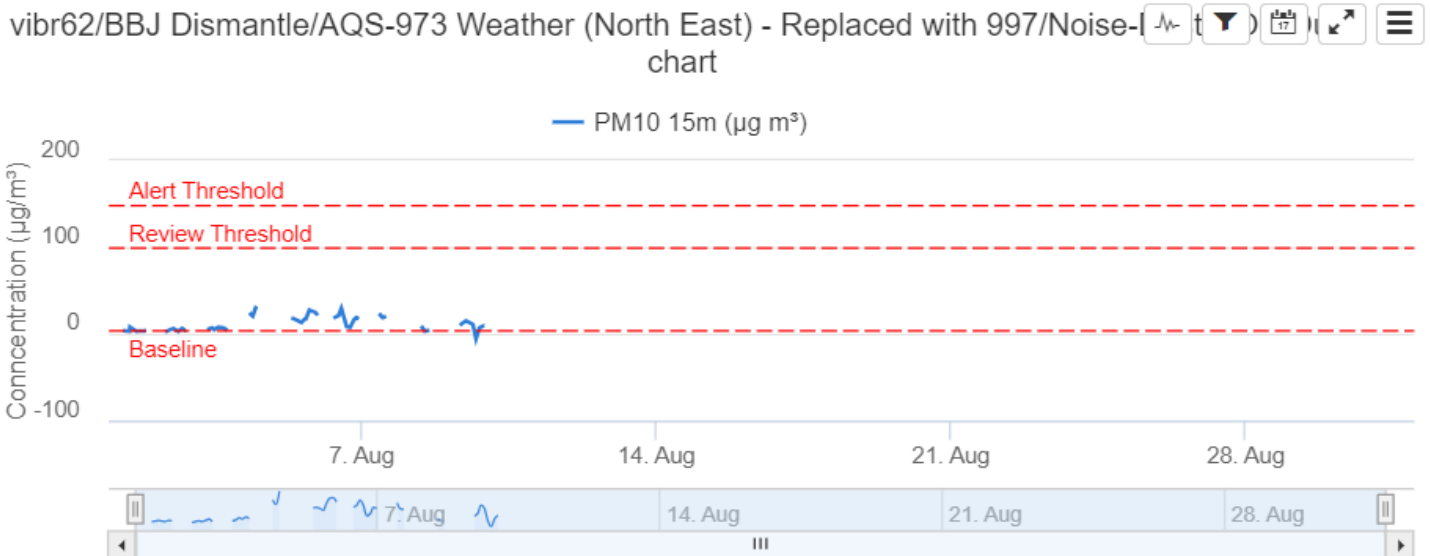
Air Quality Systems #973 – Dust Monitoring Station – August 23:

- Note that this monitor was swapped for a new one due to technical issues. The new monitor for this location is AQS #997. This data is shown below.

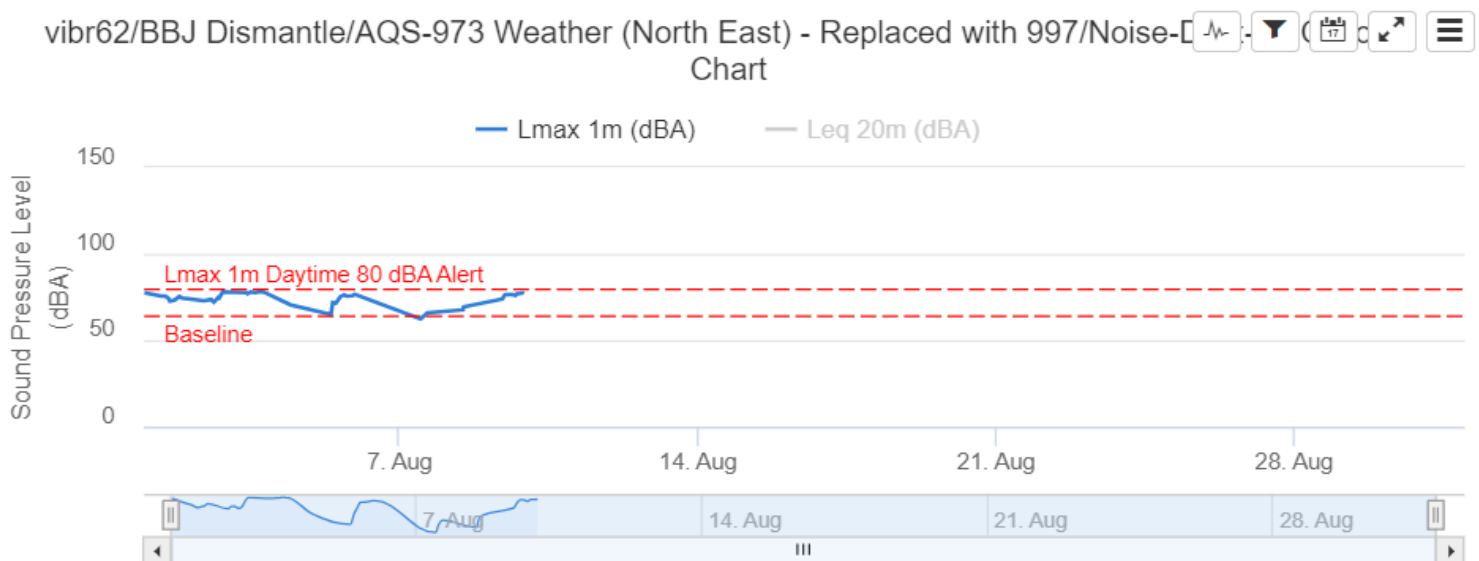
Air Quality Systems #973 – Noise Monitoring Station – August 23:

- Note that this monitor was swapped for a new one due to technical issues. The new monitor for this location is AQS #997. This data is shown below.

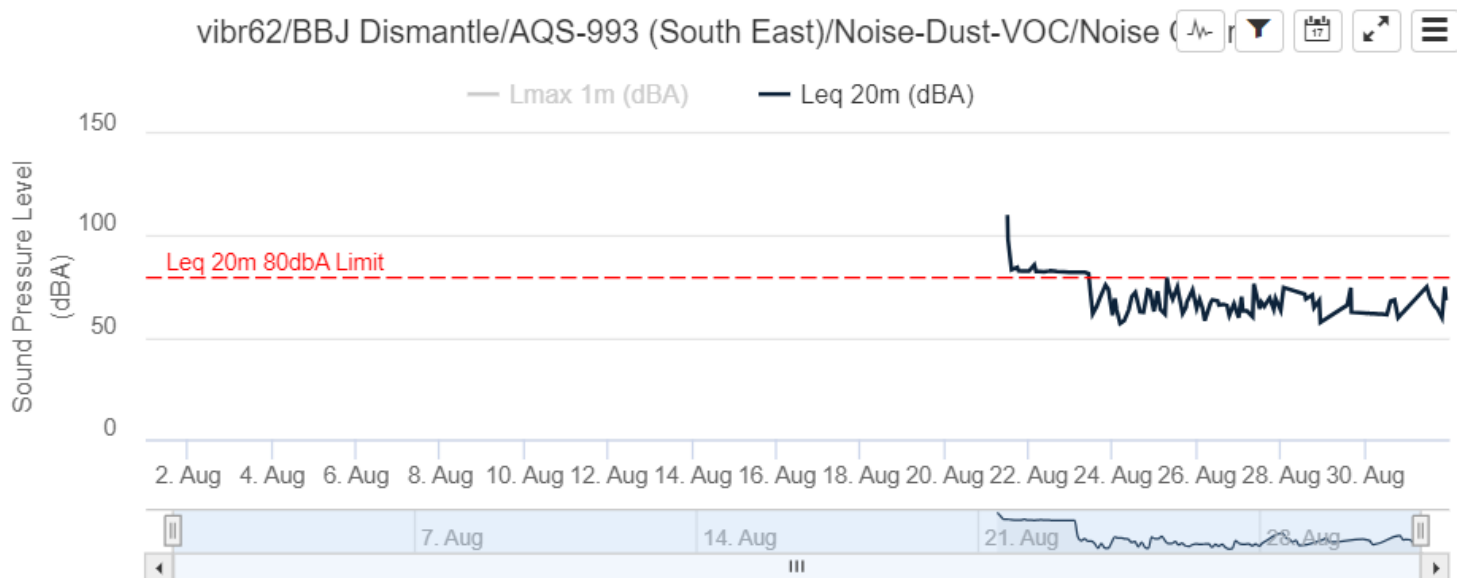
Air Quality Systems #993 – Noise Monitoring Station – August 23:

- Note that this Monitor was running and on for the entire month of August as shown above for the air quality data. However, the speaker for the noise was broken. Since then, Vibranalysis came out and fixed the monitor where you see the data begin and that's why there is that big spike. This Spike was due to installation and maintenance on the monitor.

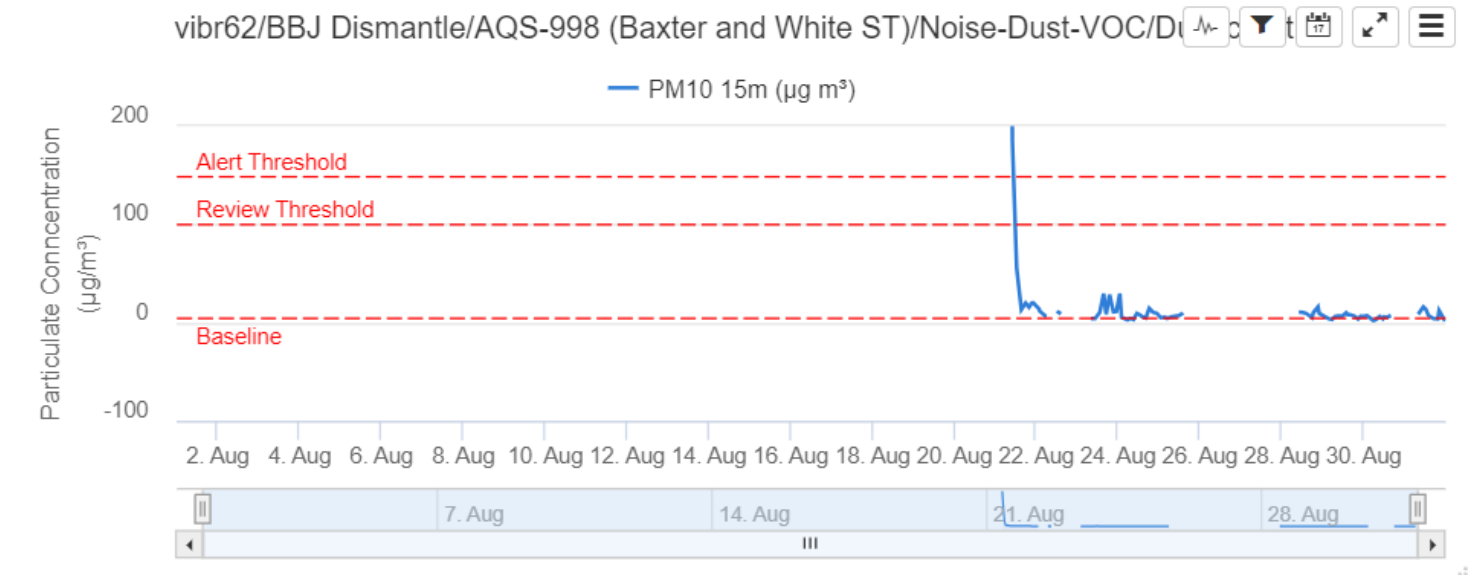
Air Quality Systems #998 – Dust Monitoring Station – August 23:

- Note that the gap in the data is from when we took this monitor out from our site and had it relocated directly on Baxter Street in front of the residences to get more accurate noise/air quality data for them.

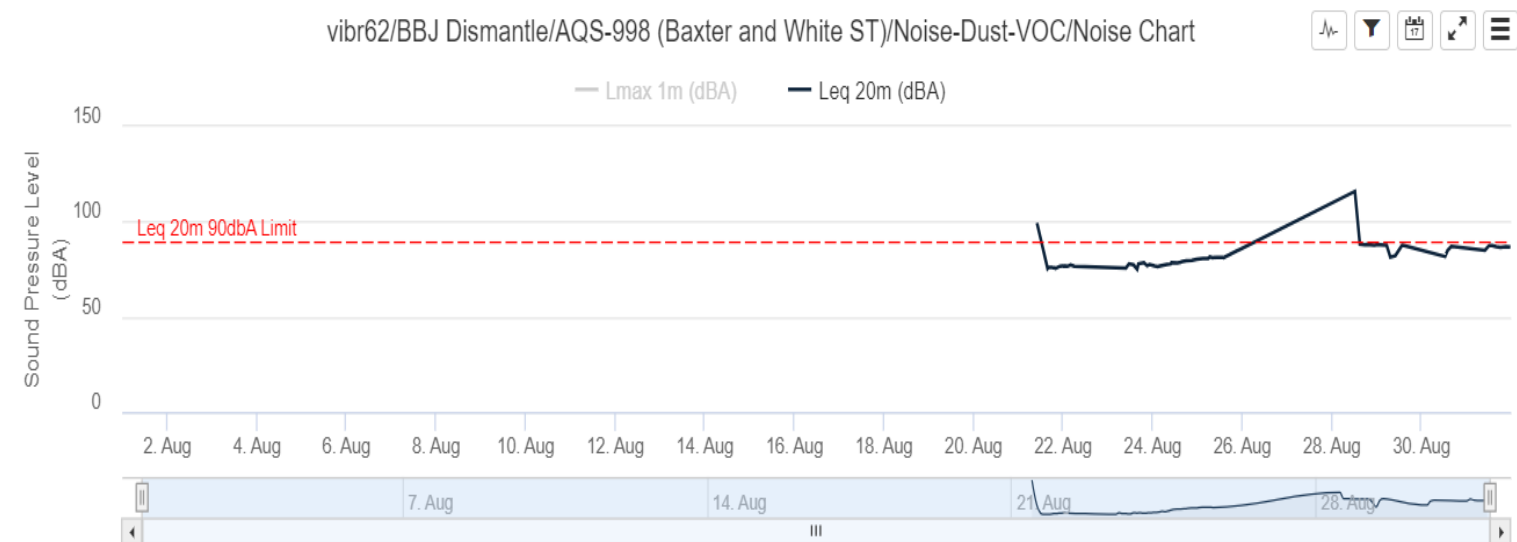
Air Quality Systems #998 – Noise Monitoring Station – August 23:

During the month of August, we experienced noise levels greater than the alert threshold AQS monitor #998, #993, #977, & #997. After investigation of the cause of these spikes in noise in this area, it was noted that these alerts were not caused by construction activity. As stated in the last report, AQS #998 was to be relocated from inside of our site to across the street on the residential side of Baxter to get more accurate readings. (see data below) This monitor experienced an exceedance but it was during the crews lunch break I was unable to pin point the exact cause of the exceedance but its safe to say probably caused by traffic or sirens as our site was not active at 12:21 PM. The additional exceedance shown for the month of August from AQS #993 was also a false reading. The exceedance shown was caused during a recalibration / service for a faulty piece of equipment that needed to be replaced. This was confirmed when we got the alert I went out and was able to make contact with the technician from Vibranalysis and he said it was due to him servicing the microphone of the monitor. For AQS #977, as stated above, this exceedance did happen on a Saturday that we were working. However, it was at 5:30 PM and the site closed at 3:30 PM. AQS #997 was mobilized onto Baxter Street on 8/23/23, the installation of this monitor was the reason there is an initial spike as shown on the graph.

- Note that the gap in the data is from when we took this monitor out from our site and had it relocated directly on Baxter Street in front of the residences to get more accurate noise/air quality data for them.

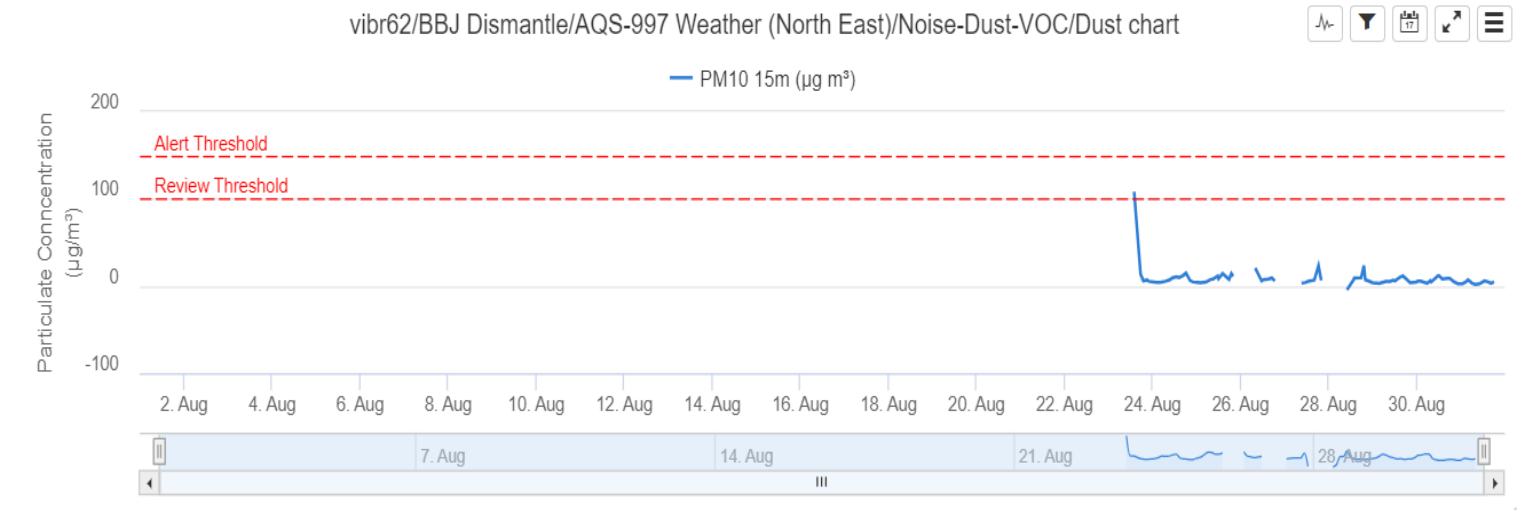
Air Quality Systems #997 – Dust Monitoring Station – August 23:

- Please note that this is the monitor that took the place of AQS #973 as stated above.

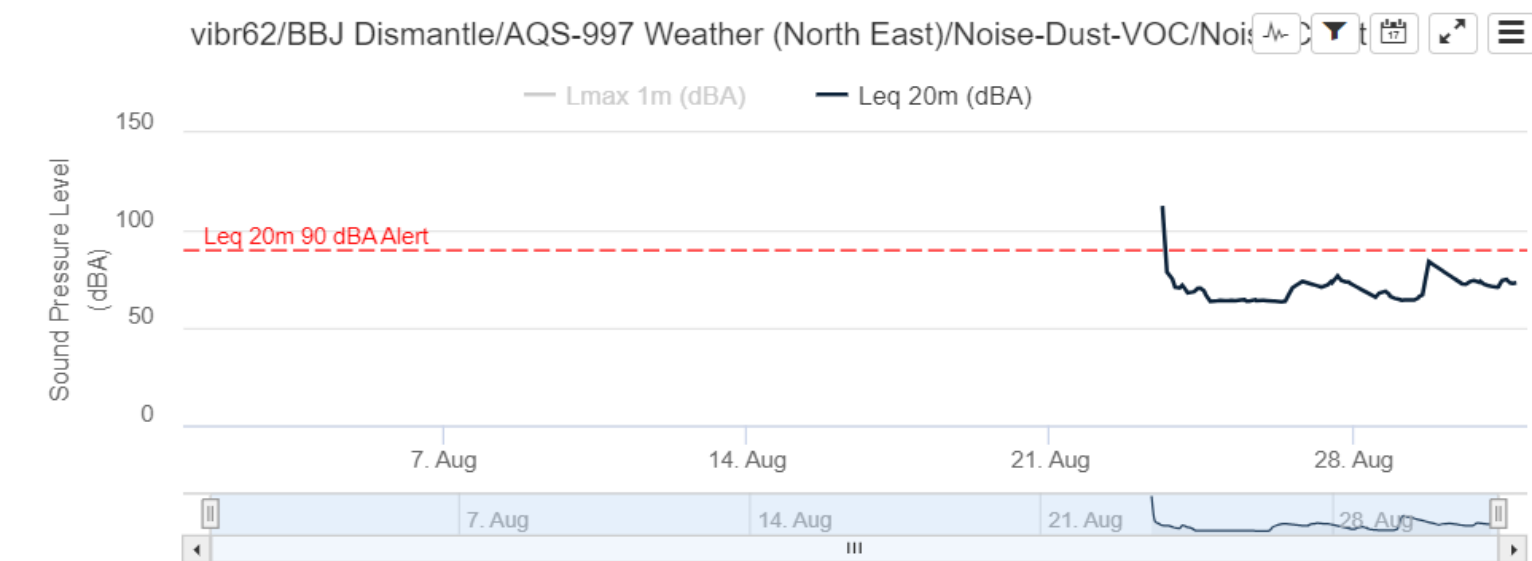
Air Quality Systems #997 – Noise Monitoring Station – August 23:

- Please note that this is the monitor that took the place of AQS #973 as stated above.
