**AIR, NOISE AND VIBRATION
MONTHLY MONITORING REPORT
Number 013 – August 2023**

Prepared By:
Gramercy
Group Inc.

DDC. Project ID:	BBJ M DSS	Period Start: 8/01/23 End 8/31/23	
Project Name:	NYC Borough Based Jails System – Manhattan Dismantle and Swing Space		
DDC Pin No.:	8502021CR0004P-06P

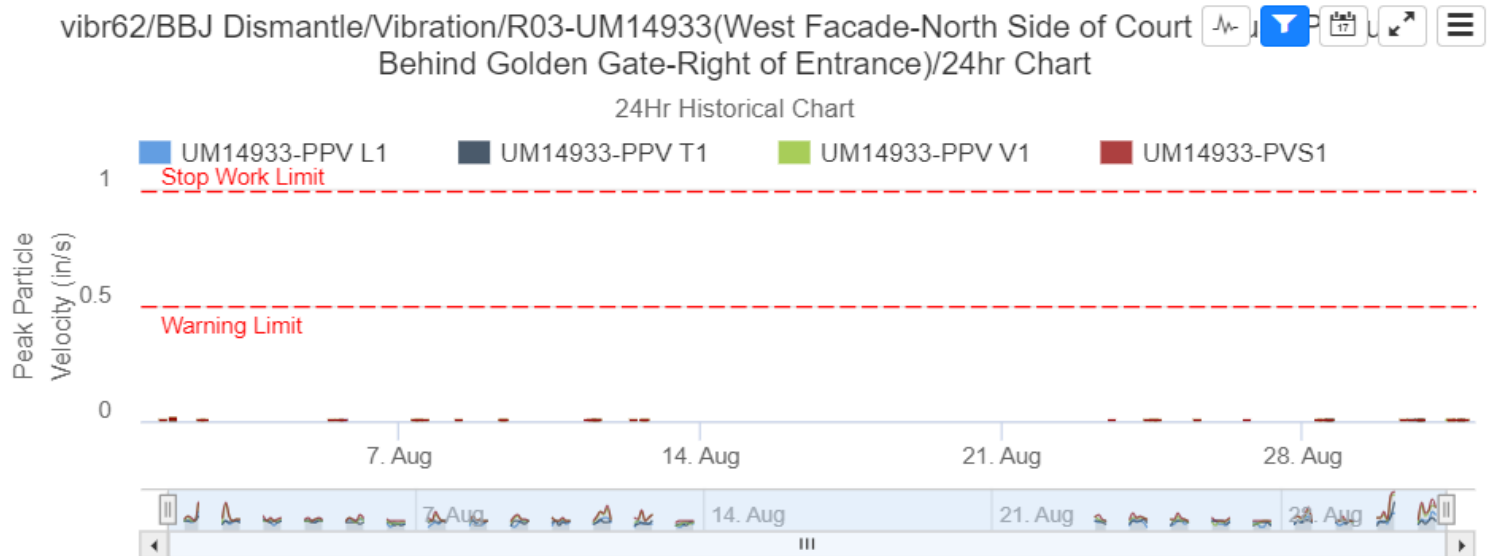
Vibration Monitor – (R03) August 23:

- R03 (the furthest monitor from the site) was down for the period shown below. This was due to one of the components needing to be replaced. Vibranalysis ordered the new part and serviced the unit and was functioning properly again. We would like to reiterate that even though the monitor was down, the other vibration monitors in this area serve as coverage to ensure that vibration from the site is still below threshold.

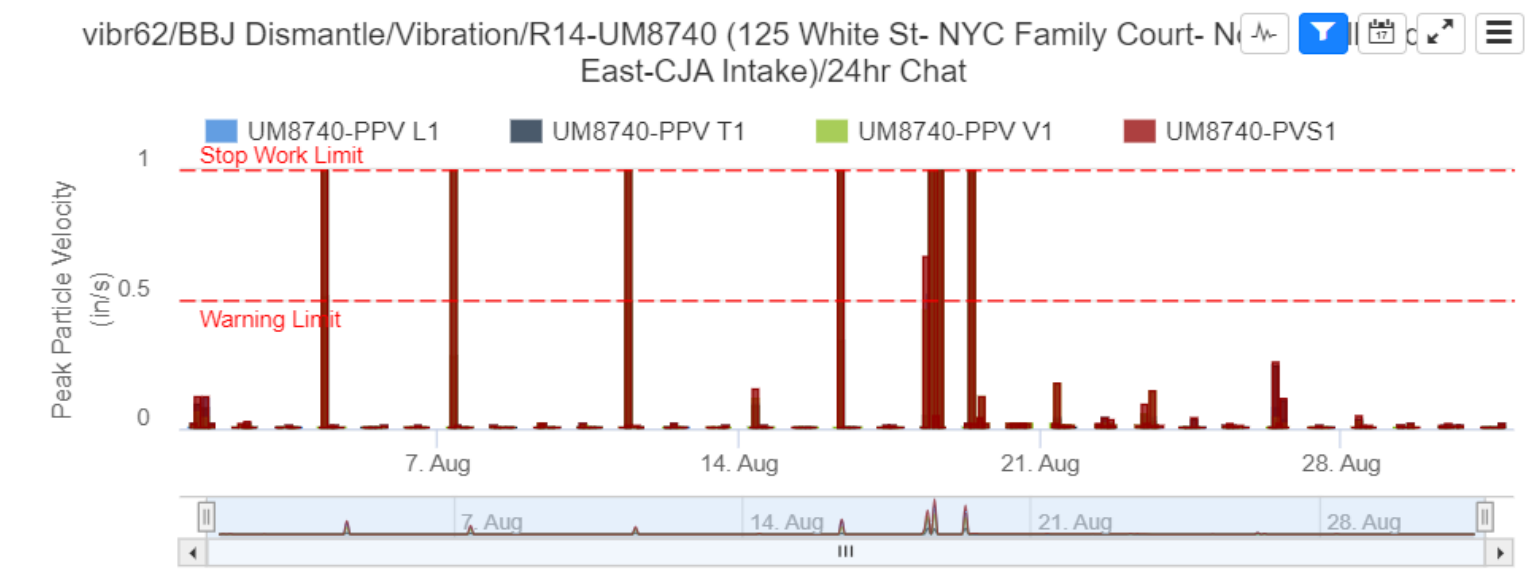
Vibration Monitor – (R14) August 23:

Number of Workdays in a Month	Number of Vibration Monitoring Days in a Month	Number of Days with Vibration Levels above Action Levels by Month (in/sec)	Comments
22	31	8	All Vibration alerts were from R14 located in the CJA intake area. This is the monitor that gets knocked / bumped into by either officer or inmates during their processing procedures. R11 also had 2 warnings during the month of August which are below the limit. We took every alert seriously and made sure it was not caused by our operations. We are in the process of relocating this monitor to a place in that area that will be more out of their way so we can stop having these false alarms.

During the Month of August 2023, there were 6 vibration monitor exceedances shown above, and 2 warnings. When we got these alerts, they were investigated immediately..), I also want to reiterate that Vibration Monitor R14 located in the CJA Intake area that goes off multiple times every month due to all the foot traffic in this space and people physically hitting into the monitor. We still investigate this every time it happens, and we continue to remind the personnel in this area to be mindful of the monitor. None of the exceedances from R14 are related to construction activity. Vibration monitors R01 and R02 were off during 08/13 – 08/22 due to connection issues. Both monitors had the antennas swapped for larger ones that hold a better connection and since then the issue has been resolved. Vibration monitor R03 (the furthest monitor from the site) was down due to component needing to be replaced within the modem. Vibrabalysis ordered the new part and serviced the unit and was functioning properly again. We would like to reiterate that even though the monitor was down, the other vibration monitors in this area serve as coverage to ensure that vibration from the site is still below the threshold.

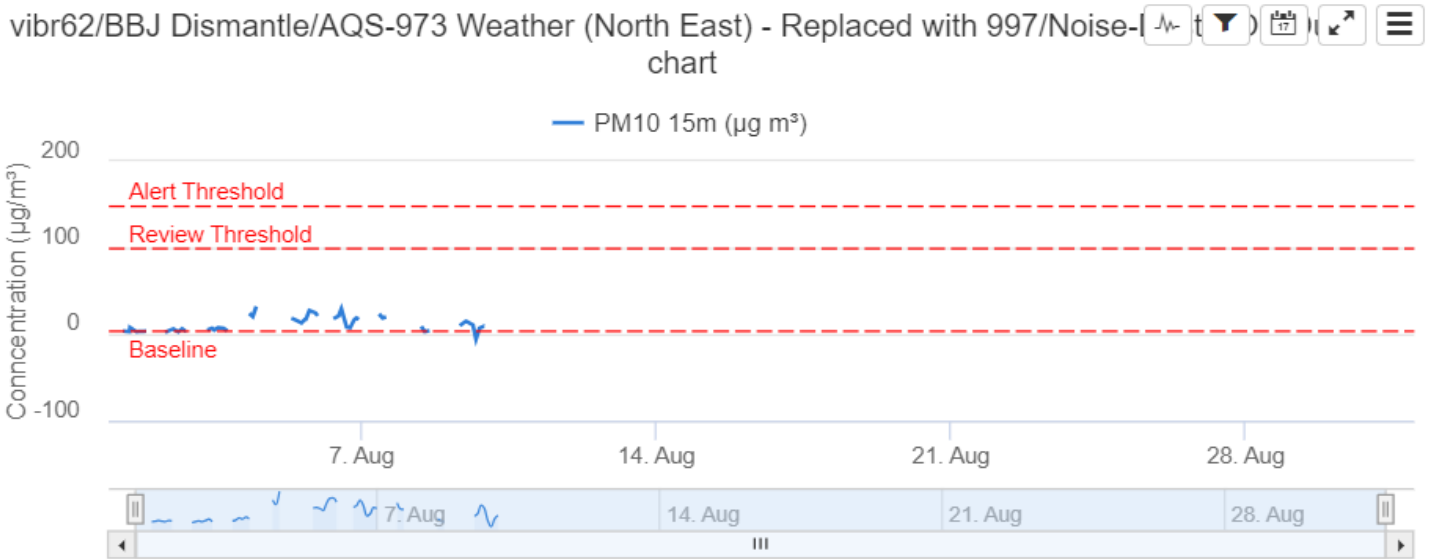
Air Quality Systems #973 – Dust Monitoring Station – August 23:

- Note that this monitor was swapped for a new one due to technical issues. The new monitor for this location is AQS #997. This data is shown below.

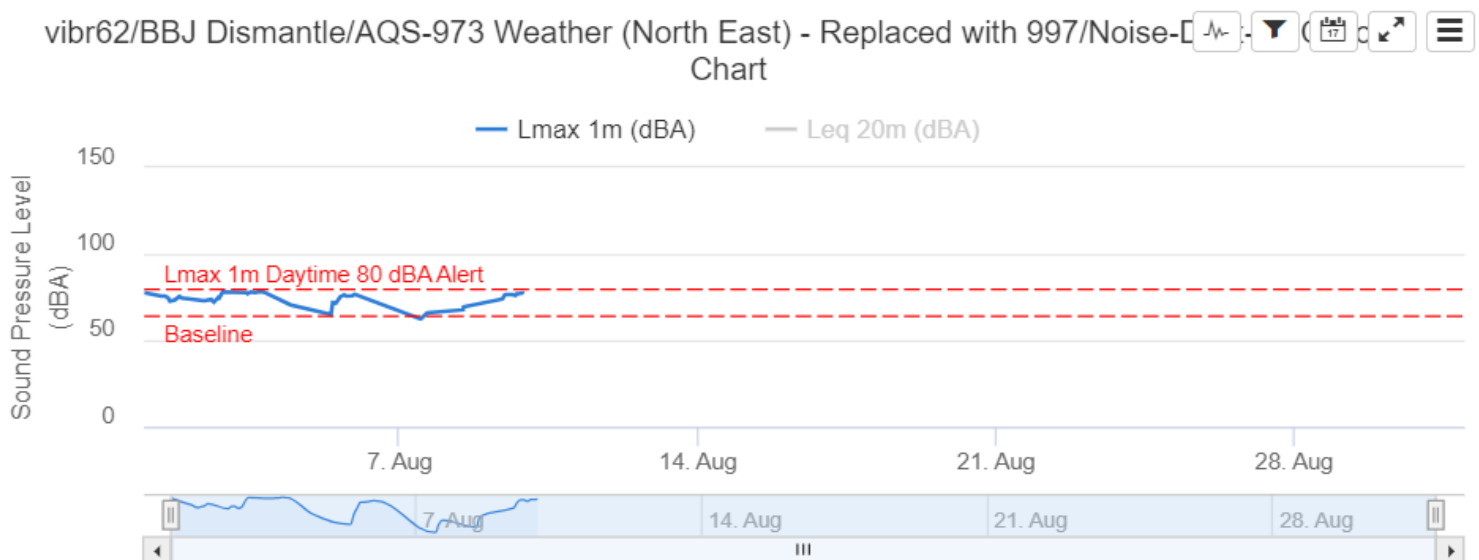
Air Quality Systems #973 – Noise Monitoring Station – August 23:

- Note that this monitor was swapped for a new one due to technical issues. The new monitor for this location is AQS #997. This data is shown below.

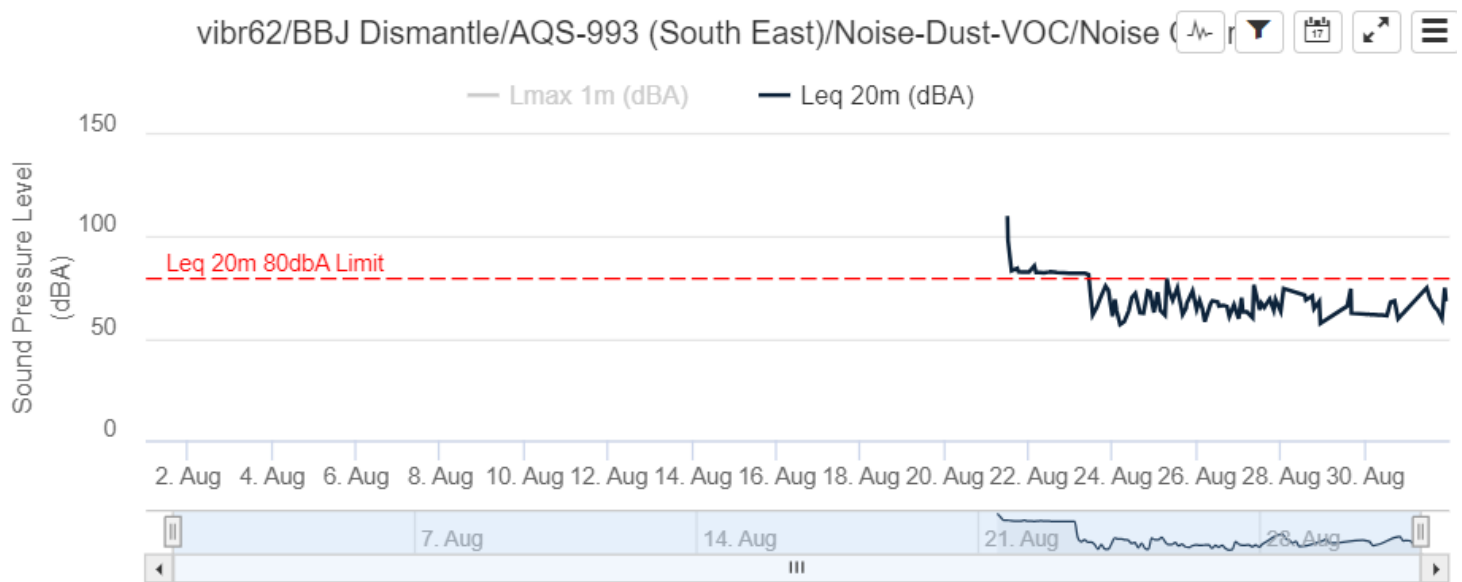
Air Quality Systems #993 – Noise Monitoring Station – August 23:

- Note that this Monitor was running and on for the entire month of August as shown above for the air quality data. However, the speaker for the noise was broken. Since then, Vibranalysis came out and fixed the monitor where you see the data begin and that's why there is that big spike. This Spike was due to installation and maintenance on the monitor.

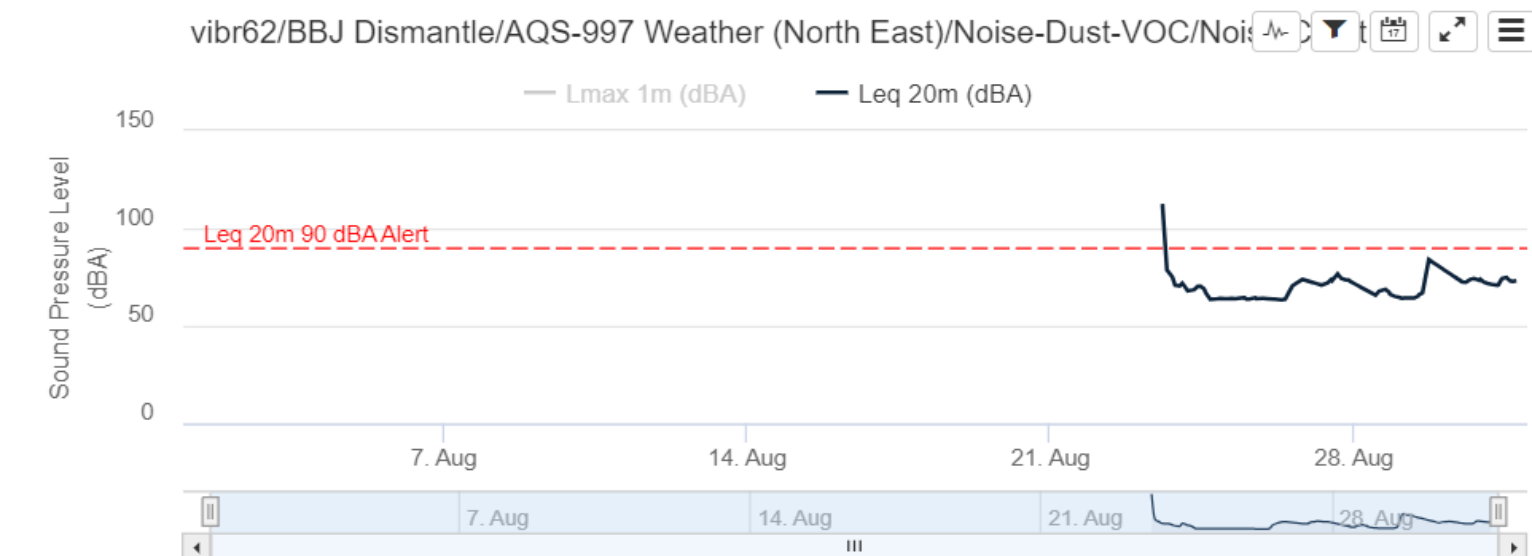
Air Quality Systems #997 – Noise Monitoring Station – August 23:

- Please note that this is the monitor that took the place of AQS #973 as stated above.
