**AIR, NOISE AND VIBRATION
MONTHLY MONITORING REPORT
Number 008**

DDC Pin No.:	BBJ-XSP	Period Start: 3/1/23 End 3/31/23
Project Name:	NYCDDC D&B – The Bronx Site Preparation	
DDC Project No.:	8502021CR0004P-06P

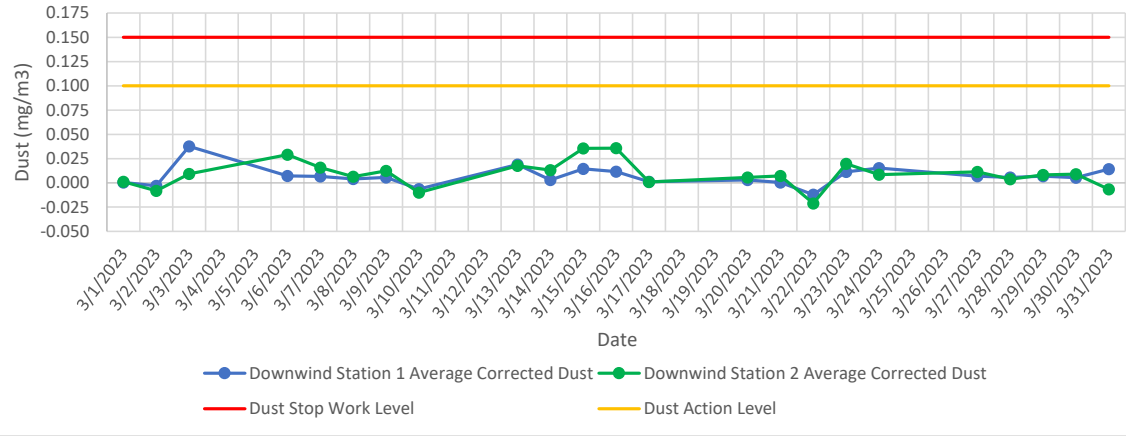
March 2023, 15-min Running Average Air Quality Data, PM 10ug/m3 Plot

Date: Time	Maximum Dust Reading Before Corrective Action 15 Minute TWA (ug/m ³)	Maximum Dust Reading After Corrective Action 15 Minute TWA (ug/m ³)	Corrective Action
3/16/23 8:40am	132	78	An elevated reading was caused by dust from rock drilling activities. Work was stopped until particulate matter concentrations returned under the exposure limit.
3/27/23 7:05am	166	-5	An elevated reading was caused by dust from rock scraping activities. Work was stopped and watering was implemented within the work area.
3/31/23 7:08am	182	19	Two elevated readings were caused by dust during rock drilling for an anchor bolt installation. This activity ceased and particulate matter concentrations returned to under the exposure limit after work was

stopped.
<p>Narrative Summary of Air Monitoring, Excursions and Corrective Actions: <i>In March 2023, construction-related levels of Particulate Matter (PM) PM10 did surpass the Daily Permissible Exposure Limits (PEL) as set by federal standards for the 8-hour Time Weighted Average (TWA) and did cause air quality concerns to the community and/or onsite workers.</i></p>			
<p>2) Community Noise Monitoring Weekly Summary Units to be determined (TBD) typically a weighted decibels (dBA) level</p>			
Number of Workdays in a Month	Number of Noise Monitoring Days in a Month	Number of Days with Noise Levels above Action Levels by Month	Comments
23	23	5	There were five instances of noise levels above the 80 dBA limit. Instances occurred on 3/1, 3/2, 3/3, 3/15, and 3/31 and are detailed below.

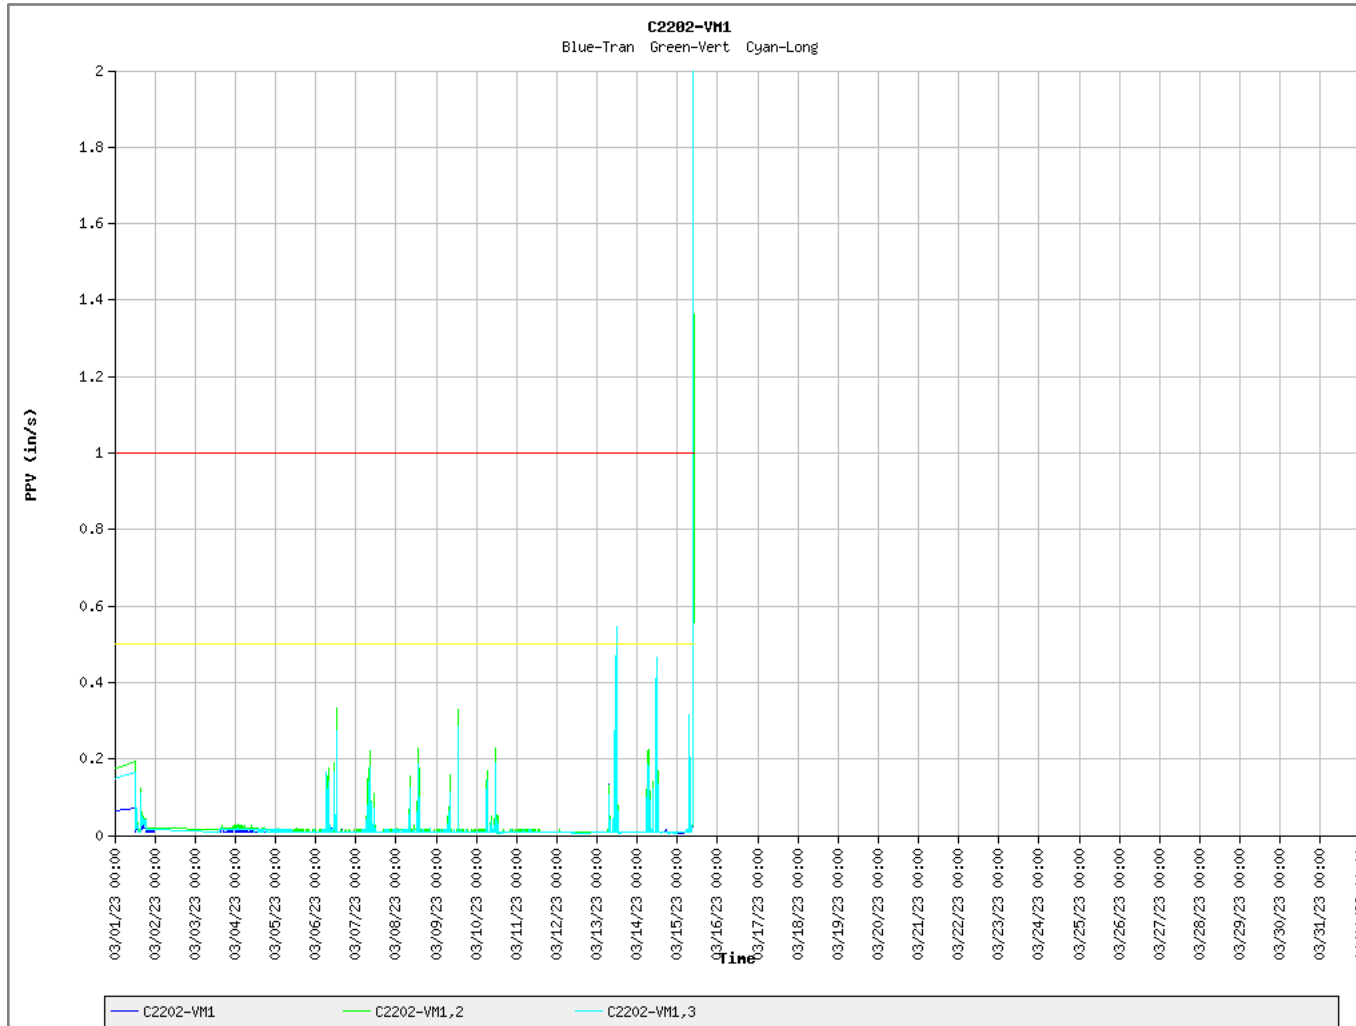
The Bronx Site Preparation March 2023 Vibration Monitoring Data Plots

Date: Time	Maximum Vibration Level before Corrective Action (in/sec)	Maximum Vibration Level after Corrective Action (in/sec)	Corrective Action
3/13/2023 12:31	0.545	0.17	Exceedances observed at VM1 were caused by backfilling near the sensor.
3/15/2023 10:17 to 11:01	9.78	N/A	Cable of VM1 was found cut on 3/16/23. As the remaining construction work that requires vibration monitoring is 50 ft away from VM1, Wang was instructed to remove VM1 on 3/16/23.
3/7/2023 18:26 & 19:17	0.915	0.075	Exceedances observed at VM5 were recorded during non-construction hours.
3/15/2023 08:04	0.5	0.035	This is an isolated event recorded at VM5. Residents have access to the sensor.
3/15/2023 13:29	0.53	0.485	This is an isolated event recorded at VM5. Residents have access to the sensor.
3/16/2023 11:08	0.535	0.315	This is an isolated event recorded at VM5. Residents have access to the sensor.
3/21/2023 05:54	0.88	0.01	Exceedance observed at VM5 was recorded during non-construction hours.

The exceedance recorded at VM1 on March 13th was caused by backfilling near the sensor. The exceedances recorded at VM1 on March 15th were caused by a cut cable. As the remaining construction work that requires vibration monitoring is 50 ft away from VM1, Wang was instructed to remove VM1 on March 16th.

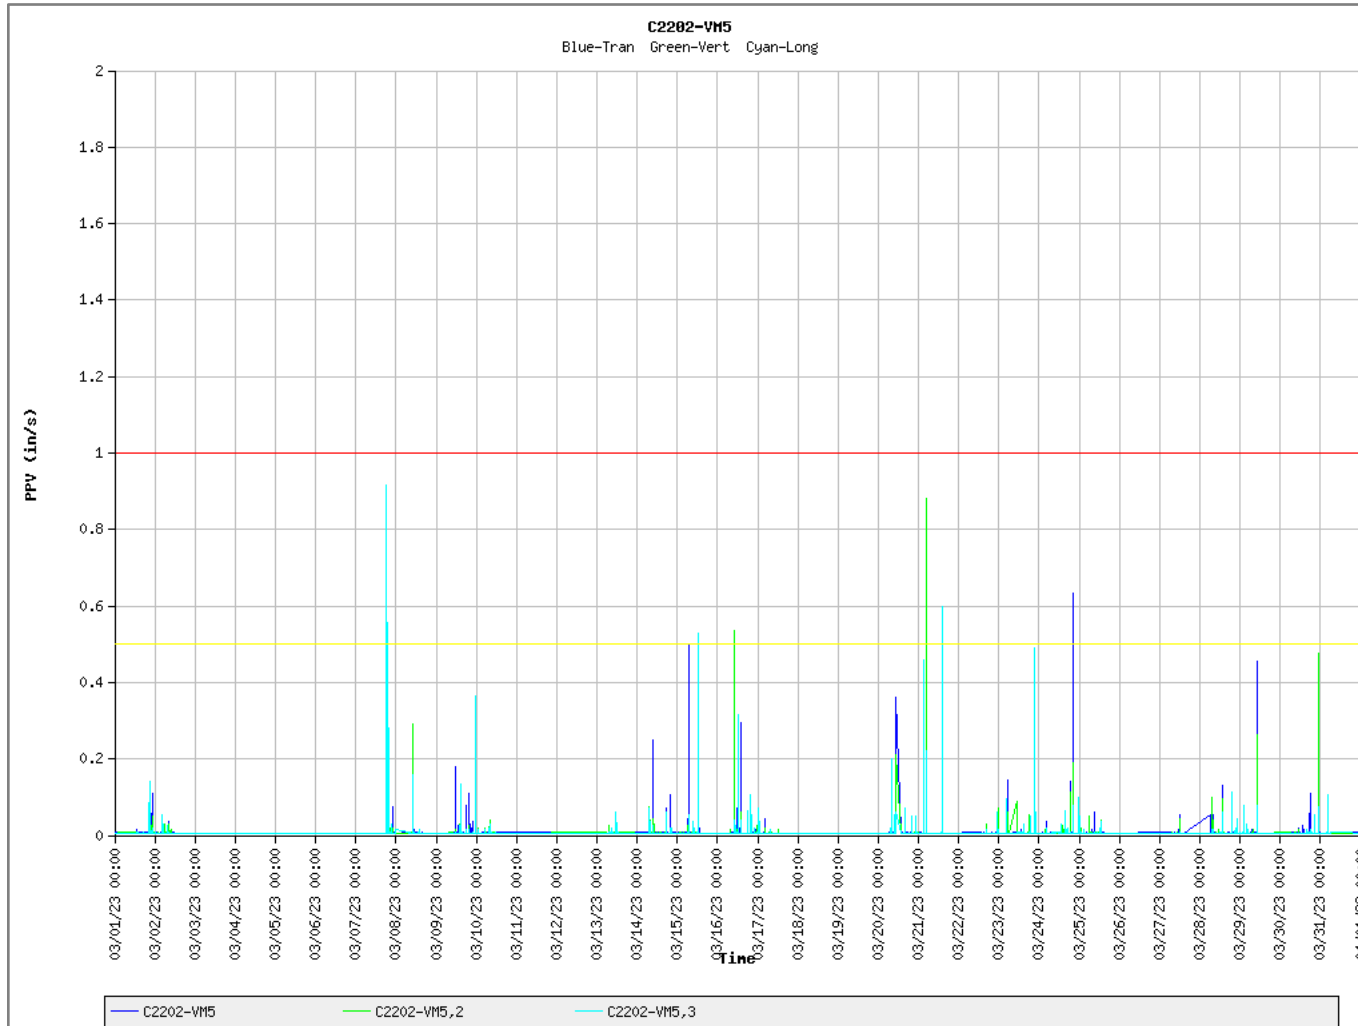
The Bronx Site Preparation March 2023 Vibration Monitoring Data Plots

3/21/2023 15:22	0.6	0.06	Exceedance observed at VM5 was recorded during non-construction hours.
3/24/2023 21:20	0.635	0.005	Exceedance observed at VM5 was recorded during non-construction hours.
3/1/2023 17:03	0.675	0.025	Exceedance observed at VM6 was recorded during non-construction hours.
3/3/2023 09:54	1.172	0.05	Exceedance observed at VM9 was caused by Wang testing the sensor.
3/3/2023 11:59	0.916	0.208	This is an isolated event recorded at VM9, likely caused by disturbance. No corrective actions or mitigation measures were required.

In March 2023, four vibration monitors had recorded exceedances. There were exceedances recorded during non-construction hours at VM5 and VM6. There were isolated events recorded at VM5, where residents have access to the sensor as it is installed in the basement of a residential building. There were isolated events recorded at VM5 during baseline period as well. Two isolated events were recorded at VM9 on March 3rd, the first event was caused by Wang testing the sensor. For the second event, per GC, no vibratory work was performed near the sensor, the exceedance was likely caused by disturbance. Therefore, no corrective actions or mitigation measures were required.
