#### AIR, NOISE AND VIBRATION MONTHLY MONITORING REPORT Number 001

DDC. Project ID:		BBJ-XSP		Period Start: 11/1/22 End 11/30/22						
Project Name:		NYCDDC D&B – The Bronx Site Preparation								
DDC Pin No.:		8502021CR0004P-06P

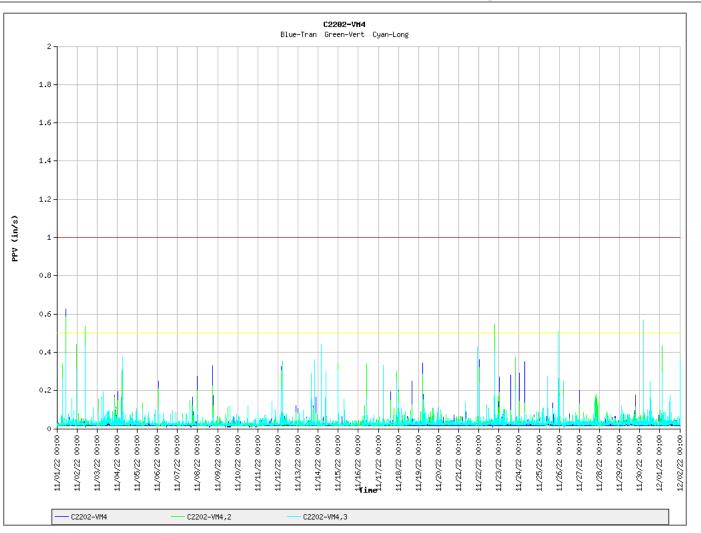
C2202-VM4 Transverse C2202-VM4,2 Vertical C2202-VM4,3 Longitudinal

11/2/2022 10:05	0.535	0.11	This is an isolated event recorded at VM4 location. Laborers installing water misters along fence near sensor this isolated event.					
11/22/2022 17:40	0.545	N/A	Exceedance observed at VM4 was recorded during non-construction hours.					
11/25/2022 21:59	0.51	N/A	Exceedance observed at VM4 was recorded during non-construction hours.					
11/30/2022 03:23	0.57	N/A	Exceedance observed at VM4 was recorded during non-construction hours.					
11/4/2022 12:23	0.525	0.485	This is an isolated event recorded at VM5 location. Residents have access to the sensor.					
11/9/2022 22:23	0.575	N/A	Exceedance observed at VM5 was recorded during non-construction hours.					
11/11/2022 06:37	0.525	N/A	Exceedance observed at VM5 was recorded during non-construction hours.					
11/15/2022 12:34	0.91	0.11	This is an isolated event recorded at VM5 location. Residents have access to the sensor.

There was exceedance recorded at VM4 on November 1<sup>st</sup> and 2<sup>nd</sup>. Laborers were installing water misters along the fence located near sensor which caused the exceedances. Once completed, the readings returned to be within the project threshold afterwards.

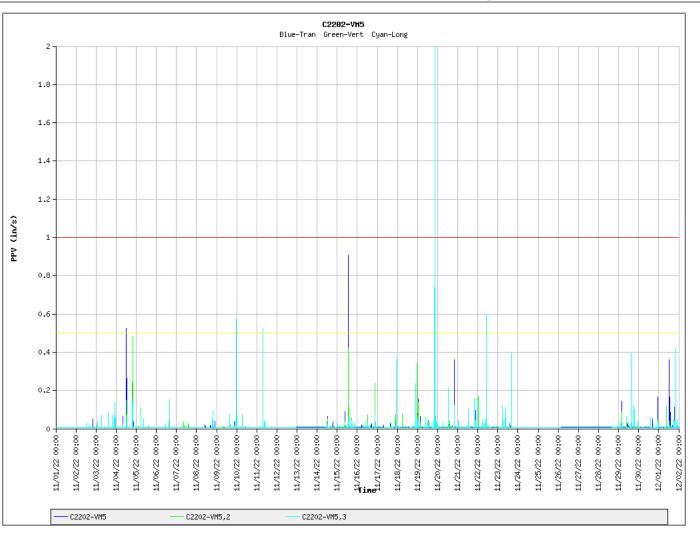
C2202-VM5 Transverse C2202-VM5,2 Vertical C2202-VM5,3 Longitudinal

11/19/2022 19:13 & 19:49	2.06	N/A	Exceedances observed at VM5 were recorded during non-construction hours.					
11/22/2022 09:25	0.6	0.02	This is an isolated event recorded at VM5 location. Residents have access to the sensor.

VM5 is installed in the basement of a residential building, where third-party are able to access to the sensor. There were isolated events recorded at VM5 during baseline period as well.
