**AIR, NOISE AND VIBRATION
MONTHLY MONITORING REPORT
Number 005**

DDC. Project ID:	BBJ-XSP	Period Start: 12/1/22 End 12/31/22
Project Name:	NYCDDC D&B – The Bronx Site Preparation	
DDC Pin No.:	8502021CR0004P-06P

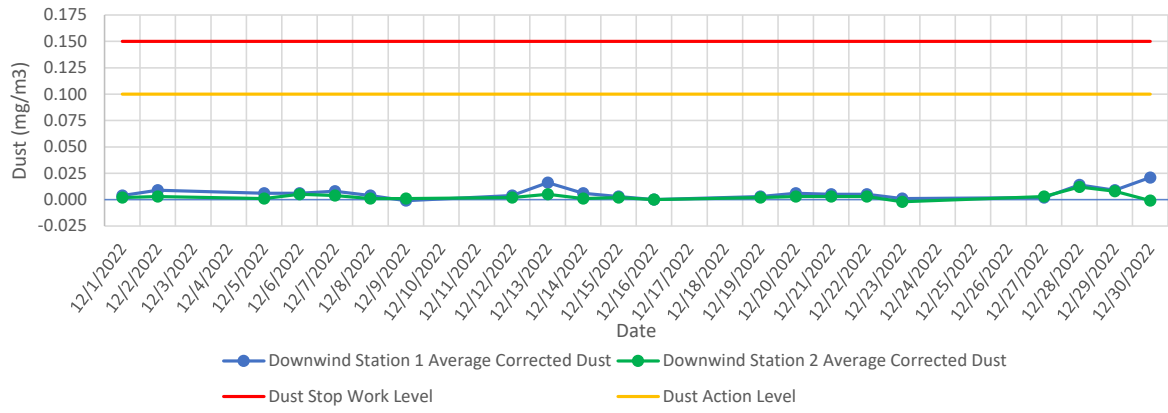
December 2022, 15-min Running Average Air Quality Data, PM 10ug/m3 Plot

In December 2022, construction-related levels of Particulate Matter (PM) PM10 did not surpass the Daily Permissible Exposure Limits (PEL) as set by federal standards for the 8-hour Time Weighted Average (TWA) and did not cause air quality concerns to the community or onsite workers.

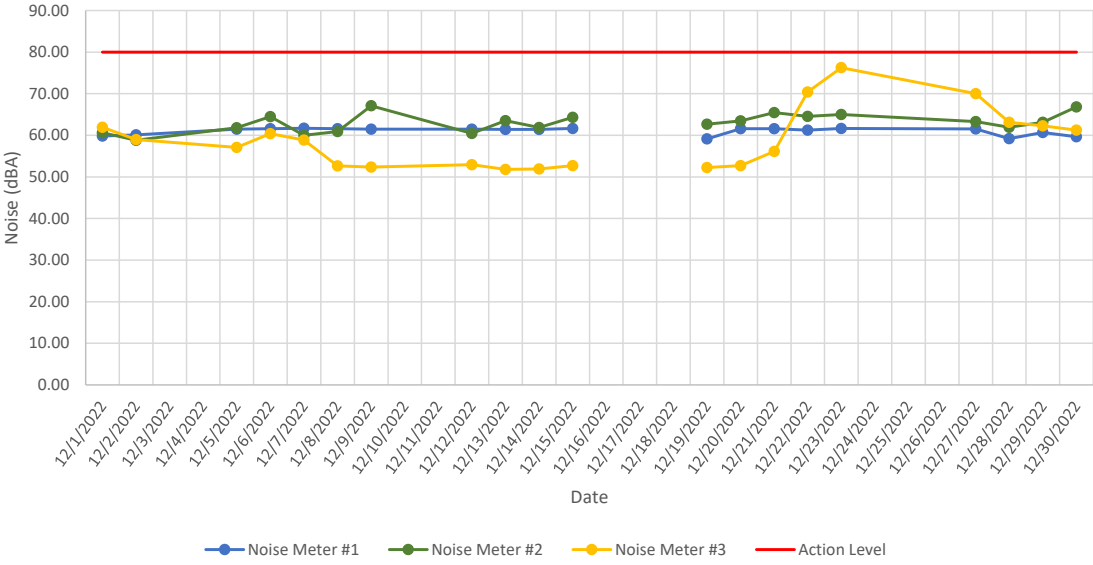
December 2022, Average Equivalent Sound Level Plot (Laeq)

In December 2022, construction-related levels of noise did not surpass the limits of Local Law 113 and the daily average was below the limits and did not cause noise concerns for the community.

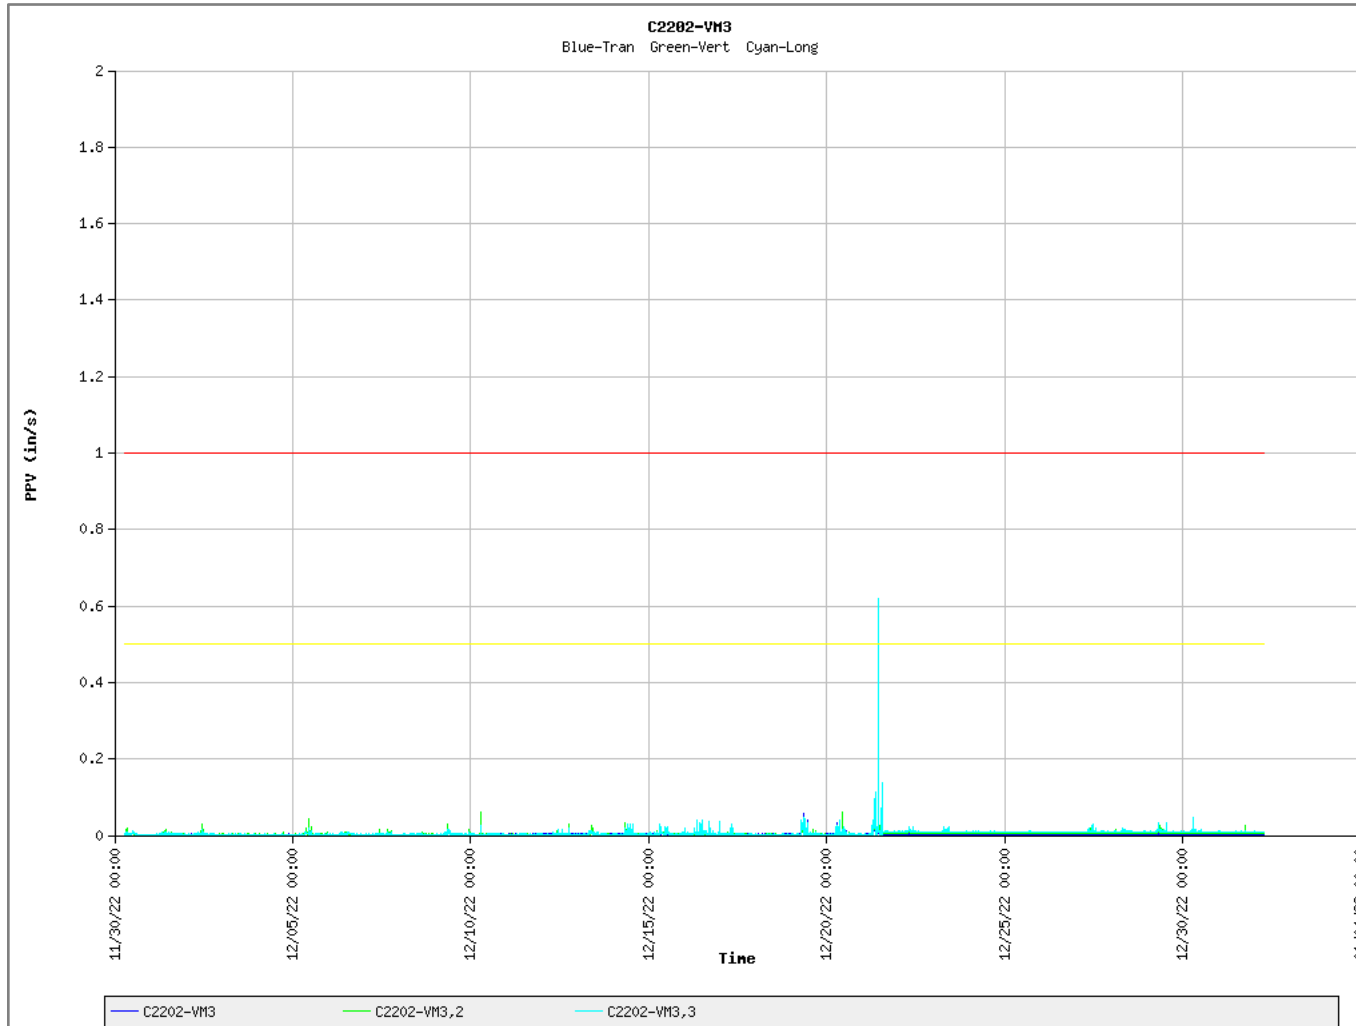
The Bronx Site Preparation December 2022 Vibration Monitoring Data Plots

There were exceedances recorded at VM3 and VM4 on December 21st and December 23rd caused by excavation and hammering foundation near the sensors.

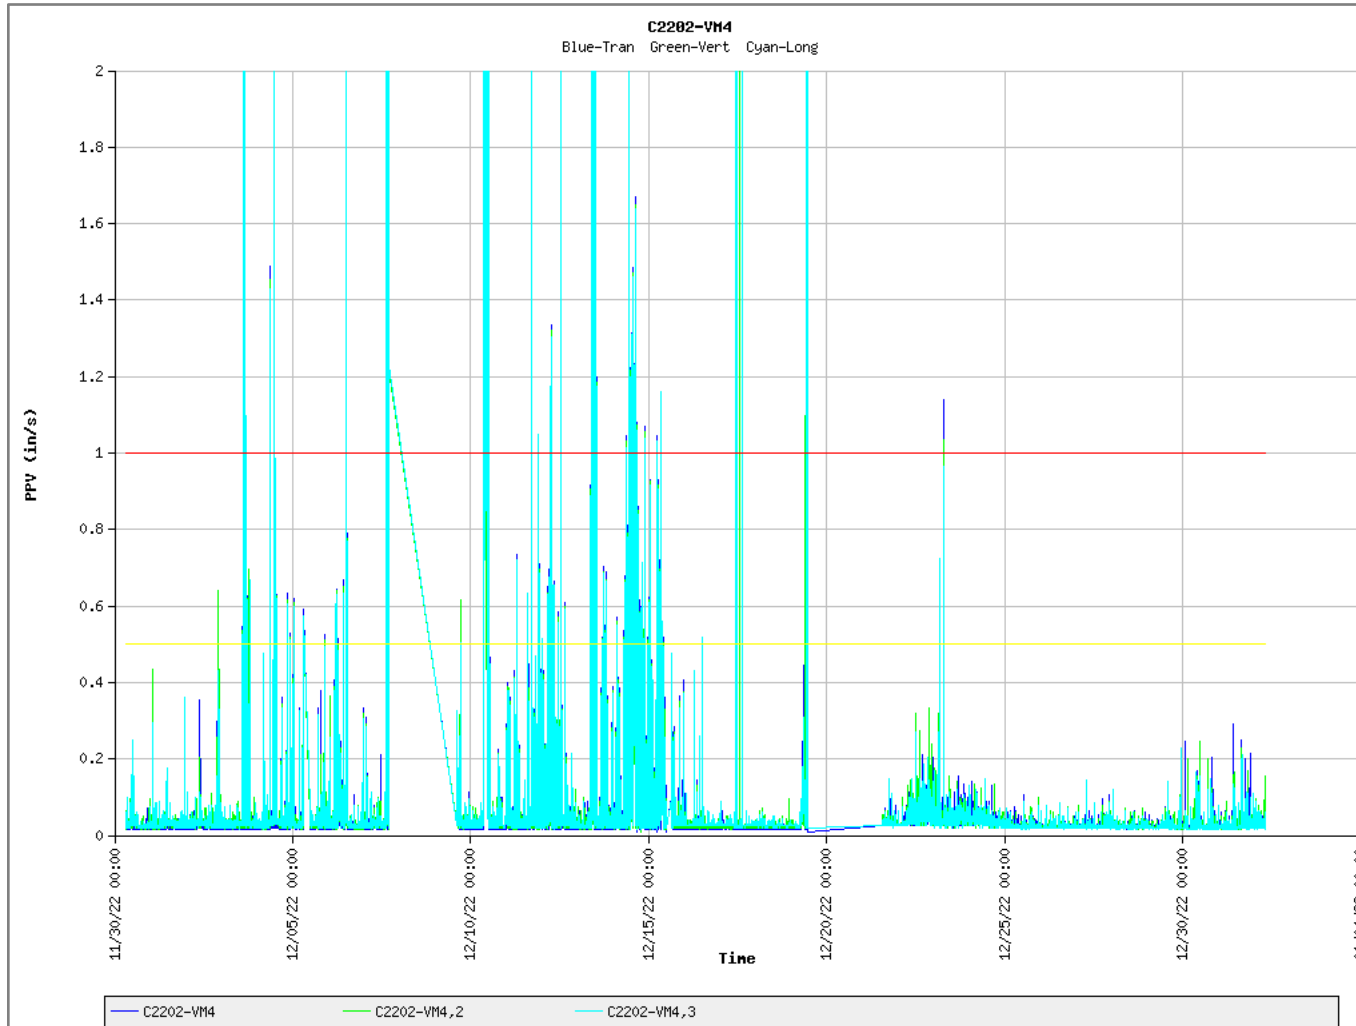
The Bronx Site Preparation December 2022 Vibration Monitoring Data Plots

Exceedances recorded at VM4 between December 2nd and December 19th were caused by a malfunction sensor and signal cable. The malfunction sensor and signal cable were replaced on December 21st. Once completed, the readings returned to be within the project threshold afterwards.

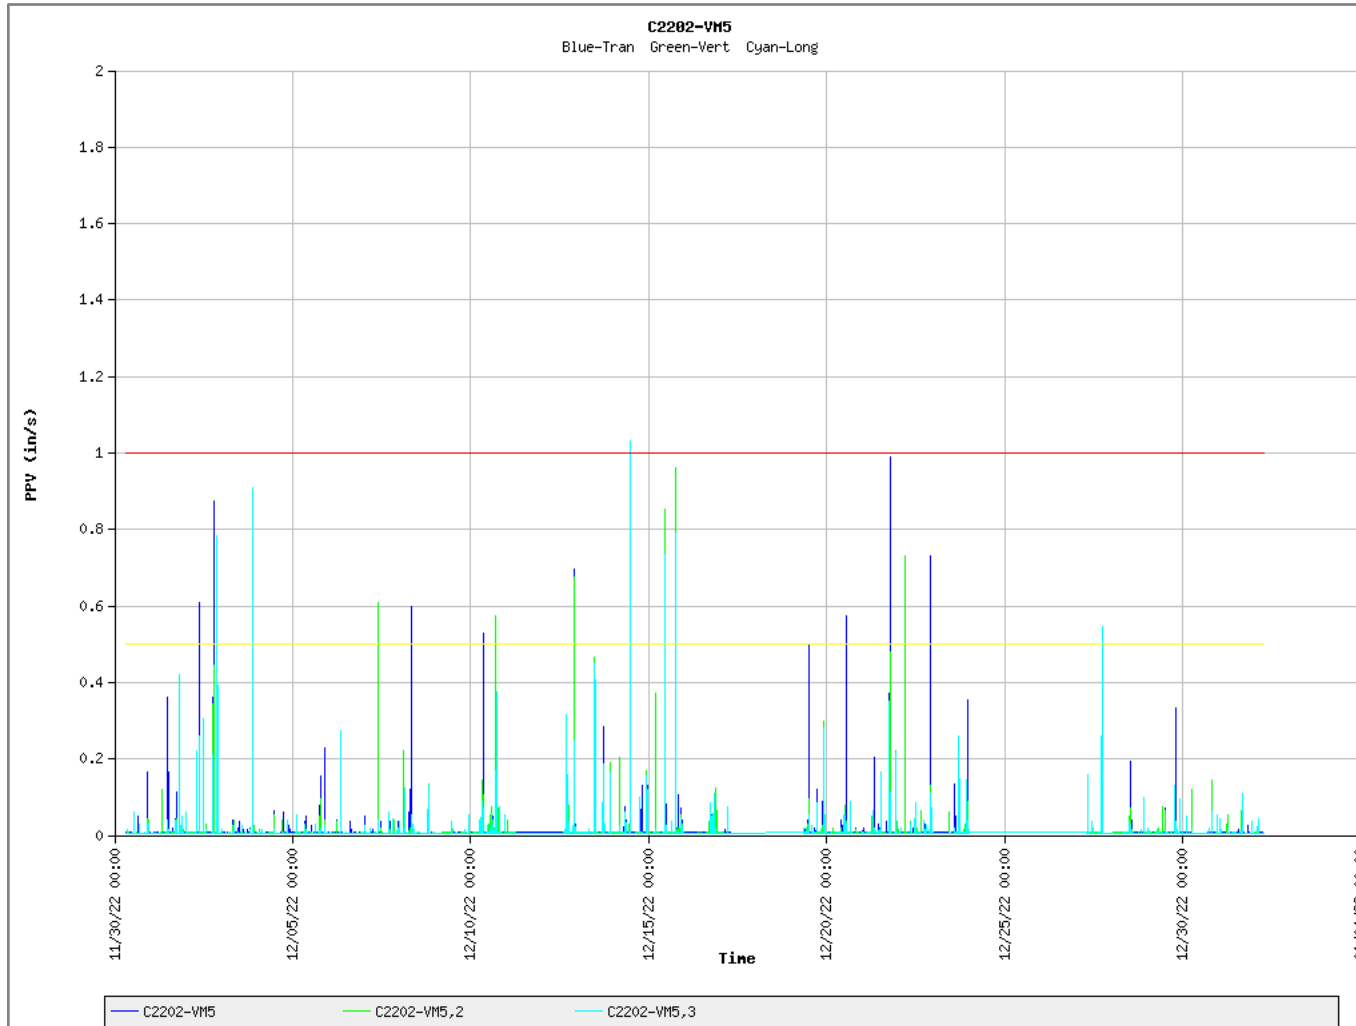
The Bronx Site Preparation December 2022 Vibration Monitoring Data Plots

12/2/2022 08:54	0.61	0.36	This is an isolated event recorded at VM5. Residents have access to the sensor.
12/2/2022 18:47, 21:12, & 21:12	0.91	0.025	Exceedances observed at VM5 were recorded during non-construction hours.
12/7/2022 09:42	0.61	0.06	This is an isolated event recorded at VM5. Residents have access to the sensor.
12/8/2022 07:59	0.6	0.135	This is an isolated event recorded at VM5. Residents have access to the sensor.
12/10/2022 08:40 & 16:28	0.575	0.375	Exceedances observed at VM5 were recorded during non-construction hours.
12/12/2022 21:44	0.695	0.14	Exceedance observed at VM5 was recorded during non-construction hours.
12/14/2022 11:37	1.03	0.17	This is an isolated event recorded at VM5. Residents have access to the sensor.
12/15/2022 11:16	0.855	0.16	This is an isolated event recorded at VM5. Residents have access to the sensor.
12/15/2022 18:17	0.96	0.105	Exceedance observed at VM5 was recorded during non-construction hours.

Narrative Summary of Vibration Monitoring, Excursions and Corrective Actions:
 In December 2022, four vibration monitors had recorded exceedances. There were exceedances recorded during non-construction hours at VM4, VM5, and VM6. There were isolated events recorded at VM5, where residents have access to the sensor as it is installed in the basement of a residential building. There were isolated events recorded at VM5 during baseline period as well.

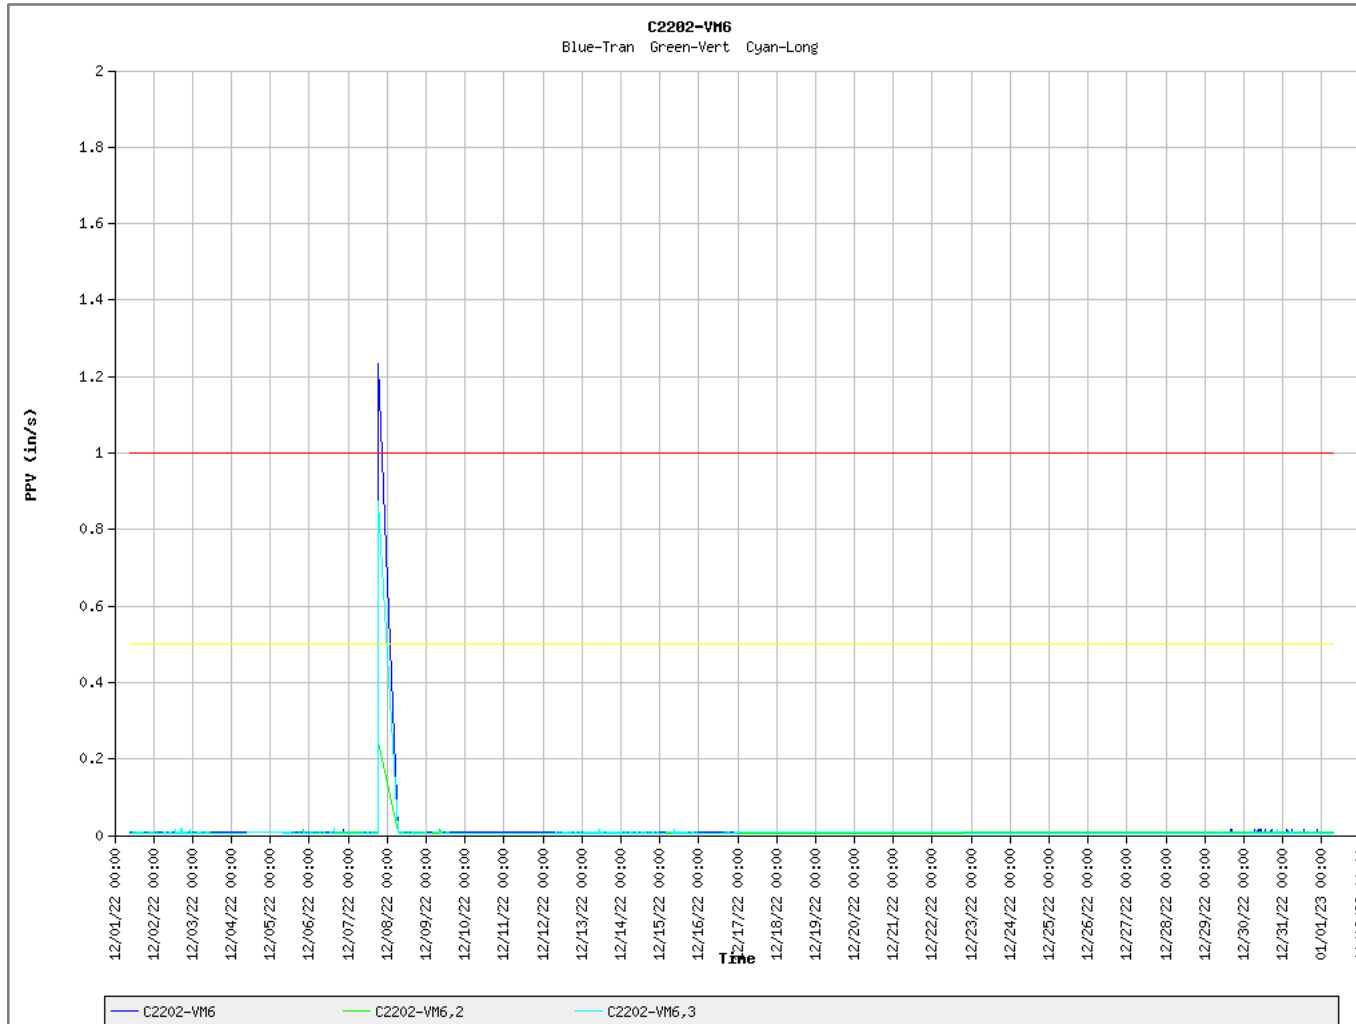
The Bronx Site Preparation December 2022 Vibration Monitoring Data Plots

Date: Time	Maximum Vibration Level before Corrective Action (in/sec)	Maximum Vibration Level after Corrective Action (in/sec)	Corrective Action
12/19/2022 12:05	0.5	0.3	This is an isolated event recorded at VM5. Residents have access to the sensor.
12/20/2022 12:58	0.575	0.09	This is an isolated event recorded at VM5. Residents have access to the sensor.
12/21/2022 18:40	0.99	0.22	Exceedance observed at VM5 was recorded during non-construction hours.
12/22/2022 04:40 & 21:56	0.73	0.13	Exceedances observed at VM5 were recorded during non-construction hours.
12/27/2022 17:35 & 17:46	0.545	0.195	Exceedances observed at VM5 were recorded during non-construction hours.
12/7/2022 18:28	1.235	0.01	Exceedance observed at VM6 was recorded during non-construction hours.
