**AIR, NOISE AND VIBRATION
MONTHLY MONITORING REPORT
Number 010**

Prepared By: Roux / Wang Technology

DDC Pin No.:	BBJ-XSP	Period Start: 4/1/23 End 4/30/23
Project Name:	NYCDDC – The Bronx Site Preparation	
DDC Project No.:	8502021CR0004P-06P

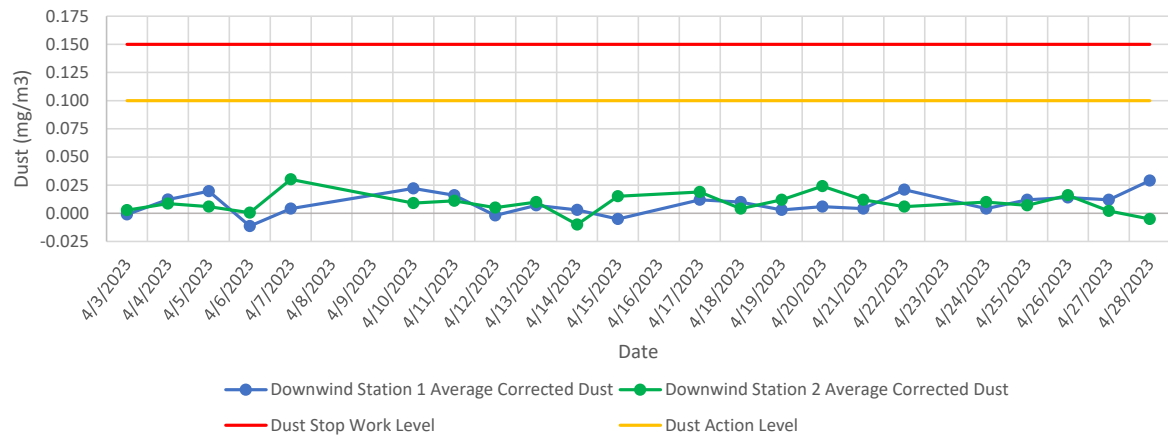
April 2023, 15-min Running Average Air Quality Data, PM 10ug/m3 Plot

Number of Workdays in a Month	Number of Air Monitoring Days in a Month	Number of Days with Dust Concentrations above Action Concentrations by Month (100 ug/m ³ 15 minute TWA)	Comments
23	22	2	There were three instances of CAMP excursions above the 0.100 ug/m ³ dust action level. In all instances, there were no exceedances. These instances occurred on 4/26 and 4/28 and are detailed below. Dust monitoring was not performed on 4/29 due to inclement weather.

Date: Time	Maximum Dust Reading Before Corrective Action 15 Minute TWA (ug/m ³)	Maximum Dust Reading After Corrective Action 15 Minute TWA (ug/m ³)	Corrective Action
4/26/23 7:45am	109	13	An elevated reading was caused by saw cutting taking place near the CAMP station. Water was used to mitigate dust in the area.
4/26/23 9:00am	108	56	An elevated reading was caused by saw cutting taking place near the CAMP station. Water was used to mitigate dust in the area.
4/28/23 8:00am	116	29	An elevated reading was caused by hammer drilling activities. Water was used to mitigate dust in the area.

Narrative Summary of Air Monitoring, Excursions and Corrective Actions:
In April 2023, construction-related levels of Particulate Matter (PM) PM10 did not surpass the Daily Permissible Exposure Limits (PEL) as set by federal standards for the 8-hour Time Weighted Average (TWA) and did not cause air quality concerns to the community and/or onsite workers.

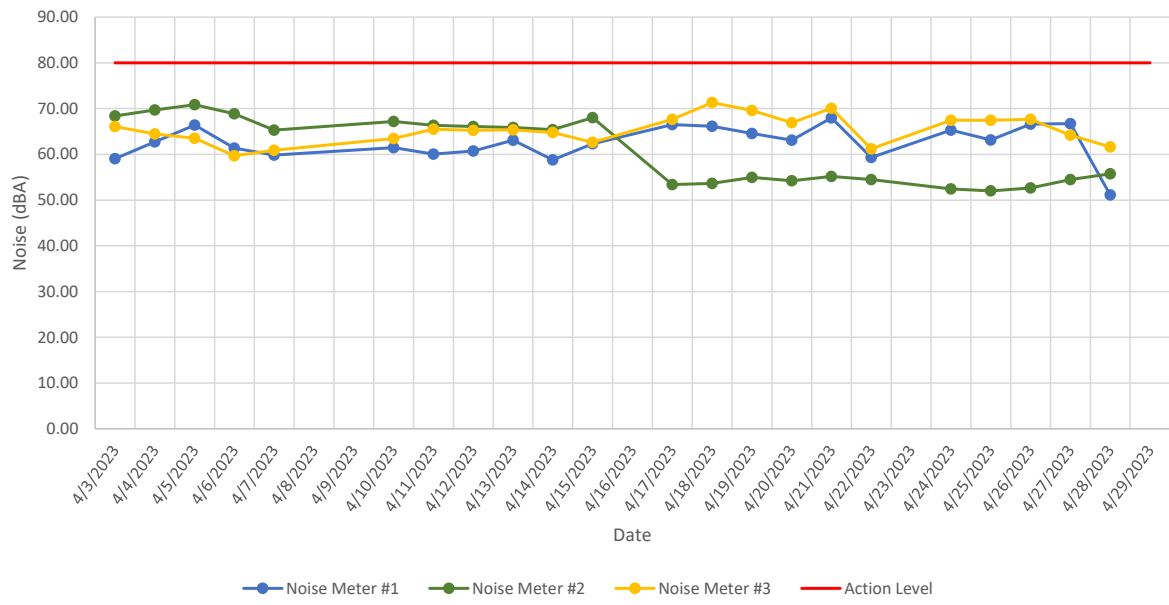
April 2023, Average Equivalent Sound Level Plot (Laeq)

Number of Workdays in a Month	Number of Noise Monitoring Days in a Month	Number of Days with Noise Levels above Action Levels by Month	Comments
23	22	0	There were no instances of noise levels above the 80 dBA limit. Noise monitoring was not performed on 4/29 due to inclement weather.

Narrative Summary of Air Monitoring, Excursions and Corrective Actions:
In April 2023, construction-related levels of noise did not surpass the limits of Local Law 113 of 2005 and did not cause noise concerns for the community.

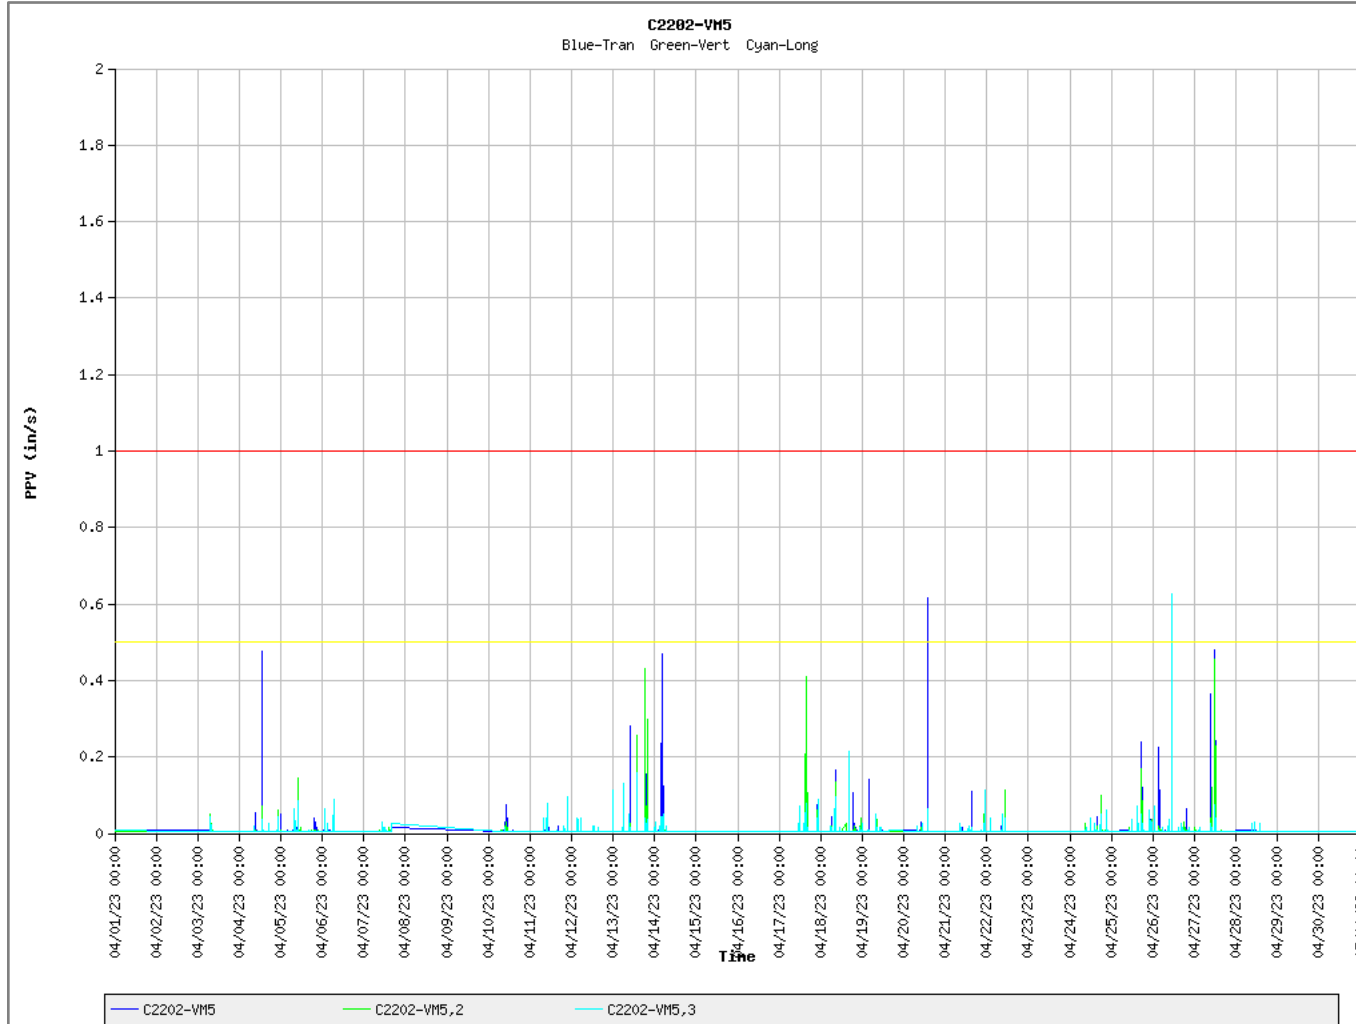
C2202-VM5 Transverse
C2202-VM5.2 Vertical
C2202-VM5.3 Longitudinal

Date: Time	Maximum Vibration Level before Corrective Action (in/sec)	Maximum Vibration Level after Corrective Action (in/sec)	Corrective Action
4/20/2023 13:55	0.615	0.02	This is an isolated event recorded at VM5.
4/26/2023 10:53	0.625	0.065	This is an isolated event recorded at VM5.
4/1/2023 10:06 to 18:05	4.81	0.1	Exceedances observed at VM6 were recorded during non-construction hours.
4/2/2023 10:54 to 16:34	6.865	0.025	Exceedances observed at VM6 were recorded during non-construction hours.
4/3/2023 16:05 to 18:22	5.3	0.03	Exceedances observed at VM6 were recorded during non-construction hours.
4/7/2023 12:51	1.98	0.045	This is an isolated event recorded at VM6.
4/8/2023 11:33	0.655	0.075	This is an isolated event recorded at VM6.
4/9/2023 15:03 to 15:35	6.18	0.06	Exceedances observed at VM6 were recorded during non-construction hours.
4/10/2023 13:47 & 13:50	2.865	0.03	These are isolated events recorded at VM6.

In April 2023, four vibration monitors had recorded exceedances. There were exceedances recorded during non-construction hours at VM6. There were isolated events recorded at VM5 and VM6, where residents have access to the sensors as they are installed in the basement of residential buildings. There were isolated events recorded at VM5 and VM6 during baseline period as well.

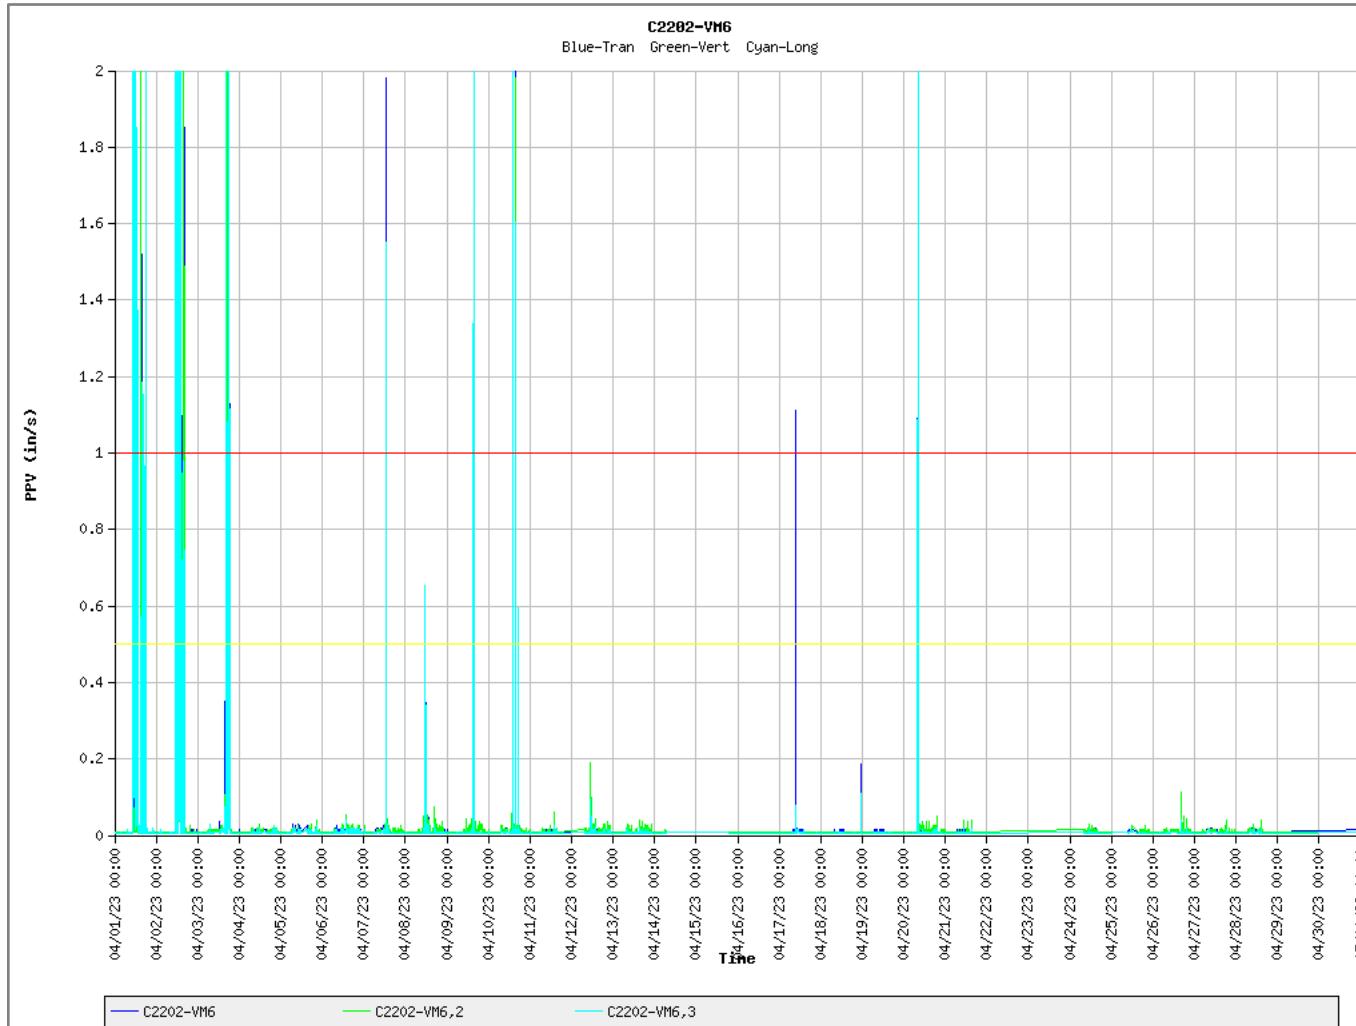
C2202-VM6 Transverse
C2202-VM6,2 Vertical
C2202-VM6,3 Longitudinal

4/10/2023 15:18 to 17:13	2.04	0.025	Exceedances observed at VM6 were recorded during non-construction hours.
4/17/2023 09:36	1.11	0.02	This is an isolated event recorded at VM6.
4/20/2023 08:05 to 08:07	5.07	0.05	Exceedances observed at VM6 were due to unit being serviced; geophone sensor was leveled.
4/5/2023 07:24 to 08:49	8.646	0.375	Exceedances observed at VM9 were caused by backfilling, compacting, and installing concrete road base. Workers reduced intensity level of machinery to reduce vibrations. The exceedances were not continuous high readings. None of the nearby homes had exceedances during this period.
4/6/2023 08:54 to 11:44	0.601	0.426	Exceedances observed at VM9 were caused by moving equipment near the sensor. Workers reduced intensity level of

The exceedances recorded at VM6 on April 20th was due to the unit being serviced; the geophone was being leveled.

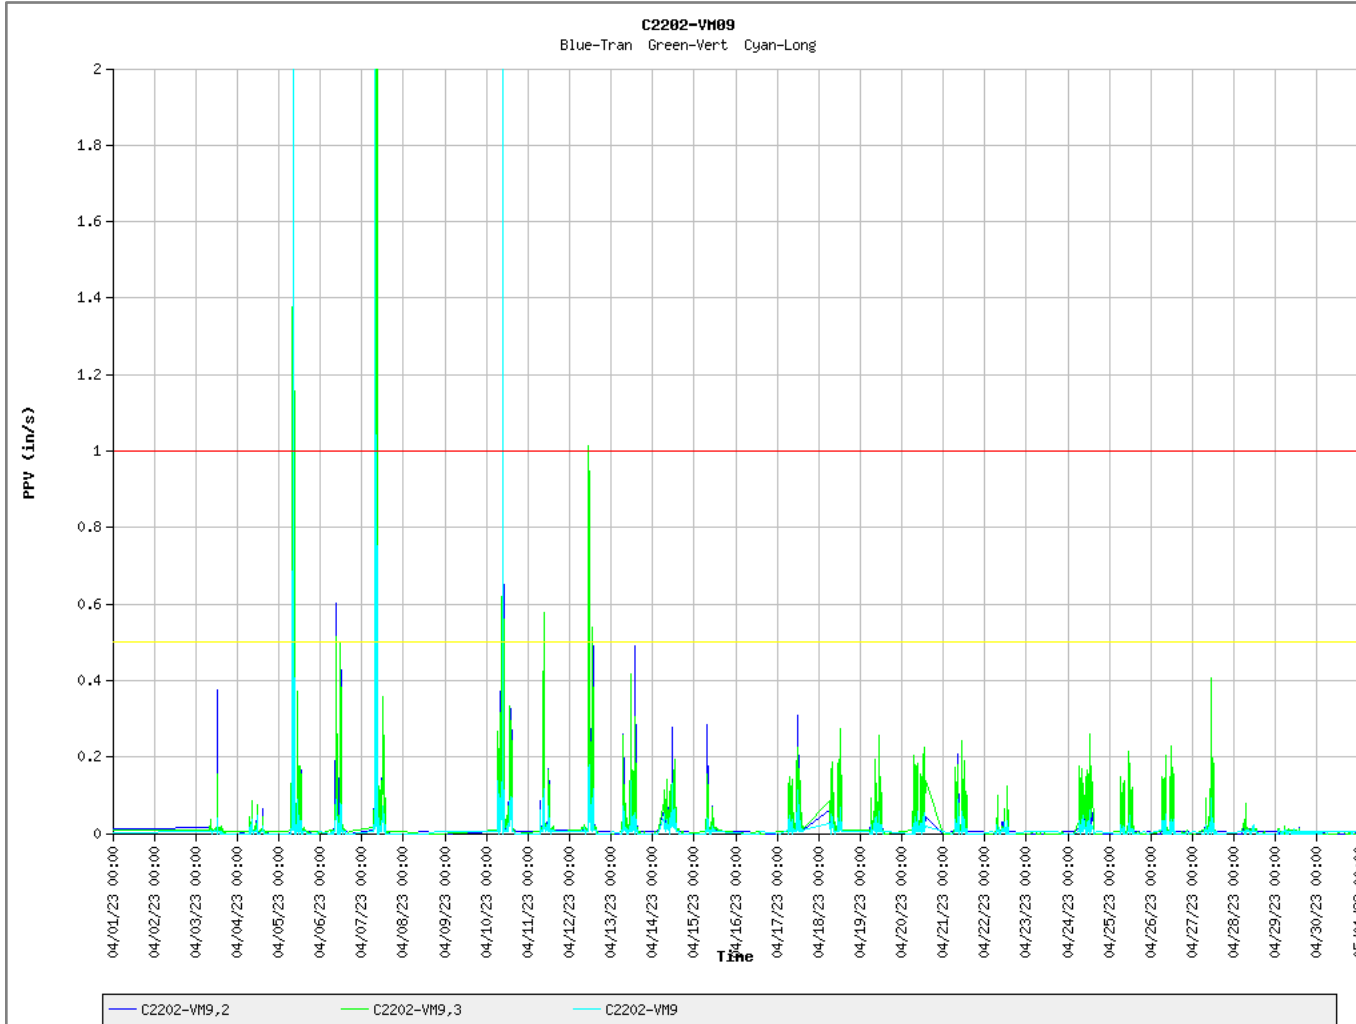
C2202-VM9 Longitudinal
C2202-VM9,2 Transverse
C2202-VM9,3 Vertical

machinery to reduce vibrations.
4/7/2023 07:24 to 08:49	8.593	0.356	Exceedances observed at VM9 were caused by backfilling, compacting, and installing concrete road base. Workers reduced intensity level of machinery to reduce vibrations. The exceedances were not continuous high readings. None of the nearby homes had exceedances during this period.
4/10/2023 08:34 to 8:54 & 9:44 to 10:04	10.897	0.415	Exceedances observed at VM9 were caused by pouring asphalt for street restoration. Workers reduced intensity level of machinery to reduce vibrations. The exceedances were not continuous high readings. None of the nearby homes had exceedances during this period.
4/11/2023 08:59 & 09:04	0.577	0.187	Exceedances observed at VM9 were caused by pouring asphalt for street restoration. Workers reduced intensity level of machinery to reduce vibrations.
4/12/2023 11:09 to 13:24	1.014	0.491	Exceedances observed at VM9 were caused by relocating lining station and equipment to 142 nd Street. Workers reduced intensity level of machinery to reduce vibrations.

The exceedances recorded at VM9 and VM10 on April 5th and April 7th were caused by backfilling, compacting, and installing concrete road base. Workers reduced intensity level of machinery to reduce vibrations. The exceedances were not continuous high readings. None of the nearby homes had exceedances during this period.

The exceedances recorded at VM9 and VM10 on April 6th were caused by moving equipment near the sensors. Workers reduced intensity level of machinery to reduce vibrations.

The exceedances recorded at VM9 on April 10th and April 11th, and the exceedances recorded at VM10 on April 10th were caused by pouring asphalt for street restoration. Workers reduced intensity level of machinery to reduce vibrations. The exceedances were not continuous high readings. None of the nearby homes had exceedances during this period.

The exceedances recorded at VM9 and VM10 on April 12th were caused by relocating lining station and equipment to 142nd Street. Workers reduced intensity level of machinery to reduce vibrations.

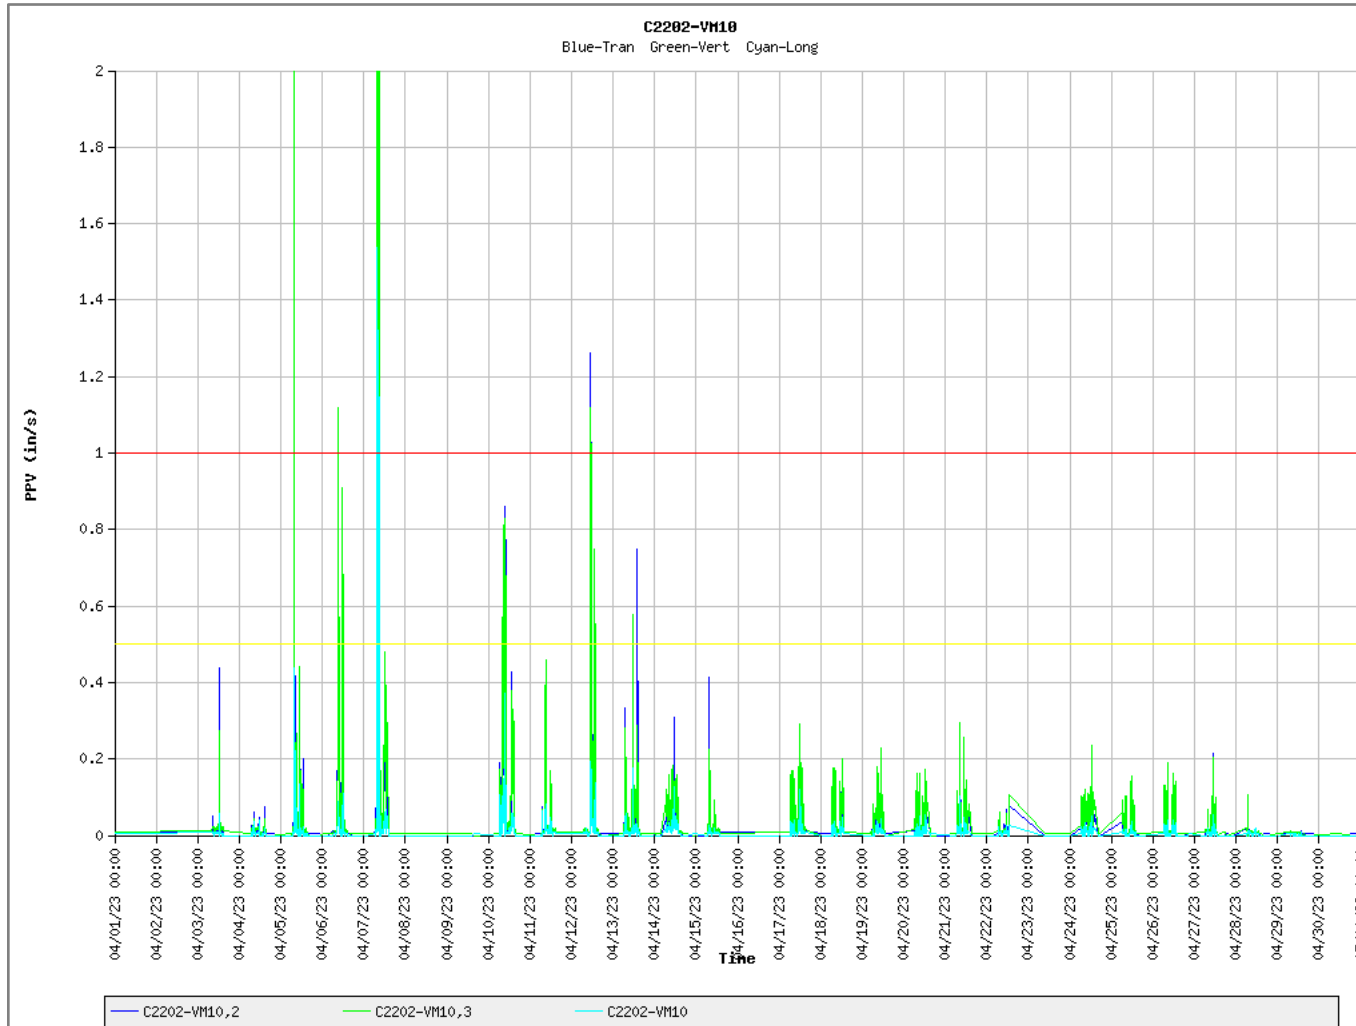
C2202-VM10 Longitudinal
C2202-VM10,2 Transverse
C2202-VM10,3 Vertical

4/5/2023 07:29 & 07:34	2.724	0.443	Exceedances observed at VM10 were caused by backfilling, compacting, and installing concrete road base. Workers reduced intensity level of machinery to reduce vibrations.
4/6/2023 08:54 to 12:14	1.117	0.375	Exceedances observed at VM10 were caused by moving equipment near the sensor. Workers reduced intensity level of machinery to reduce vibrations.
4/7/2023 07:39 to 7:54 & 8:34 to 08:49	5.421	0.48	Exceedances observed at VM10 were caused by backfilling, compacting, and installing concrete road base. Workers reduced intensity level of machinery to reduce vibrations. The exceedances were not continuous high readings. None of the nearby homes had exceedances during this period.
4/10/2023 08:09 to 10:04	0.862	0.429	Exceedances observed at VM10 were caused by pouring asphalt for street restoration. Workers reduced intensity level of machinery to reduce vibrations.

4/12/2023 11:04 to 13:39	1.261	0.193	Exceedances observed at VM10 were caused by relocating lining station and equipment to 142 nd Street. Workers reduced intensity level of machinery to reduce vibrations.
4/13/2023 11:39 to 14:09	0.748	0.095	Exceedances observed at VM10 was due to the unit being serviced.

The exceedances recorded at VM10 on April 13th was due by the unit being serviced.
