**AIR, NOISE AND VIBRATION
MONTHLY MONITORING REPORT
Number 015**

Prepared By: Roux / Wang Technology

DDC Project No.:	BBJ-XSP	Period Start: 10/1/23 End 10/31/23	
Project Name:	NYCDDC D&B – The Bronx Site Preparation		
DDC Pin No.:	8502021CR0004P-06P		
1) Community Air Monitoring Monthly Status Summary			
TWA – Time Weighted Average ug/m ³ - micrograms per cubic meter			
Number of Workdays in a Month	Number of Air Monitoring Days in a Month	Number of Days with Dust Concentrations above Action Concentrations by Month (100 ug/m ³ 15 minute TWA)	Comments
22	21	1	There were three 15-minute readings over the dust action concentration on 10/26 that are detailed below. Dust monitoring not performed on 10/20 due to rain.
Community Air Monitoring Weekly Excursions and Corrective Actions			
Action Concentration = 100 ug/m ³ 15 minute TWA above background concentration Stop Work Concentration = 150 ug/m ³ 15 minute TWA above background concentration			
Date: Time	Maximum Dust Reading Before Corrective Action 15 Minute TWA (ug/m ³)	Maximum Dust Reading After Corrective Action 15 Minute TWA (ug/m ³)	Corrective Action

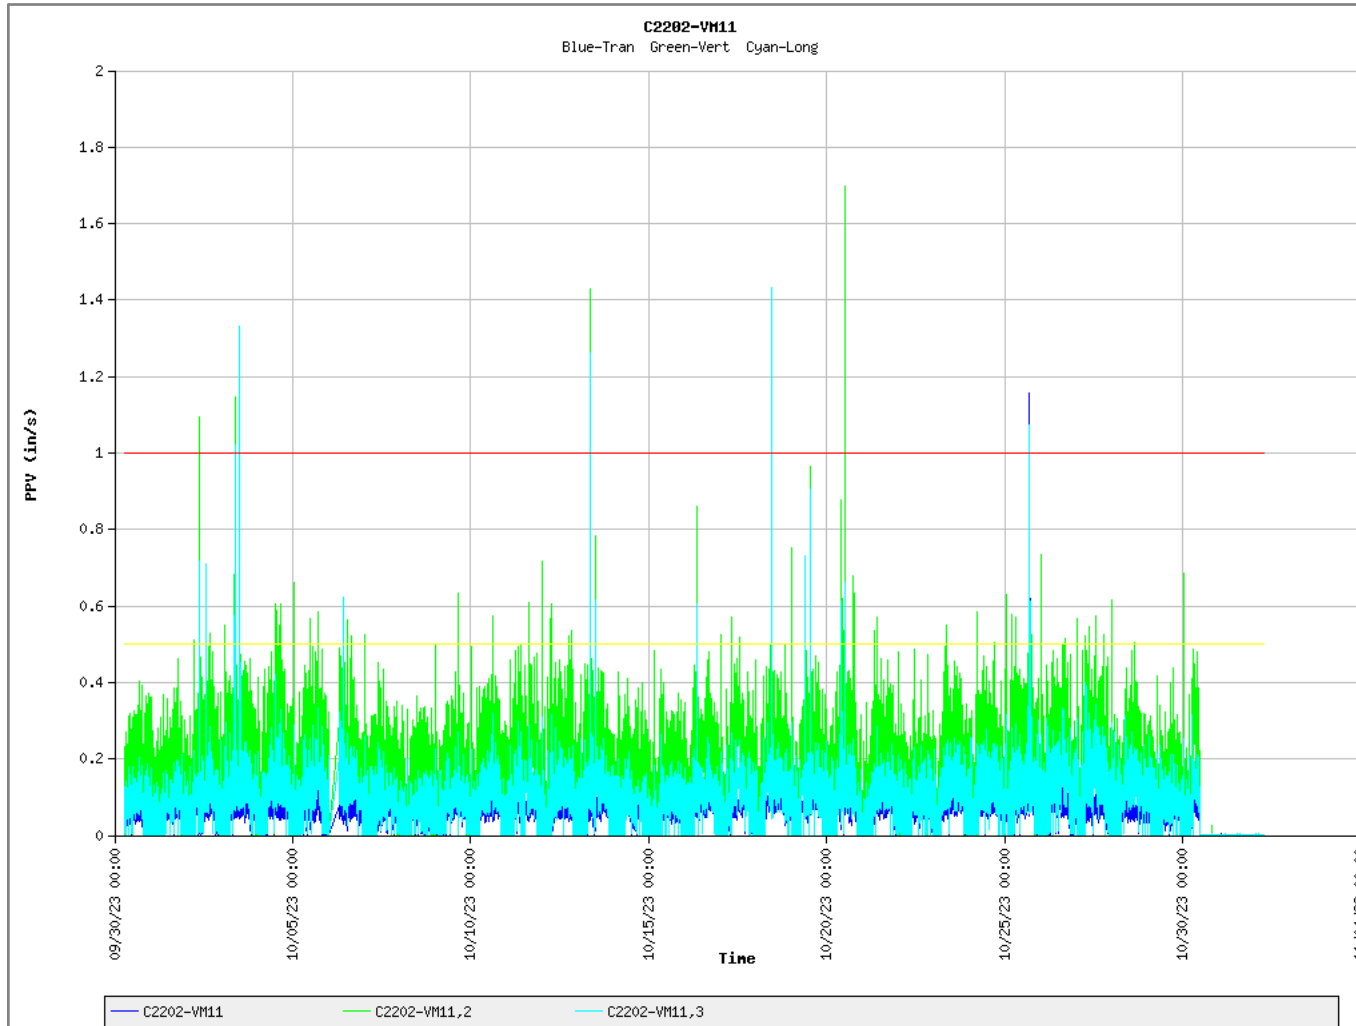
The Bronx Site Preparation October 2023 Vibration Monitoring Data Plots

There were exceedances recorded during non-construction hours at VM11. No corrective action was required at this time.

The exceedances recorded at VM11 on October 17th, October 20th, October 23rd, October 25th, and October 27th were due to preparation work for blasting, where excavators in the area were moving rocks. The size of rocks being loaded into the truck was reduced post events.

The rest of the exceedances recorded at VM11 and VM12 were non-construction related. The event times when the exceedances were recorded were reviewed by the contractor, it is confirmed that no work was being performed in the area during these event periods. No corrective action was required at these times.

C2202-VM11 Transverse
C2202-VM11,2 Vertical
C2202-VM11,3 Longitudinal

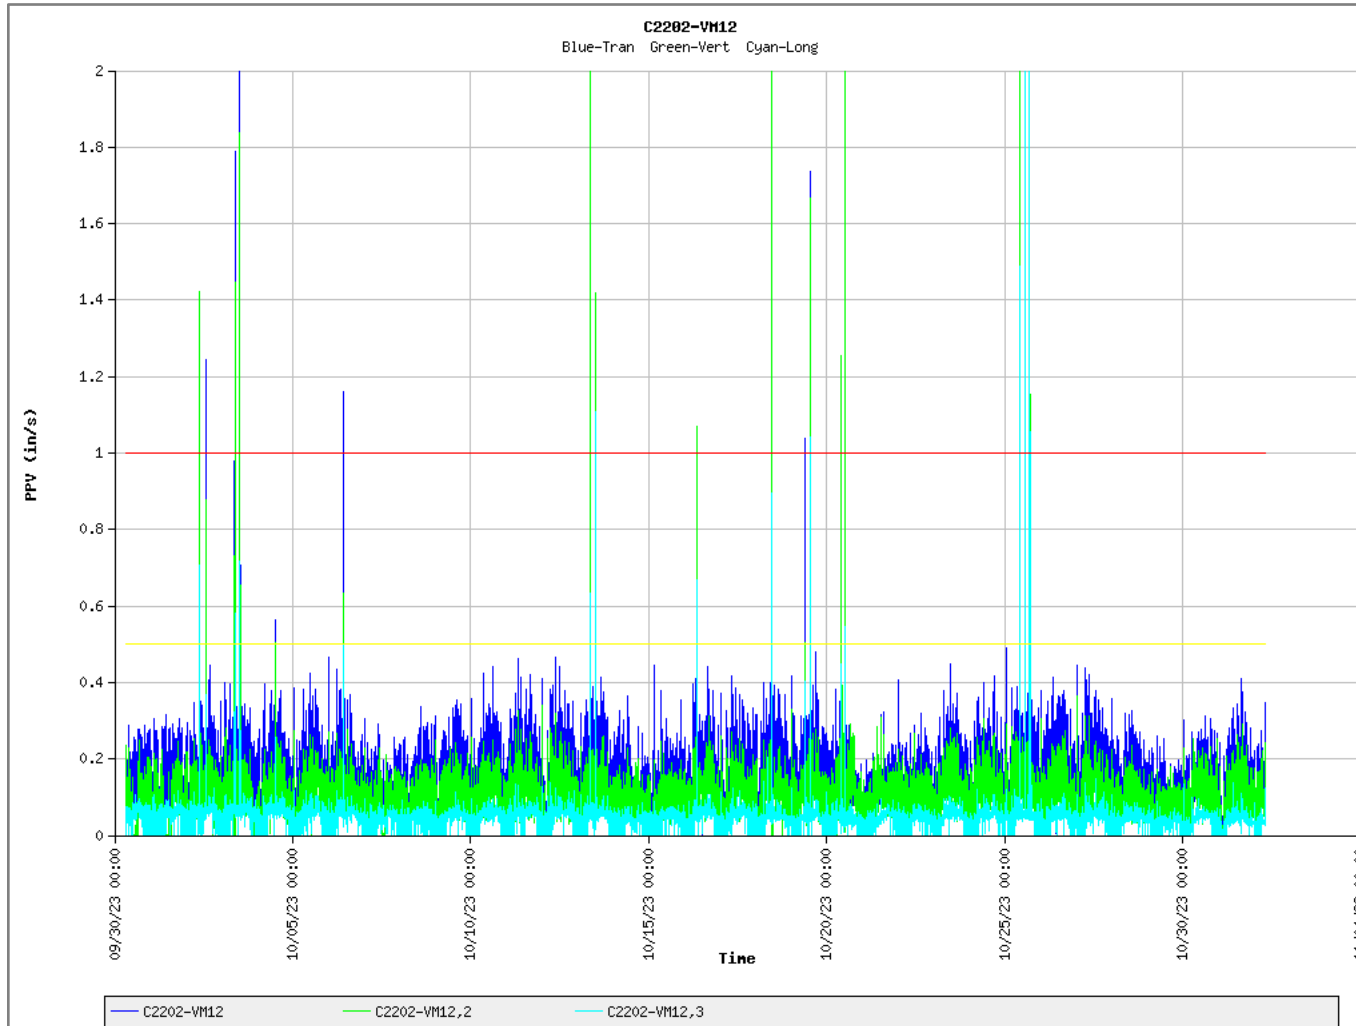
The Bronx Site Preparation October 2023 Vibration Monitoring Data Plots

C2202-VM12 Transverse
C2202-VM12,2 Vertical
C2202-VM12,3 Longitudinal

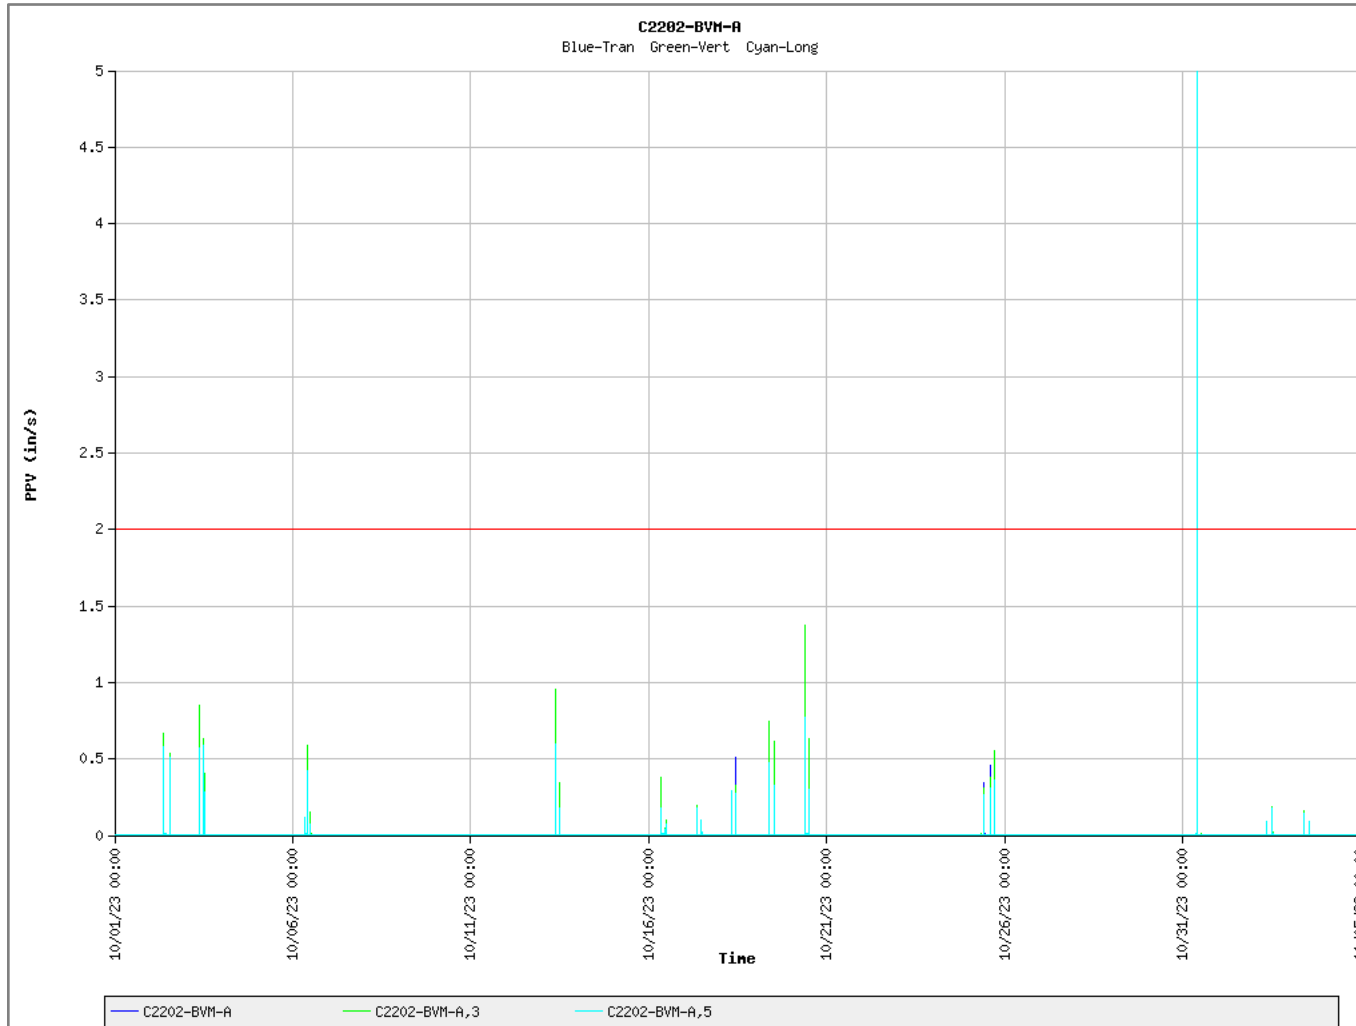
The Bronx Site Preparation October 2023 Vibration Monitoring Data Plots

The exceedances recorded at BVM-A and BVM-C on October 31st were due to relocation of the sensors. No corrective action was required at this time.

C2202-BVM-A Transverse
C2202-BVM-A,3 Vertical
C2202-BVM-A,5 Longitudinal

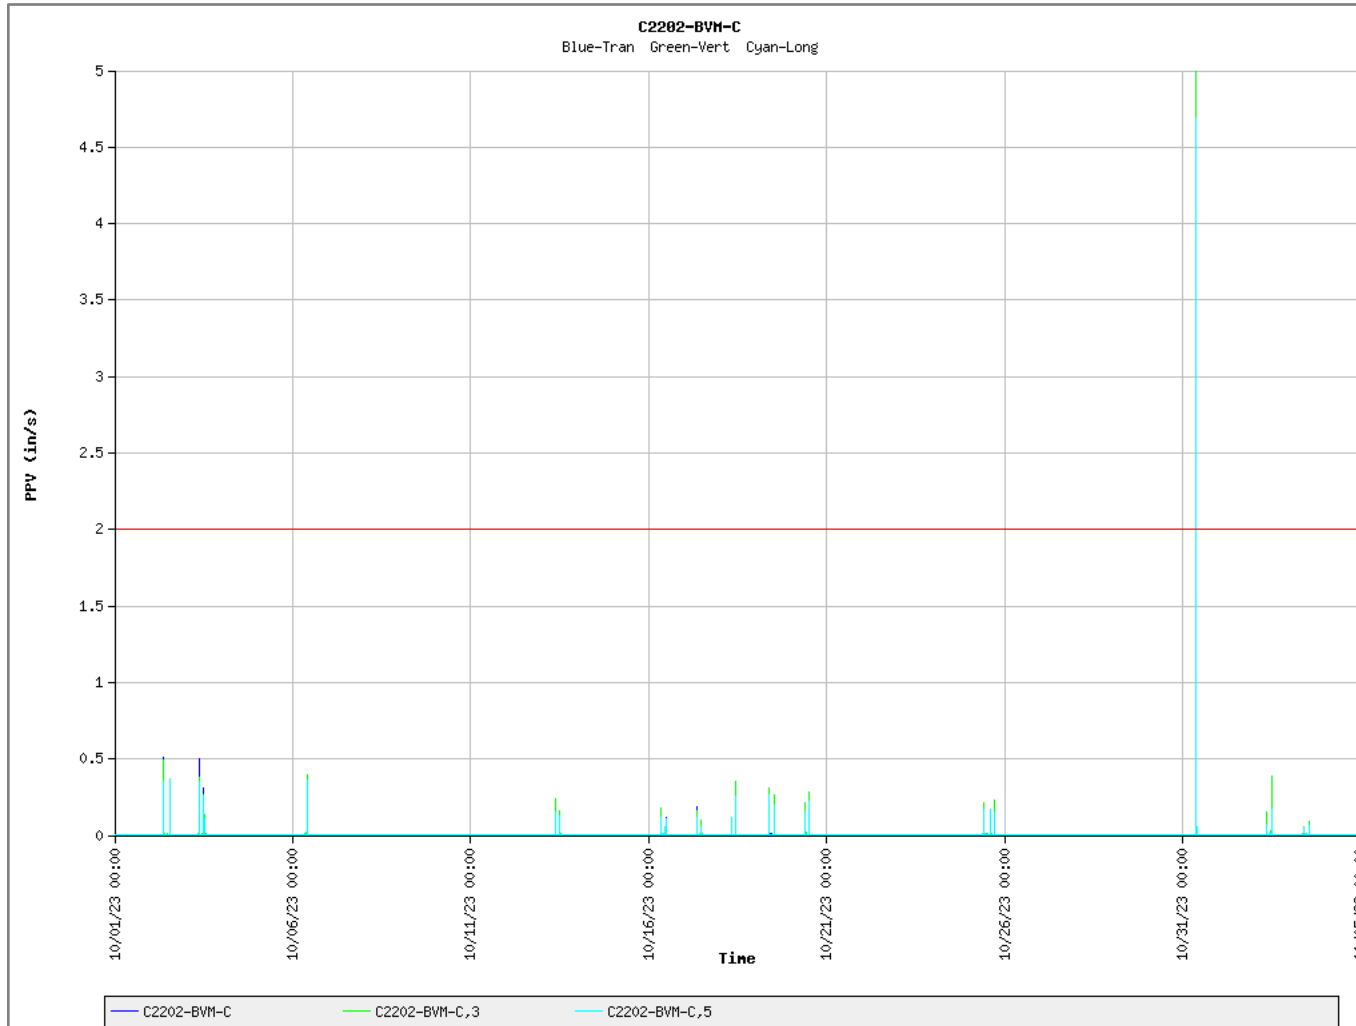
The Bronx Site Preparation October 2023 Vibration Monitoring Data Plots

C2202-BVM-C Transverse
C2202-BVM-C,3 Vertical
C2202-BVM-C,5 Longitudinal
