**AIR, NOISE AND VIBRATION  
MONTHLY MONITORING REPORT  
Number 016**

Prepared By: Roux / Wang Technology

<b>DDC Project No.:</b>	BBJ-XSP	<b>Period Start:</b> 11/1/23 <b>End</b> 11/30/23	
<b>Project Name:</b>	NYCDDC D&B – The Bronx Site Preparation		
<b>DDC Pin No.:</b>	8502021CR0004P-06P		
<b>1) Community Air Monitoring Monthly Status Summary</b>			
TWA – Time Weighted Average ug/m <sup>3</sup> - micrograms per cubic meter			
Number of Workdays in a Month	Number of Air Monitoring Days in a Month	Number of Days with Dust Concentrations above Action Concentrations by Month (100 ug/m <sup>3</sup> 15 minute TWA)	Comments
19	19	2	There were two 15-minute readings over the dust action concentration on 11/9 and three on 11/14 that are detailed below.
<b>Community Air Monitoring Monthly Excursions and Corrective Actions</b>			
Action Concentration = 100 ug/m <sup>3</sup> 15 minute TWA above background concentration Stop Work Concentration = 150 ug/m <sup>3</sup> 15 minute TWA above background concentration

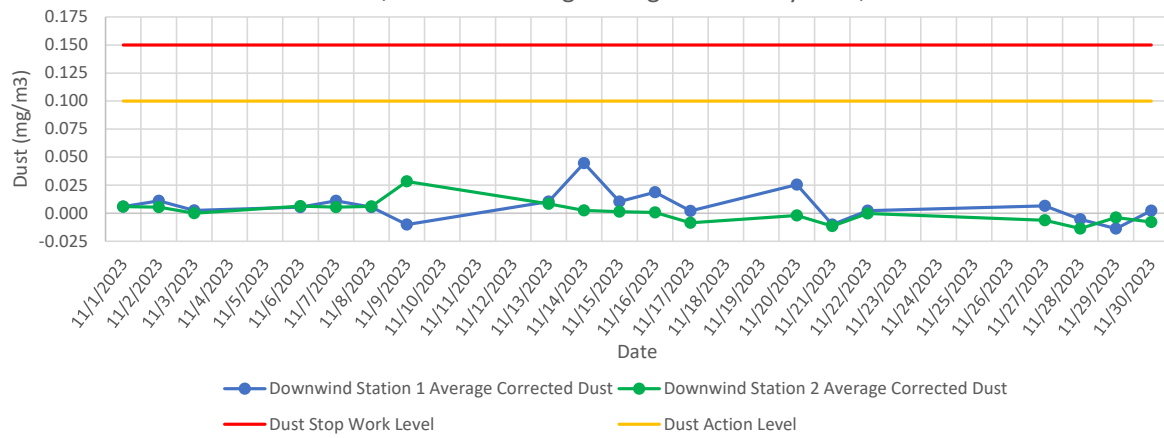
November 2023, 15-min Running Average Air Quality Data, PM 10 Plot

Date: Time	Maximum Dust Reading Before Corrective Action 15 Minute TWA (ug/m <sup>3</sup> )	Maximum Dust Reading After Corrective Action 15 Minute TWA (ug/m <sup>3</sup> )	Corrective Action
11/9 10:19	0.650	0.510	An elevated reading above the dust action level was caused by the movement of blast pads. Work was temporarily stopped, and water was used to mitigate dust in the work area.  Mitigative measure not fully effective upon immediate implementation.
11/9 10:34	0.510	-0.026	An elevated reading above the dust action level was caused by the movement of blast pads. Work was temporarily stopped, and water was used to mitigate dust in the work area.
11/14 11:51	0.287	0.169	An elevated reading above the dust action level was caused by nearby excavation activities. Work was temporarily stopped, and water was used to mitigate dust in the work area.

Mitigative measure not fully effective upon immediate implementation.
11/14 12:06	0.169	0.042	An elevated reading above the dust action level was caused by nearby excavation activities. Work was temporarily stopped, and water was used to mitigate dust in the work area.
11/14 12:36	0.137	0.028	An elevated reading above the dust action level was caused by nearby excavation activities. Work was temporarily stopped, and water was used to mitigate dust in the work area.

Narrative Summary of Air Monitoring, Excursions and Corrective Actions:  
*In November 2023, construction-related levels of Particulate Matter (PM) PM10 did not surpass the Daily Permissible Exposure Limits (PEL) as set by federal standards for the 8-hour Time Weighted Average (TWA) and did not cause air quality concerns to the community and/or onsite workers.*

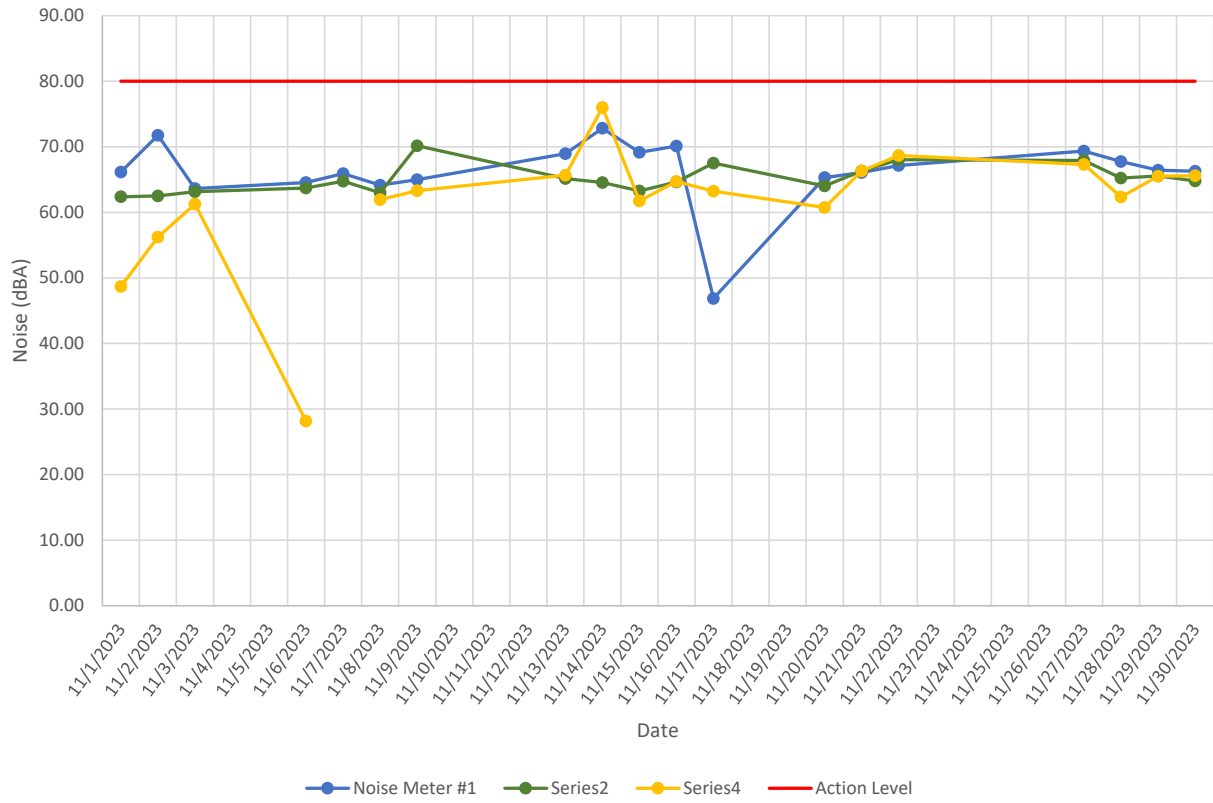
November 2023, Average Equivalent Sound Level Plot (Laeq)

*In November 2023, construction-related levels of noise did not surpass the limits of Local Law 113 of 2005. The daily average was below the limits and did not cause noise concerns for the community.*

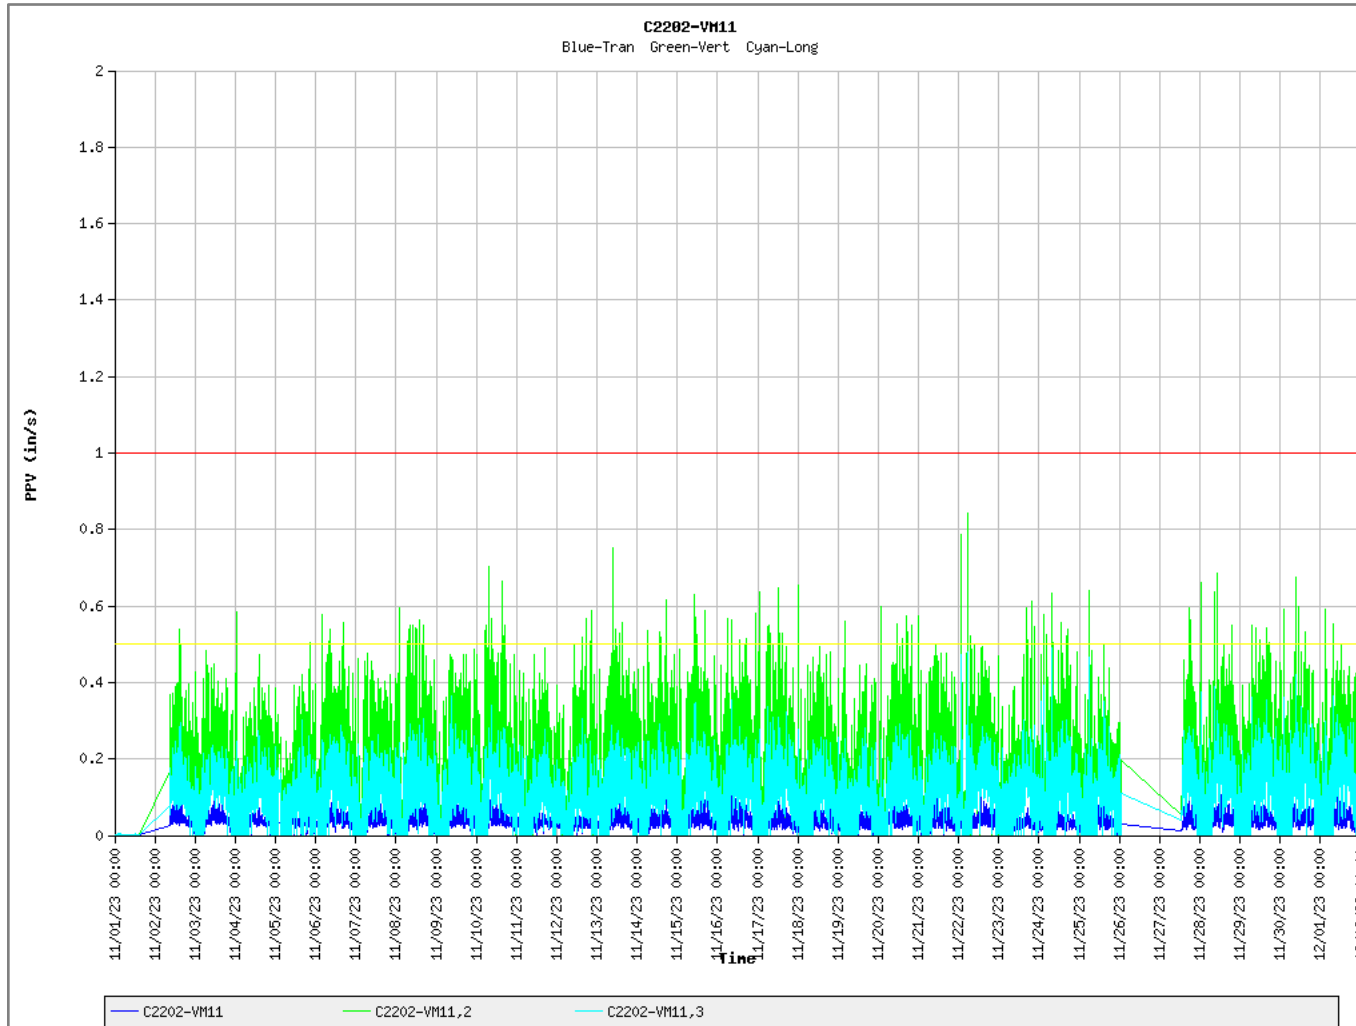
C2202-VM11 Transverse  
C2202-VM11,2 Vertical  
C2202-VM11,3 Longitudinal

11/8/2023 00:45, 05:30, & 06:35	0.5961	N/A	Exceedances observed at VM11 were recorded during non-construction hours.
11/8/2023 07:15, 08:45, 10:35, 11:05, & 13:00	0.5632	0.4977	Exceedances observed at VM11 were due to the preparation work for next blast, where excavators in the area were moving rocks and line drilling into rocks was performed. The size of rocks being loaded into the truck was reduced post events.
11/8/2023 15:45	0.5492	N/A	Exceedance observed at VM11 was recorded during non-construction hours.
11/10/2023 04:25, 04:40, 06:25, & 06:45	0.7025	N/A	Exceedances observed at VM11 were recorded during non-construction hours.
11/10/2023 07:55, 08:10, 14:45, & 14:55	0.665	N/A	Exceedances observed at VM11 were recorded during non-construction hours. There was no work due to Veteran's Day holiday.

11/10/2023 15:20 & 15:45	0.5514	N/A	Exceedances observed at VM11 were recorded during non-construction hours.
11/12/2023 09:20, 14:05, 16:25, 19:20, & 20:10	0.5871	N/A	Exceedances observed at VM11 were recorded during non-construction hours.
11/13/2023 08:50, 09:50, 12:15, & 14:15	0.7509	0.4633	Exceedances observed at VM11 were due to the preparation work for next blast, where line drilling into rocks was performed.
11/14/2023 05:10	0.5371	N/A	Exceedance observed at VM11 was recorded during non-construction hours.
11/14/2023 12:40 & 13:00	0.5309	N/A	Exceedances observed at VM11 were not construction related, it is confirmed that no work was being performed in the area.
11/14/2023 16:35	0.6157	N/A	Exceedance observed at VM11 was recorded during non-construction hours.
11/15/2023 09:05 & 09:55	0.6293	N/A	Exceedances observed at VM11 were not construction related, it is confirmed that no work was being performed in the area.

11/15/2023 10:35	0.5244	0.4431	Exceedance observed at VM11 was due to excavators in the area were moving rocks. The size of rocks being loaded into the truck was reduced post event.
11/15/2023 15:50	0.5871	N/A	Exceedance observed at VM11 was recorded during non-construction hours.
11/16/2023 05:05	0.5657	N/A	Exceedance observed at VM11 was recorded during non-construction hours.
11/16/2023 07:30	0.562	0.4512	Exceedance observed at VM11 was due to excavators in the area were moving rocks. The size of rocks being loaded into the truck was reduced post event.
11/16/2023 12:10	0.512	0.4515	Exceedance observed at VM11 was due to line drilling rocks in the area. The drill rig intensity was reduced post event.
11/16/2023 15:15, 16:20, & 22:00	0.5803	N/A	Exceedances observed at VM11 were recorded during non-construction hours.
11/17/2023 00:10, 04:40, 05:30, & 06:15	0.6386	N/A	Exceedances observed at VM11 were recorded during non-construction hours.

11/17/2023 11:20, 11:25, & 11:50	0.647	0.4465	Exceedances observed at VM11 were due to line drilling rocks in the area. The drill rig intensity was reduced post event.
11/17/2023 14:00 & 23:20	0.656	N/A	Exceedances observed at VM11 were recorded during non-construction hours.
11/19/2023 03:30	0.5604	N/A	Exceedance observed at VM11 was recorded during non-construction hours.
11/20/2023 00:15 & 00:20	0.5995	N/A	Exceedances observed at VM11 were recorded during non-construction hours.
11/20/2023 10:02	0.5523	0.4949	Exceedance observed at VM11 was due to excavators in the area were moving rocks. The size of rocks being loaded into the truck was reduced post event.
11/20/2023 13:37, 15:57, 16:32, 19:12, & 22:42	0.5734	N/A	Exceedances observed at VM11 were recorded during non-construction hours.
11/22/2023 00:15, 00:30, 04:05, 04:25, & 05:45	0.8422	N/A	Exceedances observed at VM11 were recorded during non-construction hours.

11/23/2023 15:17, 16:12, 18:57, & 20:02	0.6125	N/A	Exceedances observed at VM11 were recorded during non-construction hours.
11/24/2023 01:30, 03:20, & 06:45	0.6333	N/A	Exceedances observed at VM11 were recorded during non-construction hours.
11/24/2023 07:12 & 12:22	0.5555	N/A	Exceedances observed at VM11 were not construction related, it is confirmed that no work was being performed in the area.
11/24/2023 15:12 & 16:07	0.5399	N/A	Exceedances observed at VM11 were recorded during non-construction hours.

11/25/2023 04:35	0.6389	N/A	Exceedance observed at VM11 was recorded during non-construction hours.
11/27/2023 16:30, 17:20, & 23:25	0.66	N/A	Exceedances observed at VM11 were recorded during non-construction hours.
11/28/2023 07:45 & 09:10	0.6855	0.4965	Exceedances observed at VM11 were due to excavators in the area were moving rocks. The size of rocks being loaded into the truck was reduced post event.
11/28/2023 17:45	0.5511	N/A	Exceedance observed at VM11 was recorded during non-construction hours.
11/29/2023 06:25	0.5514	N/A	Exceedance observed at VM11 was recorded during non-construction hours.
11/29/2023 08:30 & 10:50	0.5421	N/A	Exceedances observed at VM11 were not construction related, it is confirmed that no work was being performed in the area.
11/29/2023 14:55 & 16:45	0.543	N/A	Exceedances observed at VM11 were recorded during non-construction hours.
11/30/2023 00:55	0.593	N/A	Exceedance observed at VM11 was recorded during non-construction hours.

11/30/2023 08:35 & 09:55	0.6743	0.4782	Exceedances observed at VM11 were due to excavators in the area were moving rocks. The size of rocks being loaded into the truck was reduced post event.
11/30/2023 13:45	0.5322	N/A	Exceedance observed at VM11 was recorded during non-construction hours.
11/10/2023 13:45	0.5157	N/A	Exceedance observed at VM12 was recorded during non-construction hours. There was no work due to Veteran's Day holiday.
11/17/2023 04:45	0.5555	N/A	Exceedance observed at VM12 was recorded during non-construction hours.
11/17/2023 11:23	0.5055	0.377	Exceedance observed at VM12 was due to line drilling rocks in the area. The drill rig intensity was reduced post event.
11/22/2023 04:04	0.7956	N/A	Exceedance observed at VM12 was recorded during non-construction hours.

The exceedances recorded at VM11 on November 6<sup>th</sup>, November 15<sup>th</sup>, November 16<sup>th</sup>, November 20<sup>th</sup>, November 28<sup>th</sup>, and November 30<sup>th</sup> were due to preparation work for blasting, where excavators in the area were moving rocks. The size of rocks being loaded into the truck was reduced post events.

The exceedances recorded at VM11 on November 8<sup>th</sup> and November 13<sup>th</sup> were due to excavators in the area were moving rocks and line drilling into rocks was performed in the area. The size of rocks being loaded into the truck was reduced post events.

The exceedances recorded at VM11 on November 16<sup>th</sup> and November 17<sup>th</sup>, and the exceedance recorded at VM12 on November 17<sup>th</sup> were due to line drilling into rocks was performed in the area. The intensity of the drill rig was reduced post events.

The rest of the exceedances recorded at VM11 were non-construction related. The event times when the exceedances were recorded were reviewed by the contractor, it is confirmed that no work was being performed in the area during these event periods. No corrective action was required at these times.

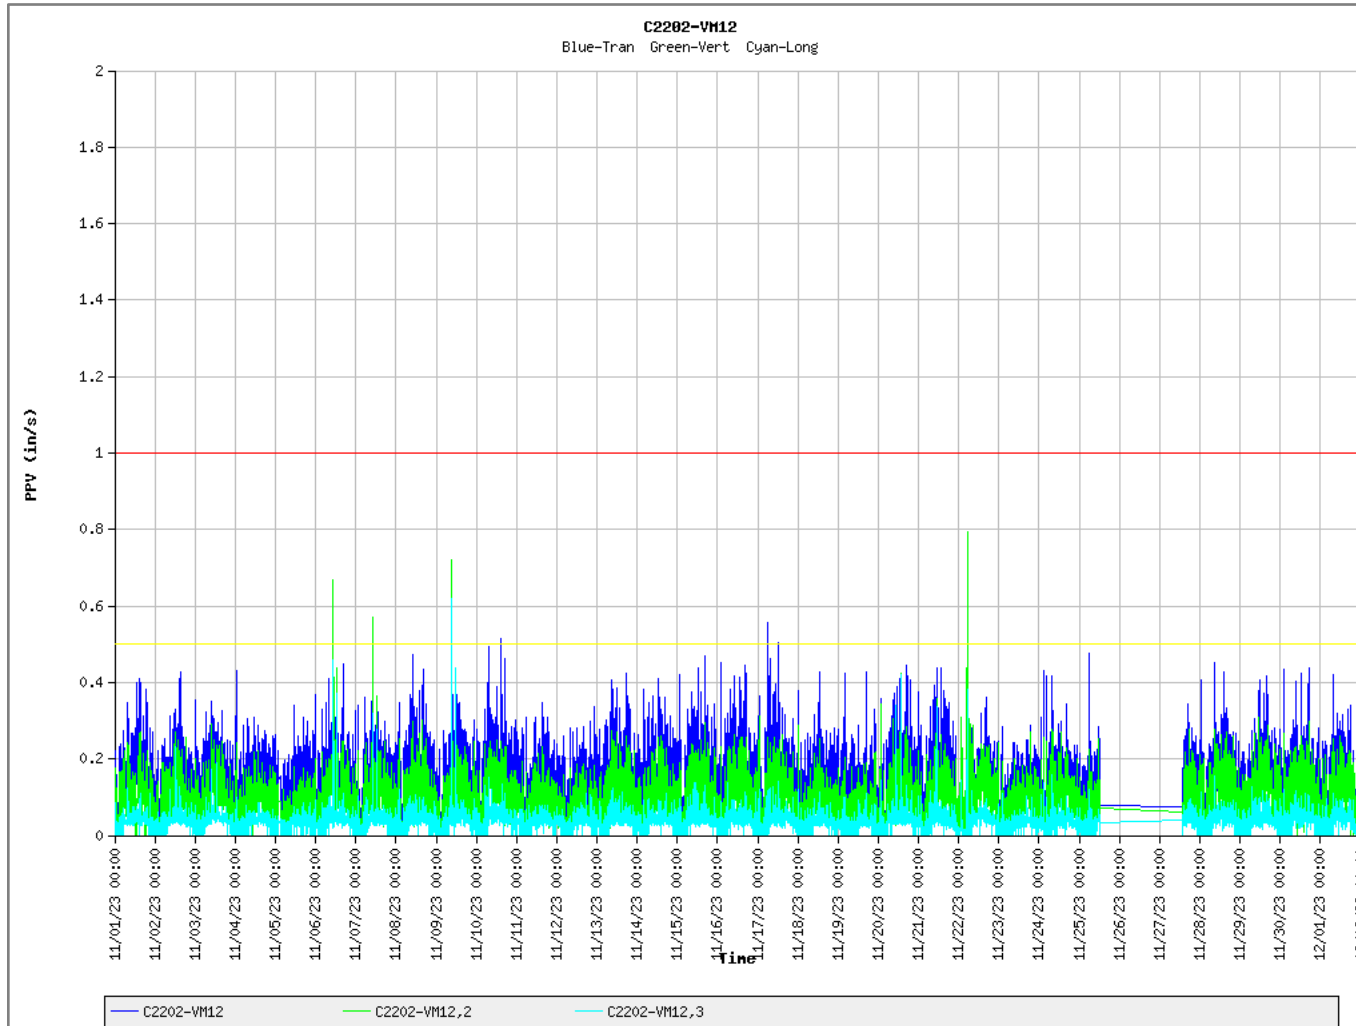
C2202-VM12 Transverse  
C2202-VM12,2 Vertical  
C2202-VM12,3 Longitudinal

There were exceedances recorded during non-construction hours at VM11 and VM12. No corrective actions were required at this time.
