**AIR, NOISE AND VIBRATION  
MONTHLY MONITORING REPORT  
Number 017**

Prepared By: Roux / Wang Technology

<b>DDC Project No.:</b>	BBJ-XSP	<b>Period Start:</b> 12/1/23 <b>End</b> 12/22/23	
<b>Project Name:</b>	NYCDDC D&B – The Bronx Site Preparation		
<b>DDC Pin No.:</b>	8502021CR0004P-06P		
<b>1) Community Air Monitoring Monthly Status Summary</b>			
TWA – Time Weighted Average ug/m <sup>3</sup> - micrograms per cubic meter			
Number of Workdays in a Month	Number of Air Monitoring Days in a Month	Number of Days with Dust Concentrations above Action Concentrations by Month (100 ug/m <sup>3</sup> 15 minute TWA)	Comments
16	15	1	There was one 15-minute reading over the dust action level on 12/15 that is detailed below.  Air Monitoring not performed on 12/18 due to inclement weather.  Air monitoring was only set up on work days.
<b>Community Air Monitoring Monthly Excursions and Corrective Actions</b>			
Action Concentration =100 ug/m <sup>3</sup> 15 minute TWA above background concentration Stop Work Concentration = 150 ug/m <sup>3</sup> 15 minute TWA above background concentration

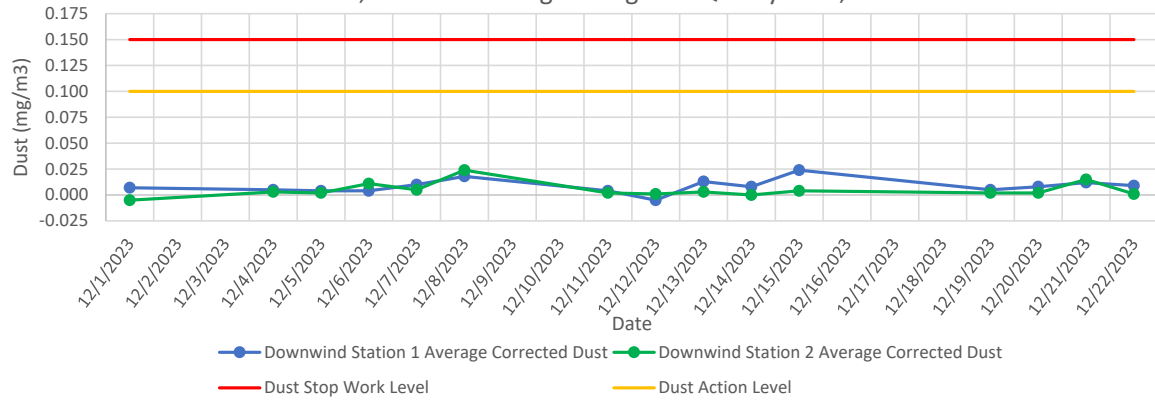
December 2023, 15-min Running Average Air Quality Data, PM Plot

Date: Time	Maximum Dust Reading Before Corrective Action 15 Minute TWA (ug/m <sup>3</sup> )	Maximum Dust Reading After Corrective Action 15 Minute TWA (ug/m <sup>3</sup> )	Corrective Action
12/15 12:36	0.131	0.041	An elevated reading above the dust action level was caused by street sweeper operating close to CAMP station. Work was temporarily stopped, and water was used to mitigate dust in the work area.
Narrative Summary of Air Monitoring, Excursions and Corrective Actions: <i>In December 2023, construction-related levels of Particulate Matter (PM) PM10 did not surpass the Daily Permissible Exposure Limits (PEL) as set by federal standards for the 8-hour Time Weighted Average (TWA) and did not cause air quality concerns to the community and/or onsite workers.</i>

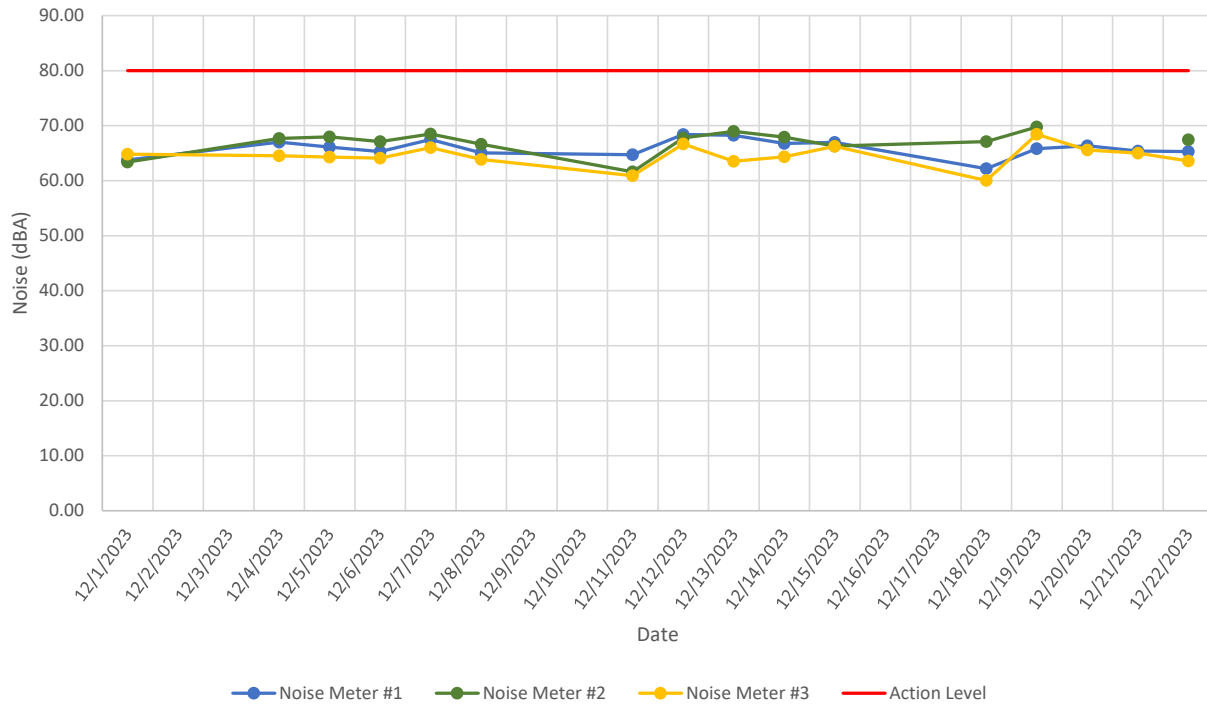
December 2023, Average Equivalent Sound Level Plot (Laeq)

Number of Workdays in a Month	Number of Noise Monitoring Days in a Month	Number of Days with Noise Levels above Action Levels by Month	Comments
16	16	2	There were three instances of noise levels above the 80 dBA limit. Two occurred on 12/13 and one on 12/18 and are detailed below.

Date: Time	Maximum Noise Reading before Corrective Action (dBA)	Maximum Noise Reading after Corrective Action (dBA)	Corrective Action
12/13/23 10:20 am	82.91	78.37	Exceedance began at 10:20am and ended at 10:30 am due to a truck idling near the noise meter along E 142st St. Operator was asked to move as soon as possible.
12/13/23 10:40 am	81.55	76.08	Exceedance began at 10:40am and ended at 11:00 am due to a truck idling near the noise meter along E 142st St. Operator was asked to move as soon as possible.
12/18/23 10:00 am	82.20	75.01	Exceedance began at 10:00am and ended at 11:10 am due to a truck idling near the noise meter along E 142st St. Operator was asked to move as soon as possible.

*In December 2023, construction-related levels of noise did surpass the limits of Local Law 113 during three occasions – two on 12/13/23 and one on 12/18/23. The daily average was below the limits and did not cause noise concerns for the community.*

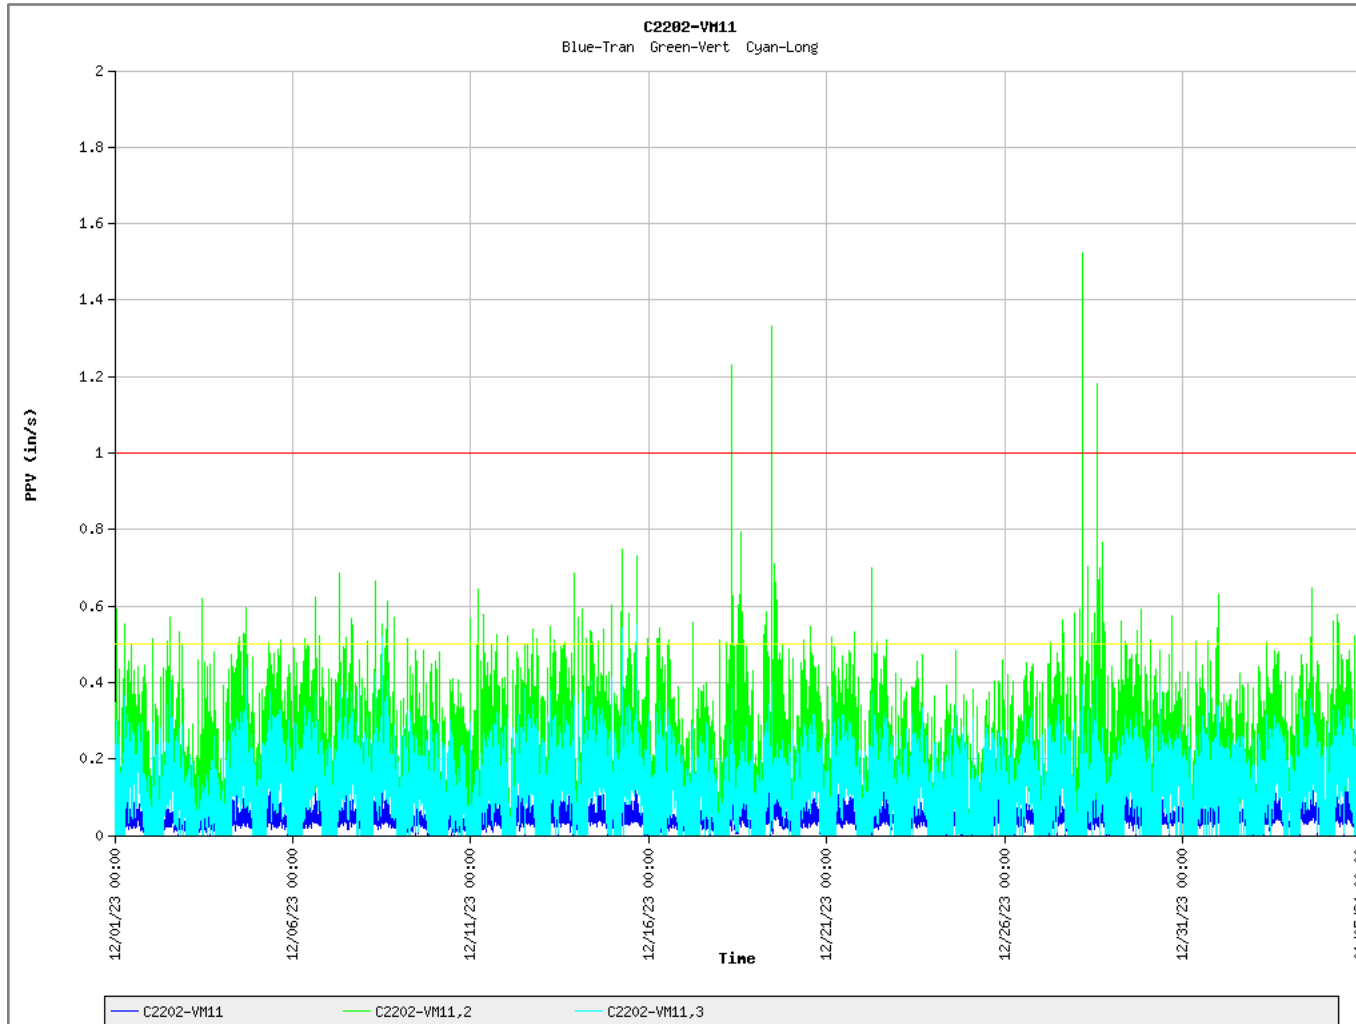
# The Bronx Site Preparation December 2023 Vibration Monitoring Data Plots

Number of Workdays in a Month	Number of Vibration Monitoring Days in a Month	Number of Days with Vibration Levels above Action Levels by Month	Comments
16	31	27	Two out of six vibration monitors recorded a total of one hundred and thirty-nine exceedances. One exceedance was caused by the excavator in the area chopping the rocks. Four exceedances were caused by the excavator moving materials in the area. One exceedance was caused by the rock excavation work. One exceedance was caused by the excavator moving the office trailer in the area. Twenty-six events are not construction related; contractor confirmed that there was no work being performed in the area during the event times. 106 exceedances were recorded during non-construction hours. Detailed information about exceedances is provided in the narrative summary section and plots.

Date: Time	Maximum Vibration Level before Corrective Action (in/sec)	Maximum Vibration Level after Corrective Action (in/sec)	Corrective Action
12/1/2023 01:30, 06:50, & 06:55	0.593	N/A	Exceedances observed at VM11 were recorded during non-construction hours.
12/2/2023 01:50, 11:25, 13:00, 19:50, & 21:05	0.5716	N/A	Exceedances observed at VM11 were recorded during non-construction hours.
12/3/2023 10:35	0.6197	N/A	Exceedance observed at VM11 was recorded during non-construction hours.
12/4/2023 10:45	0.5049	0.409	Exceedance observed at VM11 was due to rock chopping in the area. The intensity of the excavator was reduced post event.
12/4/2023 11:40	0.5185	N/A	Exceedance observed at VM11 was not construction related, it is confirmed that no work was being performed in the area.
12/4/2023 14:55, 15:25, 16:00, & 16:20	0.5949	N/A	Exceedances observed at VM11 were recorded during non-construction hours.

12/5/2023 08:15	0.503	0.4881	Exceedance observed at VM11 was due to moving materials with excavator in the area. The intensity of the excavator was reduced post event.
12/5/2023 15:45	0.5111	N/A	Exceedance observed at VM11 was recorded during non-construction hours.
12/6/2023 08:15	0.5164	0.4853	Exceedance observed at VM11 was due to moving materials with excavator in the area. The intensity of the excavator was reduced post event.
12/6/2023 10:20	0.5005	N/A	Exceedance observed at VM11 was not construction related, it is confirmed that no work was being performed in the area.

12/6/2023 14:55 & 17:50	0.6222	N/A	Exceedances observed at VM11 were recorded during non-construction hours.
12/7/2023 07:35	0.6842	0.4949	Exceedance observed at VM11 was due to moving materials with excavator in the area. The intensity of the excavator was reduced post event.
12/7/2023 11:55	0.5173	0.4499	Exceedance observed at VM11 was not construction related, it is confirmed that no work was being performed in the area.
12/7/2023 15:35 & 16:10	0.5676	N/A	Exceedances observed at VM11 were recorded during non-construction hours.
12/8/2023 02:10	0.5067	N/A	Exceedance observed at VM11 was recorded during non-construction hours.
12/8/2023 07:40	0.6641	N/A	Exceedance observed at VM11 was not construction related, it is confirmed that no work was being performed in the area.
12/8/2023 15:05, 15:45, 16:10, & 20:00	0.6125	N/A	Exceedances observed at VM11 were recorded during non-construction hours.
12/9/2023 05:20	0.5132	N/A	Exceedance observed at VM11 was recorded during non-construction hours.

12/10/2023 23:29	0.566	N/A	Exceedance observed at VM11 was recorded during non-construction hours.
12/11/2023 05:25	0.6442	N/A	Exceedance observed at VM11 was recorded during non-construction hours.
12/11/2023 08:59	0.5781	0.4959	Exceedance observed at VM11 was due to rock excavation in the area. The intensity of the excavator was reduced post event.
12/11/2023 17:15	0.5247	N/A	Exceedance observed at VM11 was recorded during non-construction hours.
12/12/2023 00:25, 14:15, 17:35, & 20:50	0.5406	N/A	Exceedances observed at VM11 were recorded during non-construction hours.
12/13/2023 05:30	0.5474	N/A	Exceedance observed at VM11 was recorded during non-construction hours.
12/13/2023 08:15	0.5105	N/A	Exceedance observed at VM11 was not construction related, it is confirmed that no work was being performed in the area.
12/13/2023 15:30 & 22:10	0.6861	N/A	Exceedances observed at VM11 were recorded during non-construction hours.

12/14/2023 00:30, 03:20, & 06:00	0.5914	N/A	Exceedances observed at VM11 were recorded during non-construction hours.
12/14/2023 08:25, 09:25, & 10:15	0.5347	N/A	Exceedances observed at VM11 were not construction related, it is confirmed that no work was being performed in the area.
12/14/2023 14:15, 17:30, & 22:45	0.6014	N/A	Exceedances observed at VM11 were recorded during non-construction hours.
12/15/2023 05:10 & 06:00	0.7485	N/A	Exceedances observed at VM11 were recorded during non-construction hours.
12/15/2023 10:15 & 10:40	0.58	N/A	Exceedances observed at VM11 were not construction related, it is confirmed that no work was being performed in the area.
12/15/2023 14:59, 16:20, & 22:55	0.7308	N/A	Exceedances observed at VM11 were recorded during non-construction hours.
12/16/2023 05:25, 06:10, 07:30, 12:35, & 13:30	0.544	N/A	Exceedances observed at VM11 were recorded during non-construction hours.

12/17/2023 05:30	0.5555	N/A	Exceedance observed at VM11 was recorded during non-construction hours.
12/18/2023 00:15 & 04:15	0.512	N/A	Exceedances observed at VM11 were recorded during non-construction hours.
12/18/2023 07:35, 07:40, & 07:55	1.2319	N/A	Exceedances observed at VM11 were not construction related, it is confirmed that no work was being performed in the area.

12/18/2023 08:25	0.6259	0.4956	Exceedance observed at VM11 was due to moving materials with excavator in the area. The intensity of the excavator was reduced post event.
12/18/2023 11:40	0.5021	0.4562	Exceedance observed at VM11 was due to moving the office trailer with excavator in the area. The intensity of the excavator was reduced post event.
12/18/2023 12:45	0.6017	N/A	Exceedance observed at VM11 was not construction related, it is confirmed that no work was being performed in the area.
12/18/2023 13:20, 14:00, 14:15, 14:40, 15:15, 15:45, & 16:05	0.7935	N/A	Exceedances observed at VM11 were recorded during non-construction hours.
12/19/2023 05:20	0.5254	N/A	Exceedance observed at VM11 was recorded during non-construction hours.
12/19/2023 06:50, 06:59, 10:55, 12:25, & 12:30	1.3322	N/A	Exceedances observed at VM11 were not construction related, it is confirmed that no work was being performed in the area.

12/19/2023 13:30, 13:50, 14:05, 14:25, & 17:50	0.6606	N/A	Exceedances observed at VM11 were recorded during non-construction hours.
12/20/2023 08:15, 12:50, & 13:10	0.5449	N/A	Exceedances observed at VM11 were not construction related, it is confirmed that no work was being performed in the area.
12/21/2023 03:20 & 19:00	0.534	N/A	Exceedances observed at VM11 were recorded during non-construction hours.
12/22/2023 06:15 & 06:20	0.6997	N/A	Exceedances observed at VM11 were recorded during non-construction hours.
12/22/2023 10:25	0.5058	N/A	Exceedance observed at VM11 was not construction related, it is confirmed that no work was being performed in the area.
12/22/2023 16:35	0.5126	N/A	Exceedance observed at VM11 was recorded during non-construction hours.
12/27/2023 06:40, 14:35, 16:15, & 23:20	0.58	N/A	Exceedances observed at VM11 were recorded during non-construction hours. The job site was shut down this week.

12/28/2023 02:20, 04:20, 04:35, 08:00, 10:25, 12:55, 13:00, 13:10, 13:40, 14:40, 14:45, 14:50, 15:40, 16:20, 17:55, 18:20, 18:45, 19:15, & 20:00	1.5227	N/A	Exceedances observed at VM11 were recorded during non-construction hours. The job site was shut down this week.
12/29/2023 06:10, 09:40, 17:40, 19:55, & 20:15	0.5918	N/A	Exceedances observed at VM11 were recorded during non-construction hours. The job site was shut down this week.
12/30/2023 02:10 & 16:25	0.5756	N/A	Exceedances observed at VM11 were recorded during non-construction hours.
12/31/2023 09:10, 17:10, & 23:15	0.5412	N/A	Exceedances observed at VM11 were recorded during non-construction hours.
12/4/2023 15:22	0.5129	N/A	Exceedance observed at VM12 was recorded during non-construction hours.
12/8/2023 07:37	0.5021	N/A	Exceedance observed at VM12 was not construction related, it is confirmed that no work was being performed in the area.

In December 2023, two vibration monitors had recorded exceedances.

There were exceedances recorded during non-construction hours at VM11 and VM12. No corrective actions were required at this time.

The exceedance recorded at VM11 on December 4<sup>th</sup> was due to rock chopping with an excavator in the area. The intensity of the excavator was reduced post event.

The exceedances recorded at VM11 on December 5<sup>th</sup>, December 6<sup>th</sup>, December 7<sup>th</sup>, and December 18<sup>th</sup> were due to excavator moving materials in the area. The intensity of the excavator was reduced post event.

The exceedance recorded at VM11 on December 11<sup>th</sup> was due to rock excavation performed in the area. The intensity of the excavator was reduced post event.

The other exceedance recorded at VM11 on December 18<sup>th</sup> was due to an excavator moving the office trailer in the area. The intensity of the excavator was reduced post event.

The rest of the exceedances recorded at VM11 and VM12 were non-construction related. The event times when the exceedances were recorded were reviewed by the contractor, it is confirmed that no work was being performed in the area during these event periods. No corrective action was required at these times.

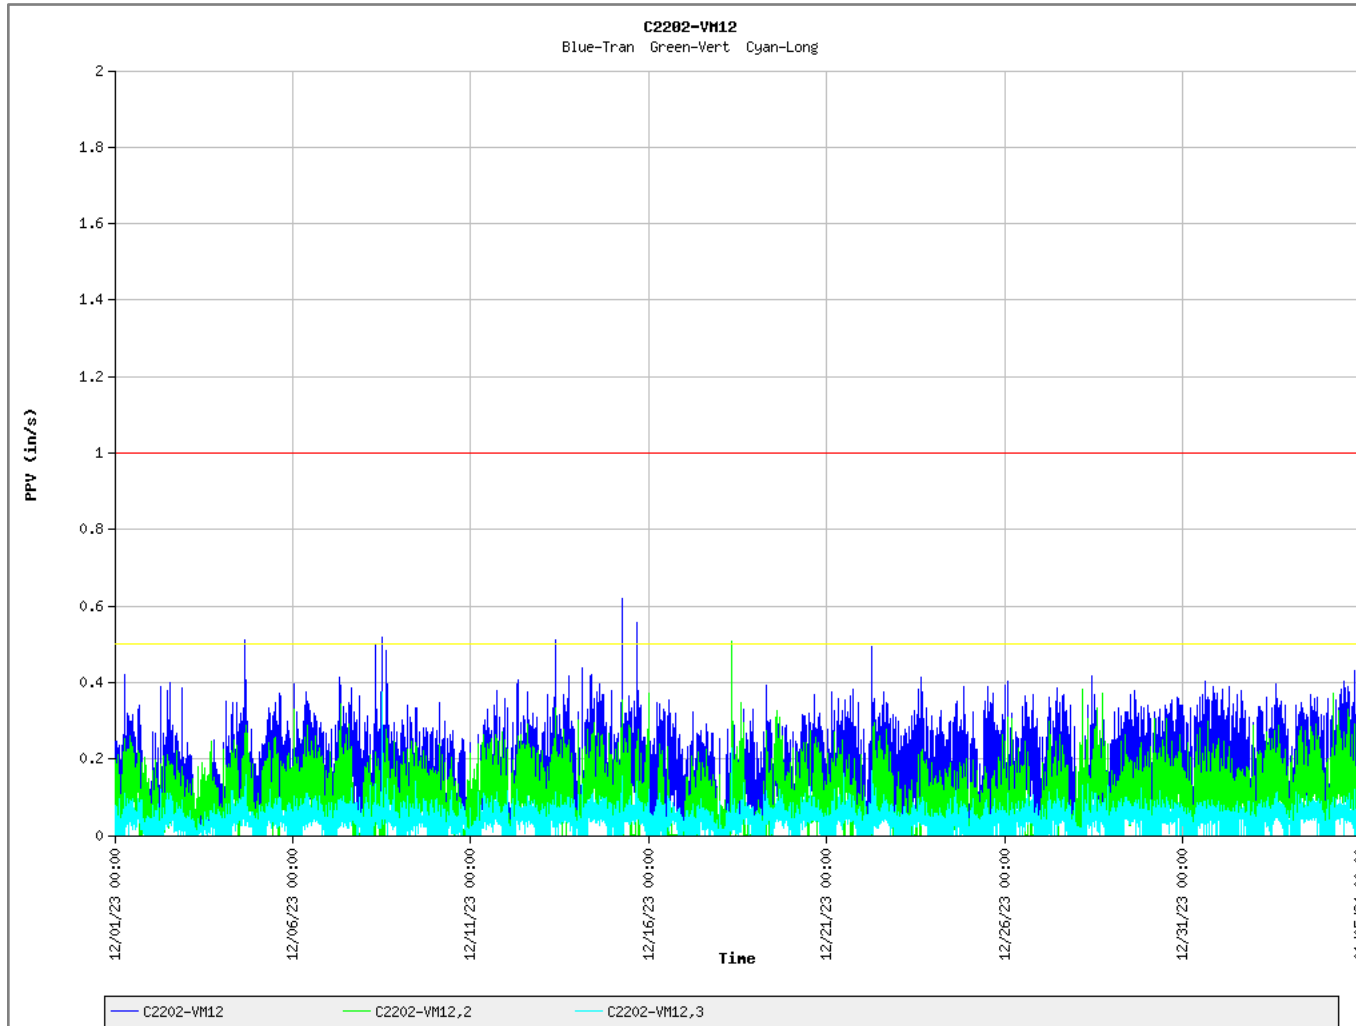
# The Bronx Site Preparation December 2023 Vibration Monitoring Data Plots

12/13/2023 09:00	0.5123	N/A	Exceedance observed at VM12 was not construction related, it is confirmed that no work was being performed in the area.
12/15/2023 05:58 & 16:17	0.62	N/A	Exceedances observed at VM12 were recorded during non-construction hours.
12/18/2023 07:39	0.5083	N/A	Exceedance observed at VM12 was not construction related, it is confirmed that no work was being performed in the area.
