**AIR, NOISE AND VIBRATION
MONTHLY MONITORING REPORT
Number 018**

Prepared By: Roux / Wang Technology

DDC Project No.:	BBJ-XSP	Period Start: 1/2/24 End 1/31/24	
Project Name:	NYCDDC D&B – The Bronx Site Preparation		
DDC Pin No.:	8502021CR0004P-06P		
1) Community Air Monitoring Monthly Status Summary			
TWA – Time Weighted Average ug/m ³ - micrograms per cubic meter			
Number of Workdays in a Month	Number of Air Monitoring Days in a Month	Number of Days with Dust Concentrations above Action Concentrations by Month (100 ug/m ³ 15 minute TWA)	Comments
21	21	5	Each exceedance was recorded during separate 15-minute readings on 1/03, 1/05, 1/08, 1/09, 1/24, respectively. See details below.
Community Air Monitoring Monthly Excursions and Corrective Actions			
Action Concentration = 100 ug/m ³ 15 minute TWA above background concentration Stop Work Concentration = 150 ug/m ³ 15 minute TWA above background concentration			
Date: Time	Maximum Dust Reading Before Corrective Action 15 Minute TWA (ug/m ³)	Maximum Dust Reading After Corrective Action 15 Minute TWA (ug/m ³)	Corrective Action

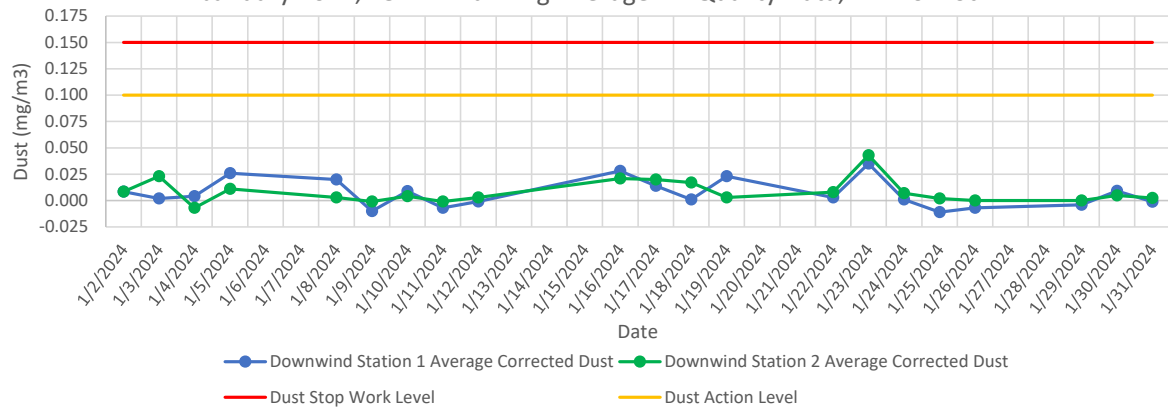
January 2024, 15-min Running Average Air Quality Data, PM 10 Plot

1/03 12:28	0.406	0.023	An elevated reading above the dust action level was caused by street sweeper operating close to CAMP station. Work was temporarily stopped, and water was used to mitigate dust in the work area.
1/05 8:45	0.159	0.034	An elevated reading above the dust action level was caused by street sweeper operating close to CAMP station. Work was temporarily stopped, and water was used to mitigate dust in the work area.
1/08 7:12	0.196	0.009	An elevated reading above the dust action level was caused by a car idling close to CAMP station. The operator was asked to move the vehicle as soon as possible.

1/09 6:34	0.124	0.002	An elevated reading above the dust action level was caused by a car idling close to CAMP station. The operator was asked to move the vehicle as soon as possible.
1/24 06:23	0.127	0.056	An elevated reading above the dust action level was caused by a car idling close to CAMP station. The operator was asked to move the vehicle as soon as possible.
1/24 7:23	0.118	0.080	An elevated reading above the dust action level was caused by a car idling close to CAMP station. The operator was asked to move the vehicle as soon as possible.

Narrative Summary of Air Monitoring, Excursions and Corrective Actions:
In January 2024, construction-related levels of Particulate Matter (PM) PM10 did not surpass the Daily Permissible Exposure Limits (PEL) as set by federal standards for the 8-hour Time Weighted Average (TWA) and did not cause air quality concerns to the community and/or onsite workers.

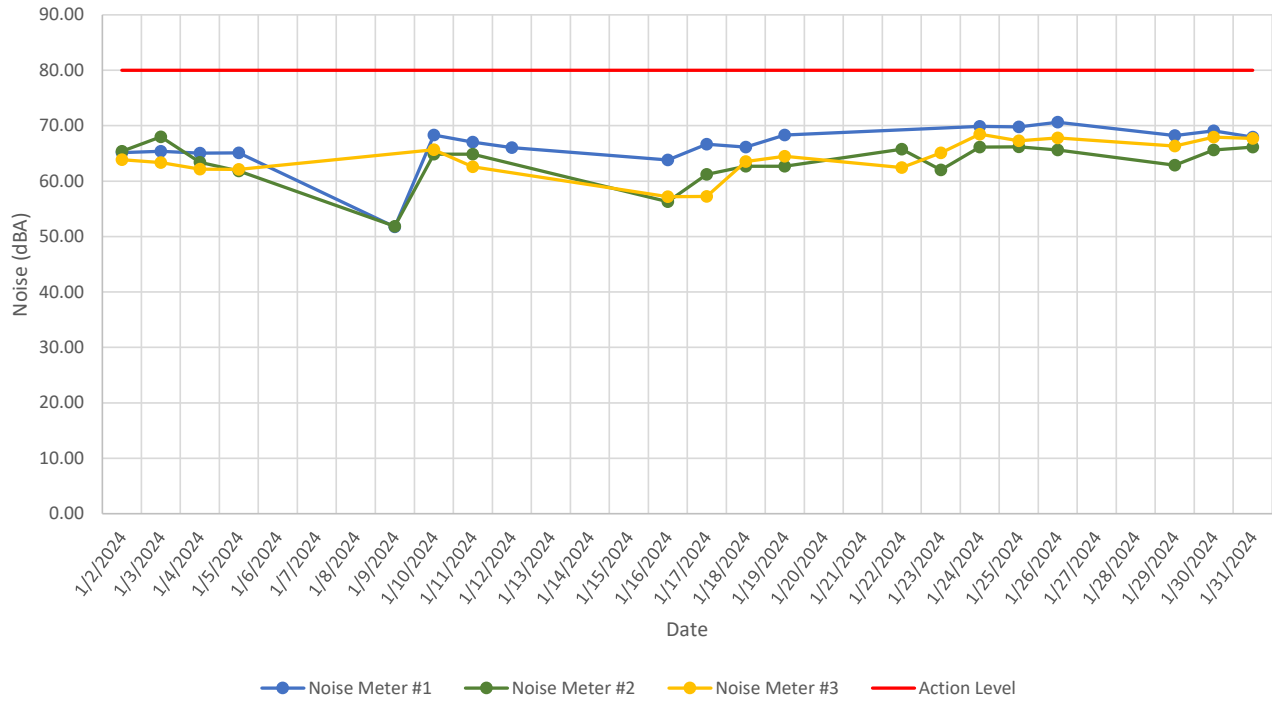
January 2024, Average Equivalent Sound Level Plot (Laeq)

Date: Time	Maximum Noise Reading before Corrective Action (dBA)	Maximum Noise Reading after Corrective Action (dBA)	Corrective Action
1/03/24 11:40 am	81.07	77.65	Exceedance began at 11:20am and ended at 11:40 am due to a truck idling near the noise meter along E 142st St. Operator was asked to move as soon as possible.

In January 2024, construction-related levels of noise did surpass the limits of Local Law 113 of 2005 during one occasion on 1/03/24. The daily average was below the limits and did not cause noise concerns for the community.

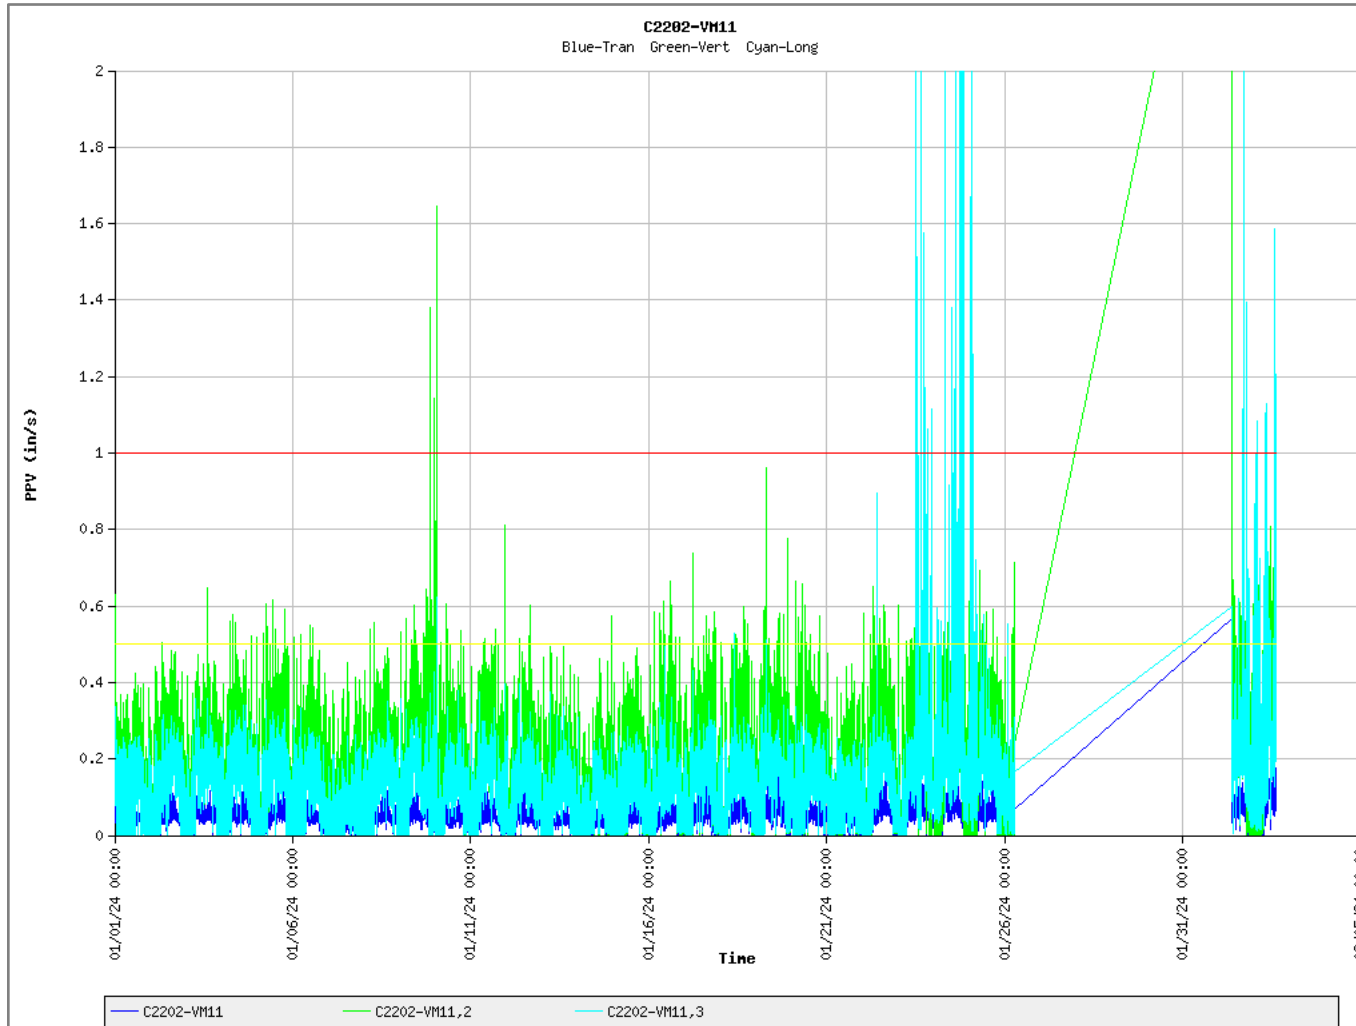
Date: Time	Maximum Vibration Level before Corrective Action (in/sec)	Maximum Vibration Level after Corrective Action (in/sec)	Corrective Action
1/1/2024 00:30	0.6312	N/A	Exceedance observed at VM11 was recorded during non-construction hours.
1/2/2024 08:15	0.503	N/A	Exceedance observed at VM11 was not construction related, it is confirmed that no work was being performed in the area.
1/3/2024 14:22 & 14:57	0.6485	N/A	Exceedances observed at VM11 were recorded during non-construction hours.
1/4/2024 05:30	0.5601	N/A	Exceedance observed at VM11 was recorded during non-construction hours.
1/4/2024 07:52, 09:17, & 09:27	0.5784	N/A	Exceedances observed at VM11 were not construction related, it is confirmed that no work was being performed in the area.
1/4/2024 19:57 & 23:27	0.5207	N/A	Exceedances observed at VM11 were recorded during non-construction hours.
1/5/2024 03:55	0.5281	N/A	Exceedance observed at VM11 was recorded during non-construction hours.

1/5/2024 06:20, 07:12, 10:17, & 12:47	0.6144	N/A	Exceedances observed at VM11 were not construction related, it is confirmed that no work was being performed in the area.
1/5/2024 18:27	0.5933	N/A	Exceedance observed at VM11 was recorded during non-construction hours.
1/6/2024 00:40, 05:25, 11:57 & 13:07	0.5508	N/A	Exceedances observed at VM11 were recorded during non-construction hours.
1/8/2024 04:15	0.5393	N/A	Exceedance observed at VM11 was recorded during non-construction hours.
1/8/2024 06:40	0.5555	N/A	Exceedance observed at VM11 was not construction related, it is confirmed that no work was being performed in the area.
1/9/2024 00:35 & 04:25	0.5679	N/A	Exceedances observed at VM11 were recorded during non-construction hours.

1/9/2024 08:30, 09:55, & 10:30	0.6026	N/A	Exceedances observed at VM11 were not construction related, it is confirmed that no work was being performed in the area.
1/9/2024 16:20, 17:10, 17:35, 18:15, 19:00, 20:15, 20:25, 20:45, 20:50, 20:55, 21:15, 22:20, 23:05, 23:10, 23:20, & 23:25	1.3806	N/A	Exceedances observed at VM11 were recorded during non-construction hours.
1/10/2024 00:45 & 04:20	1.6468	N/A	Exceedances observed at VM11 were recorded during non-construction hours.
1/10/2024 07:41, 08:11, & 08:46	0.6073	N/A	Exceedances observed at VM11 were not construction related, it is confirmed that no work was being performed in the area.
1/10/2024 17:05	0.5347	N/A	Exceedance observed at VM11 was recorded during non-construction hours.
1/11/2024 08:15 & 09:55	0.5142	N/A	Exceedances observed at VM11 were not construction related, it is confirmed that no work was being performed in the area.
1/11/2024 16:20 & 23:00	0.8102	N/A	Exceedances observed at VM11 were recorded during non-construction hours.

1/12/2024 08:30	0.5142	N/A	Exceedance observed at VM11 was not construction related, it is confirmed that no work was being performed in the area.
1/12/2024 15:10 & 16:35	0.602	N/A	Exceedances observed at VM11 were recorded during non-construction hours.
1/14/2024 23:05 & 23:25	0.5738	N/A	Exceedances observed at VM11 were recorded during non-construction hours.
1/16/2024 03:30	0.5852	N/A	Exceedance observed at VM11 was recorded during non-construction hours.
1/16/2024 07:25, 08:20, 09:45, & 10:40	0.6125	N/A	Exceedances observed at VM11 were not construction related, it is confirmed that no work was being performed in the area.
1/16/2024 13:25, 13:35, 14:25, 15:45, 15:55, 18:10, & 21:10	0.6665	N/A	Exceedances observed at VM11 were recorded during non-construction hours.
1/17/2024 05:35, 13:30, 14:25, 16:15, 16:25, 16:35, 19:00, 20:30, & 20:55	0.7367	N/A	Exceedances observed at VM11 were recorded during non-construction hours.

1/18/2024 00:25	0.5052	N/A	Exceedance observed at VM11 was recorded during non-construction hours.
1/18/2024 10:40 & 11:20	0.526	N/A	Exceedances observed at VM11 were not construction related, it is confirmed that no work was being performed in the area.
1/18/2024 16:05, 16:25, 16:30, & 19:00	0.5983	N/A	Exceedances observed at VM11 were recorded during non-construction hours.
1/19/2024 05:15	0.5865	N/A	Exceedance observed at VM11 was recorded during non-construction hours.
1/19/2024 06:35, 06:55, 07:40, 08:20, & 09:20	0.9604	N/A	Exceedances observed at VM11 were not construction related, it is confirmed that no work was being performed in the area.
1/19/2024 14:45, 15:50, 15:55, 18:35, 19:05, & 22:05	0.7783	N/A	Exceedances observed at VM11 were recorded during non-construction hours.
1/20/2024 02:55, 05:15, 06:50, 07:20, 07:35, 09:15, 10:10, 12:55, & 19:25	0.6641	N/A	Exceedances observed at VM11 were recorded during non-construction hours.

1/22/2024 01:25 & 05:45	0.5815	N/A	Exceedances observed at VM11 were recorded during non-construction hours.
1/22/2024 06:55, 07:00, & 08:30	0.6523	N/A	Exceedances observed at VM11 were not construction related, it is confirmed that no work was being performed in the area.
1/22/2024 10:30, 11:40, & 12:55	0.5657	N/A	Exceedances observed at VM11 were not construction related, it is confirmed that no work was being performed in the area.
1/22/2024	0.602	N/A	Exceedances observed at VM11 were

14:05, 14:25, 15:00, & 18:10			recorded during non-construction hours.
1/23/2024 00:35	0.6014	N/A	Exceedance observed at VM11 was recorded during non-construction hours.
1/23/2024 06:10, 08:45, 09:35, & 11:10	0.5437	N/A	Exceedances observed at VM11 were not construction related, it is confirmed that no work was being performed in the area.
1/23/2024 12:30 to 1/26/2024 06:45	9.1739	0.4788	Exceedances observed at VM11 were due to the sensor fails sensor check and malfunction. The sensor was replaced post events.
1/10/2024 00:40	0.6212	N/A	Exceedance observed at VM12 was recorded during non-construction hours.
1/11/2024 22:56	0.5406	N/A	Exceedance observed at VM12 was recorded during non-construction hours.
1/19/2024 03:41	0.5074	N/A	Exceedance observed at VM12 was recorded during non-construction hours.
1/19/2024 06:50 & 07:38	0.5638	N/A	Exceedances observed at VM12 were not construction related, it is confirmed that no work was being performed in the area.

Exceedances recorded at VM11 between January 23rd 12:30 pm and January 26th 6:45 am were due to the sensor failing sensor check and malfunction. The sensor was replaced on post events.

The rest of the exceedances recorded at VM11 and VM12 were non-construction related. The event times when the exceedances were recorded were reviewed by the contractor, it is confirmed that no work was being performed in the area during these event periods. No corrective action was required at these times.

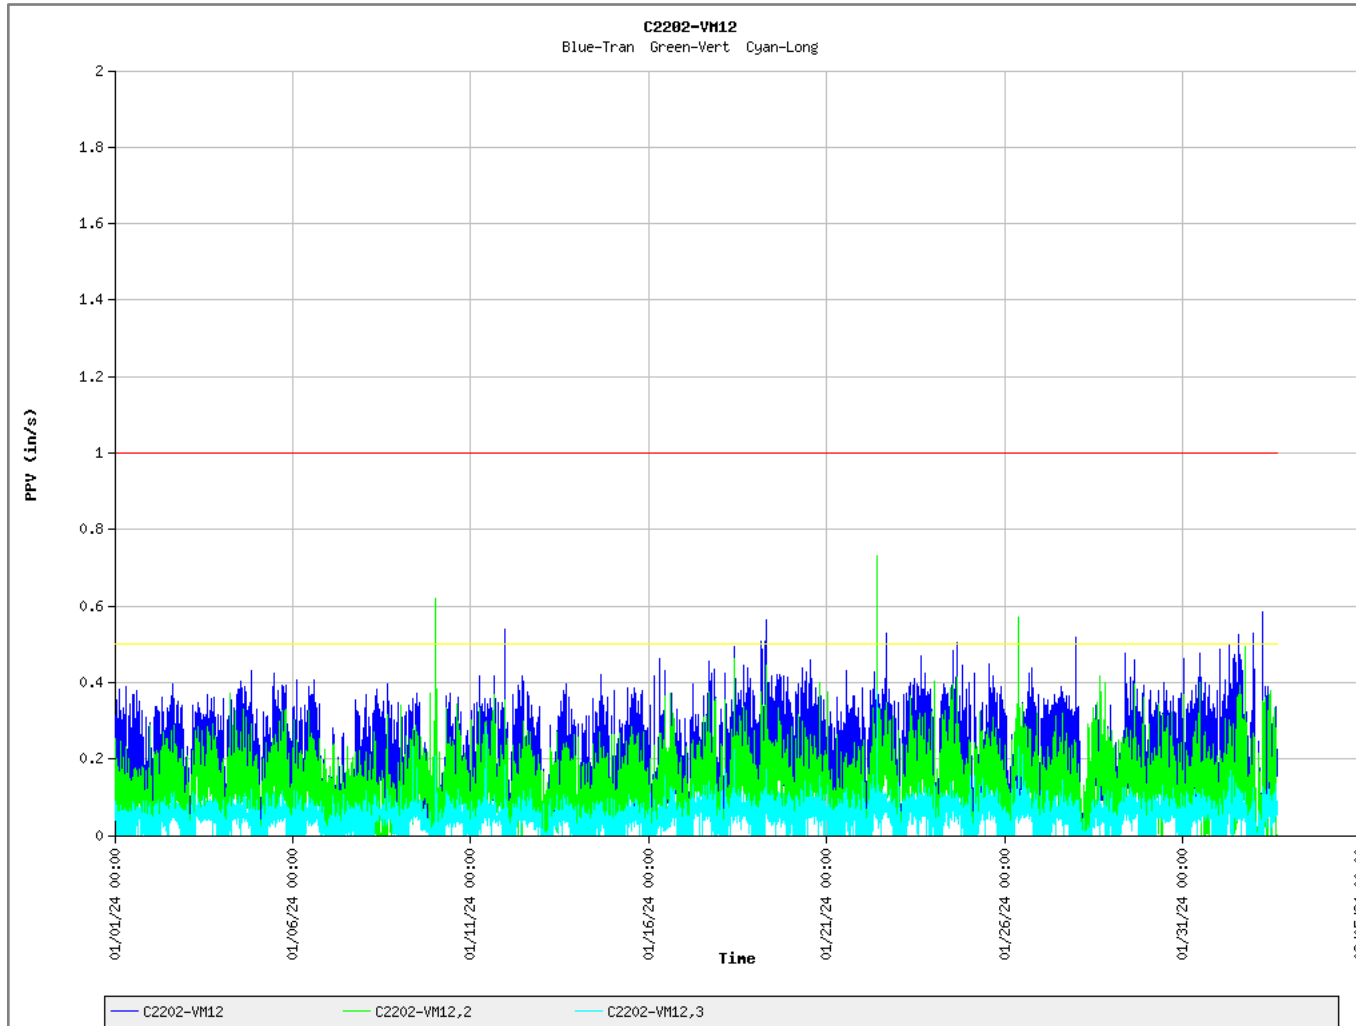
1/22/2024 16:12	0.5281	N/A	Exceedance observed at VM12 was recorded during non-construction hours.
1/24/2024 15:42	0.5027	N/A	Exceedance observed at VM12 was recorded during non-construction hours.
1/28/2024 00:21	0.5198	N/A	Exceedance observed at VM12 was recorded during non-construction hours.

There were exceedances recorded during non-construction hours at VM11 and VM12. No corrective actions were required at this time.

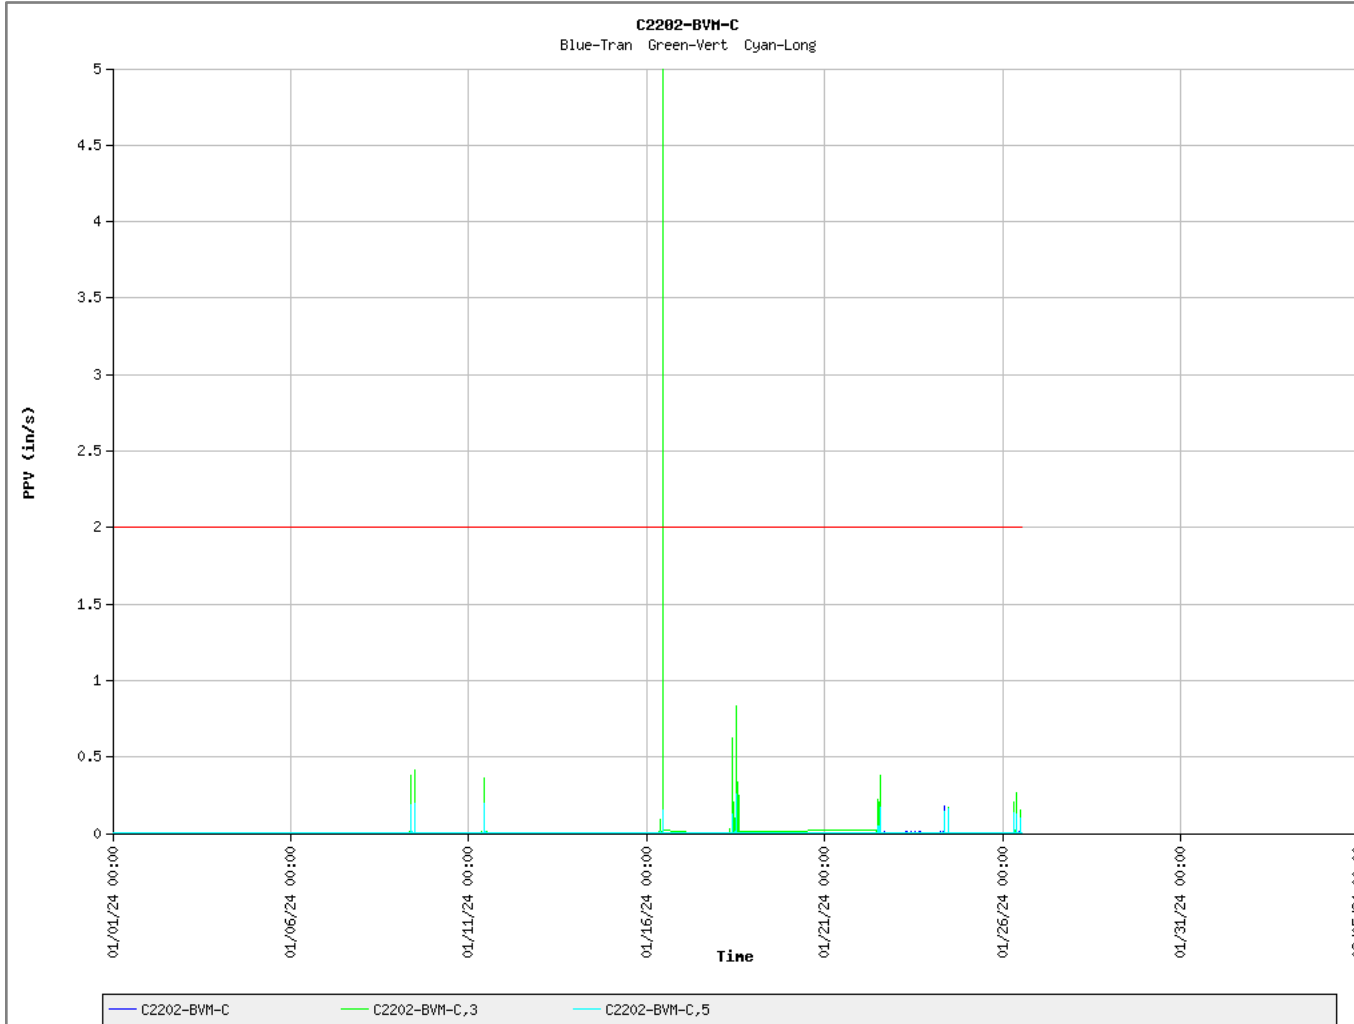
Date: Time	Maximum Vibration Level before Corrective Action (in/sec)	Maximum Vibration Level after Corrective Action (in/sec)	Corrective Action
1/16/2024 10:46, 10:47:08, 10:47:18, 11:01, & 11:15	8.0978	0.0397	The exceedances recorded at BVM-C were due to the geophone sensor being out of level as the soil underneath the geophone sensor was washed out and became loose. The soil was compacted and the geophone sensor was reseated post events on January 17 th . The geophone sensor went out of level again on January 22 nd . The geophone sensor was reseated and performed monitoring for the 2 nd blast on January 22 nd . The seismograph and the geophone sensor were replaced after blasting was completed on January 22 nd .

The exceedances recorded at BVM-C on January 16th were due to geophone sensor being out of level as the soil underneath the geophone sensor was washed out and became loose. The soil was compacted and the geophone sensor was reseated post events on January 17th. The geophone sensor went out of level again on January 22nd. The geophone sensor was reseated and performed monitoring for the 2nd blast on January 22nd. The seismograph and the geophone sensor were replaced after the blasting was completed on January 22nd.
