**AIR, NOISE AND VIBRATION  
MONTHLY MONITORING REPORT  
Number 012**

Prepared By: Roux / Wang Technology

<b>DDC Project No.:</b>	BBJ-XSP	<b>Period Start:</b> 7/1/23 <b>End</b> 7/31/23	
<b>Project Name:</b>	NYCDDC – The Bronx Site Preparation		
<b>DDC Pin No.:</b>	8502021CR0004P-06P		
<b>1) Community Air Monitoring Monthly Status Summary</b>			
TWA – Time Weighted Average ug/m <sup>3</sup> - micrograms per cubic meter			
Number of Workdays in a Month	Number of Air Monitoring Days in a Month	Number of Days with Dust Concentrations above Action Concentrations by Month (100 ug/m <sup>3</sup> 15 minute TWA)	Comments
22	21	3	Community Air Monitoring was not performed on 7/15 because there was no excavation work taking place. There were three instances above the 150 ug/m <sup>3</sup> stop work level. These instances occurred on 7/12, 7/17, 7/28 and are detailed below.
<b>Community Air Monitoring Monthly Excursions and Corrective Actions</b>			
Action Concentration =100 ug/m <sup>3</sup> 15 minute TWA above background concentration Stop Work Concentration = 150 ug/m <sup>3</sup> 15 minute TWA above background concentration

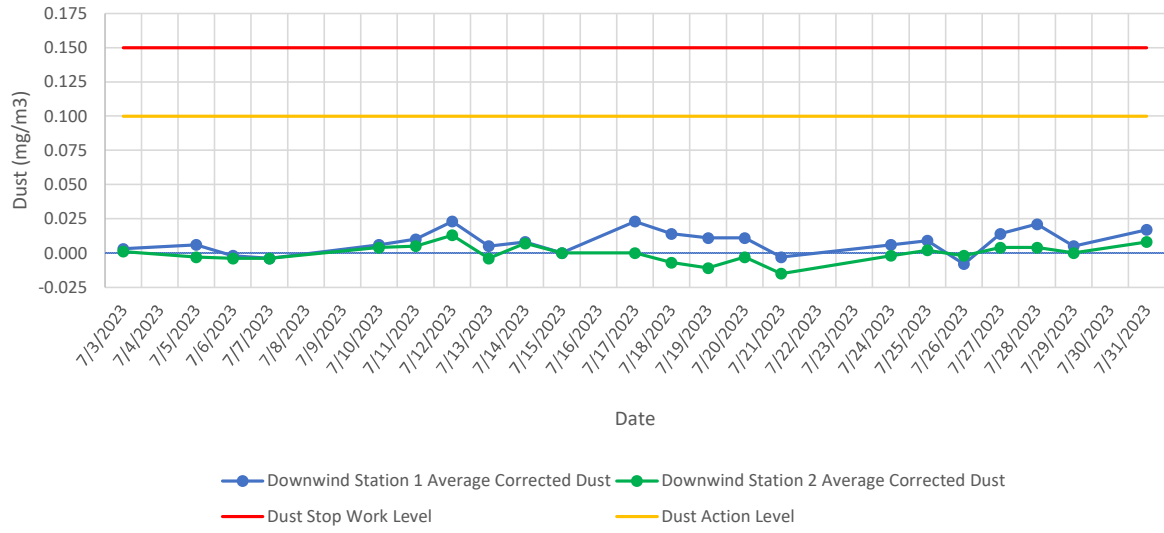
July 2023, 15-min Running Average Air Quality Data, PM 10ug/m3 Plot

Date: Time	Maximum Dust Reading Before Corrective Action 15 Minute TWA (ug/m <sup>3</sup> )	Maximum Dust Reading After Corrective Action 15 Minute TWA (ug/m <sup>3</sup> )	Corrective Action
7/12/23 7:30am	158	89	One elevated reading above the dust action level was caused by machinery moving near the Community Air Monitoring Program (CAMP) station. Work was stopped temporarily, and water was used to mitigate dust in the working area.
7/17/23 6:58am	284	94	One elevated reading above the dust action level was caused by rock scraping adjacent to the CAMP station. Work was stopped temporarily, and water was used to mitigate dust in the working area.
7/28/23 7:40am	158	83	One elevated reading above the dust action level was caused by rock scraping. Work was stopped temporarily, and water was used

to mitigate dust in the working area.
<p>Narrative Summary of Air Monitoring, Excursions and Corrective Actions:  <i>In July 2023, construction-related levels of Particulate Matter (PM) PM10 did not surpass the Daily Permissible Exposure Limits (PEL) as set by federal standards for the 8-hour Time Weighted Average (TWA) and did not cause air quality concerns to the community and/or onsite workers.</i></p>			
<p><b>2) Community Noise Monitoring Weekly Summary</b>            Units: A-weighted decibels (dBA) level</p>			
Number of Workdays in a Month	Number of Noise Monitoring Days in a Month	Number of Days with Noise Levels above Action Levels by Month	Comments
22	22	0	There were no noise levels exceedances.
<p><b>Community Noise Monitoring Monthly Excursions and Corrective Actions</b>            Action Level = 80 dBA            Stop Work Level = 80 dBA</p>			
Date: Time	Maximum Noise Reading before Corrective Action (dBA)	Maximum Noise Reading after Corrective Action (dBA)	Corrective Action

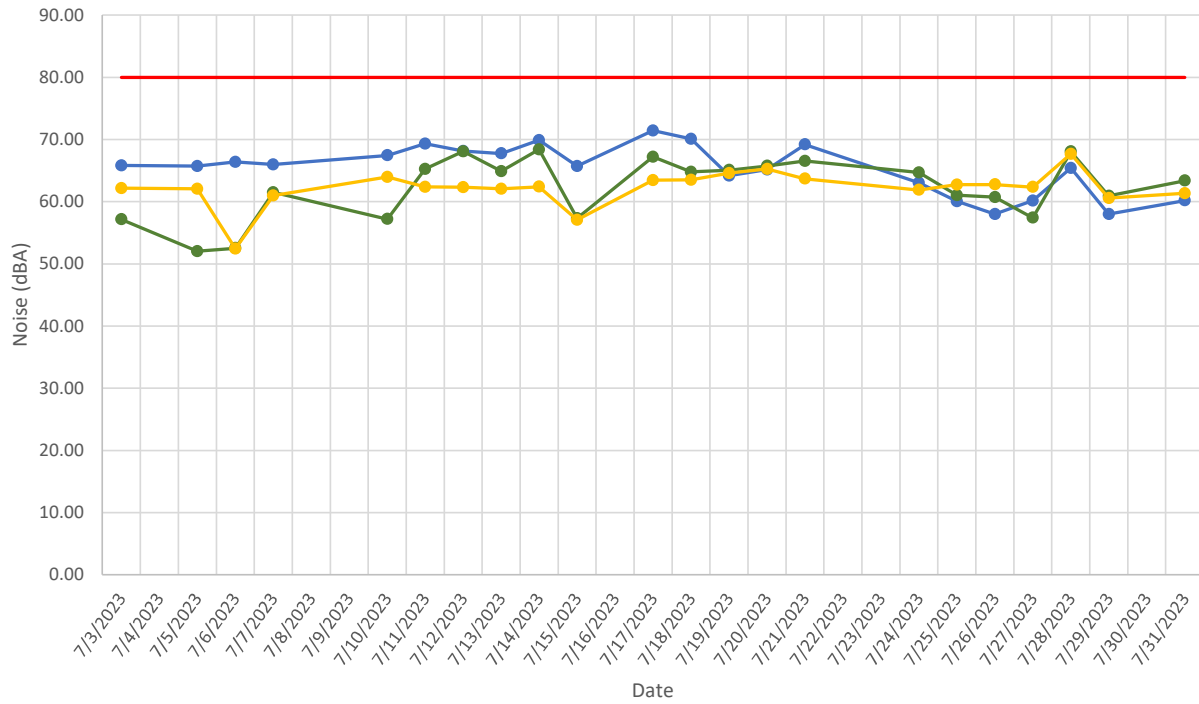
July 2023, Average Equivalent Sound Level Plot (Laeq)

N/A	N/A	N/A	N/A
<p>Narrative Summary of Air Monitoring, Excursions and Corrective Actions:  <i>In July 2023, construction-related levels of noise did not surpass the limits of Local Law 113 of 2005. The daily average was below the limits and did not cause noise concerns for the community.</i></p>

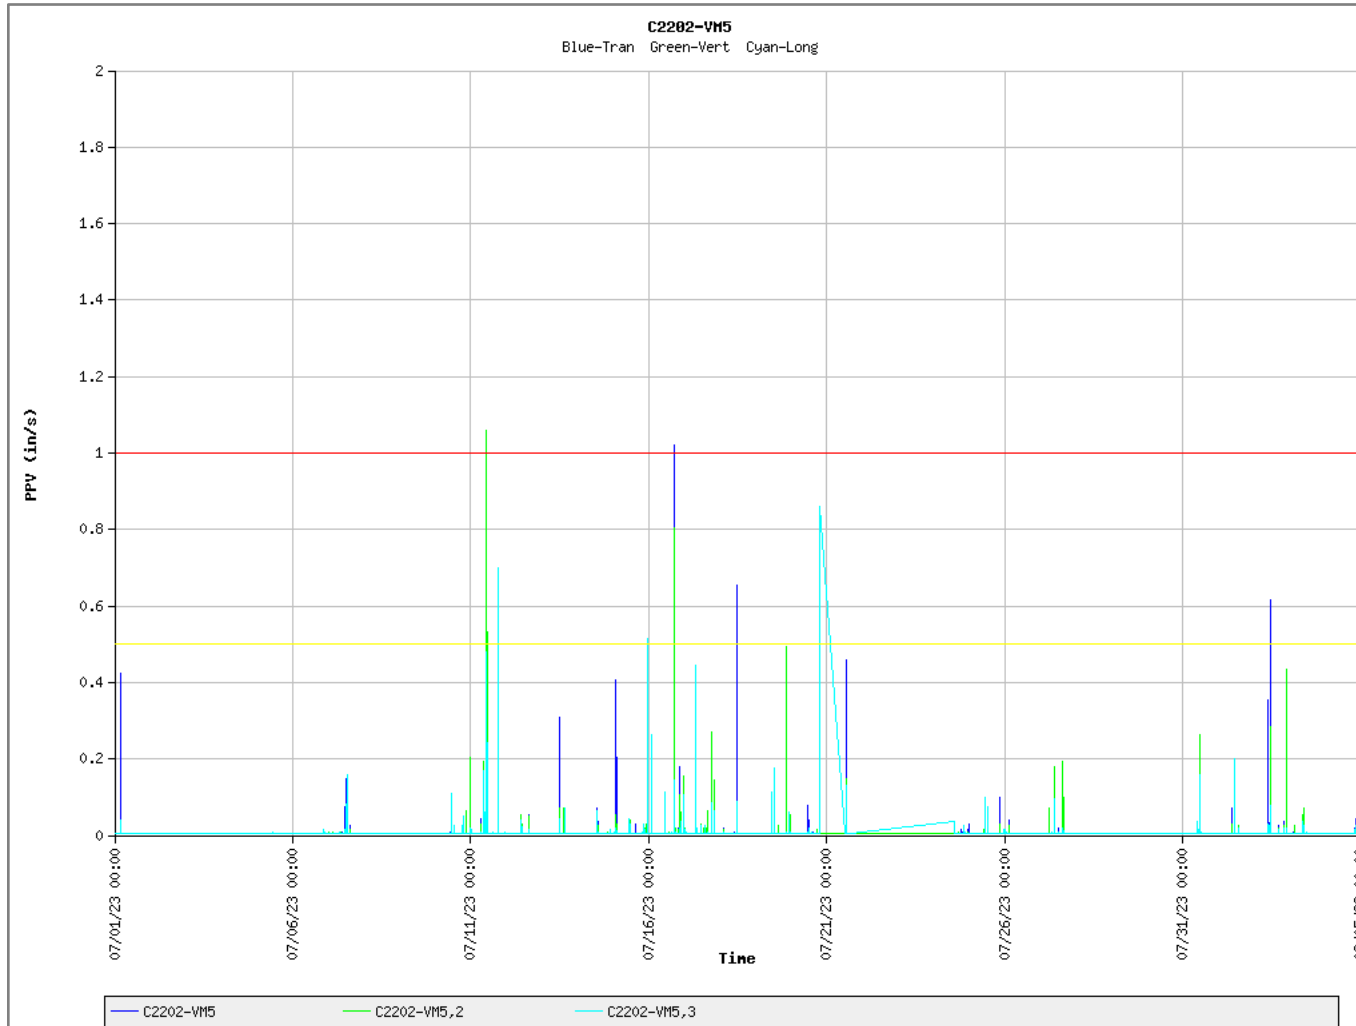
C2202-VM5 Transverse  
C2202-VM5.2 Vertical  
C2202-VM5.3 Longitudinal

Date: Time	Maximum Vibration Level before Corrective Action (in/sec)	Maximum Vibration Level after Corrective Action (in/sec)	Corrective Action
7/11/2023 10:54	1.06	0.095	This is an isolated event recorded at VM5 possibly due to non-construction related activities, associated with resident's activities.
7/11/2023 18:30	0.7	0.01	Exceedances observed at VM5 were recorded during non-construction hours.
7/15/2023 23:09	0.515	0.07	Exceedances observed at VM5 were recorded during non-construction hours.
7/16/2023 17:20	1.02	0.18	Exceedances observed at VM5 were recorded during non-construction hours.
7/18/2023 11:27	0.655	0.005	This is an isolated event recorded at VM5 possibly due to non-construction related activities, associated with resident's activities.
7/20/2023 19:02	0.86	0.005	Exceedances observed at VM5 were recorded during non-construction hours.
7/17/2023 09:30	9.075	0.025	This is an isolated event recorded at VM6 possibly due to non-construction related activities, associated with resident's activities.

There were exceedances recorded during non-construction hours at VM5. There were isolated events recorded at VM5 and VM6, possibly due to non-construction related activities, associated with resident's activities. There were isolated events recorded at VM5 and VM6 during baseline period as well. No corrective actions were required at this time.

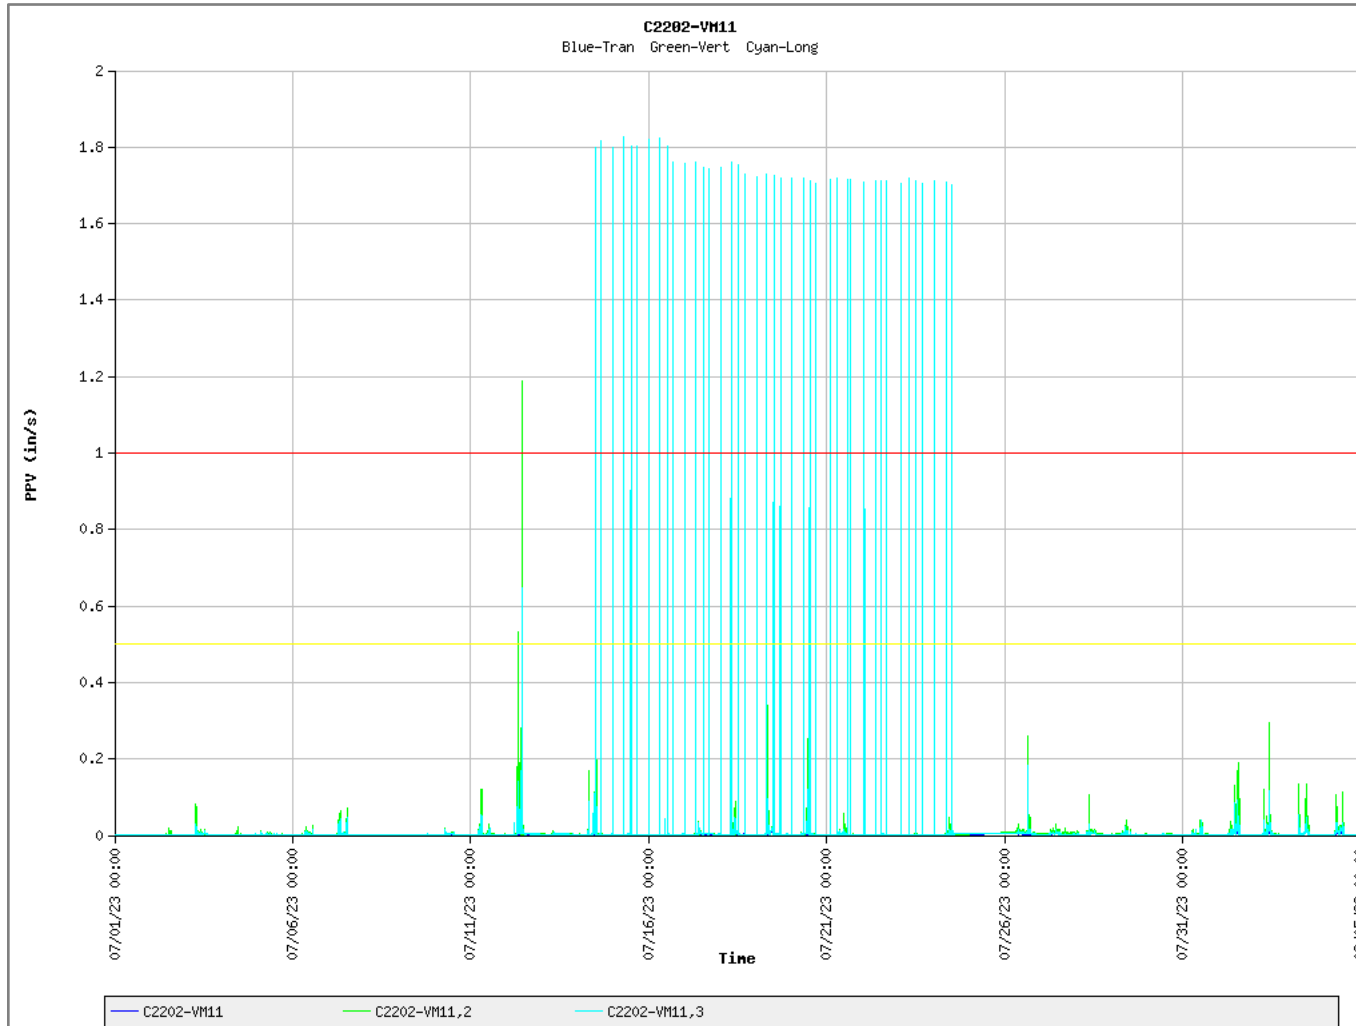
C2202-VM11 Transverse  
C2202-VM11,2 Vertical  
C2202-VM11,3 Longitudinal

7/12/2023 07:55	0.5331	0.2799	Exceedance observed at VM11 was due to unloading delivery of sewer bypass pump pipes. No corrective action was required at this time.
7/12/2023 10:45	1.1888	0.0279	Exceedance observed at VM11 was due to unloading delivery of sewer bypass pump pipes. No corrective action was required at

this time.
7/14/2023, 7/15/2023, 7/16/2023, 7/17/2023, 7/18/2023, 7/19/2023, 7/20/2023, 7/21/2023, 7/22/2023, 7/23/2023, & 7/24/2023	1.8271	0.26	Exceedances observed at VM11 was due to the sensor being out of level. The geophone was installed on the sand on top of the oil static line with a sandbag placed on top. The geophone was likely disturbed, slowly became out of level in the longitudinal direction and no longer securely attached to the structure being monitored, hence high readings that exceed the project limits were recorded randomly. Access was granted on 7/26/2023, the sand around the oil static line was repacked and the sensor was releveled. Once completed, the readings returned to be within the project threshold afterwards.
7/12/2023 10:45	0.5381	0.0242	Exceedance observed at VM12 was due to unloading delivery of sewer bypass pump pipes. No corrective action was required at this time.

The exceedances recorded at VM11 and VM12 on July 12<sup>th</sup> were due to unloading delivery of sewer bypass pump pipes. No corrective actions were required at this time.

The exceedances recorded at VM11 between July 14<sup>th</sup> and July 24<sup>th</sup> were due to sensor being out of level. The sensor was releveled on July 26<sup>th</sup>. Once completed, the readings returned to be within the project threshold afterwards.
