**AIR, NOISE AND VIBRATION
MONTHLY MONITORING REPORT
Number 010**

Prepared By: Roux / Wang Technology

DDC Project ID.:	BBJ-XSP	Period Start: 5/1/23 End 5/31/23	
Project Name:	NYCDDC – The Bronx Site Preparation		
DDC Pin No.:	8502021CR0004P-06P		
1) Community Air Monitoring Weekly Status Summary			
TWA – Time Weighted Average ug/m ³ - micrograms per cubic meter			
Number of Workdays in a Month	Number of Air Monitoring Days in a Month	Number of Days with Dust Concentrations above Action Concentrations by Month (100 ug/m ³ 15 minute TWA)	Comments
25	25	2	There were two instances of elevated readings above 150ug/m ³ . These instances occurred on 5/4 and 5/31 and are detailed below.
Community Air Monitoring Weekly Excursions and Corrective Actions			
Action Concentration =100 ug/m ³ 15 minute TWA above background concentration Stop Work Concentration = 150 ug/m ³ 15 minute TWA above background concentration			
Date: Time	Maximum Dust Reading Before Corrective Action 15 Minute TWA (ug/m ³)	Maximum Dust Reading After Corrective Action 15 Minute TWA (ug/m ³)	Corrective Action

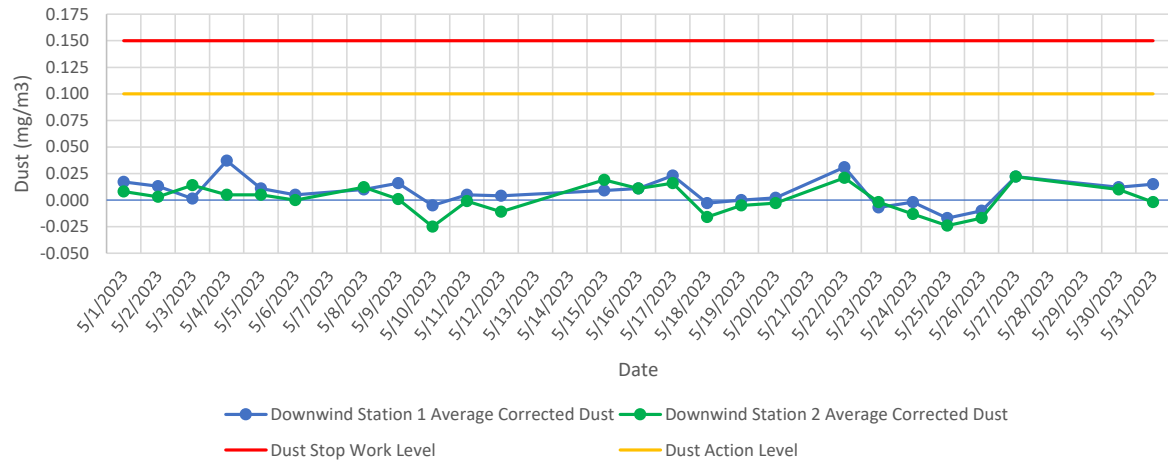
May 2023, 15-min Running Average Air Quality Data, PM 10ug/m3 Plot

5/4/23 9:56am	173	91	One elevated reading above the stop work level was caused by work activities taking place near the CAMP station. Work was stopped temporarily, and water was used to mitigate dust in the area but there were no subsequent concentrations above the action or stop work level so work continued.
5/31/23 11:39am	175	71	One elevated reading above the stop work level was caused by rock hammering taking place near the CAMP station. Work was stopped temporarily, and water was used to mitigate dust in the area but there were no subsequent concentrations above the action or stop work level so work continued.

Narrative Summary of Air Monitoring, Excursions and Corrective Actions:
In May 2023, construction-related levels of Particulate Matter (PM) PM10 did surpass the Daily Permissible Exposure Limits (PEL) as set by federal standards for the 8-hour Time Weighted Average (TWA) but did not cause air quality concerns to the community and/or onsite workers.

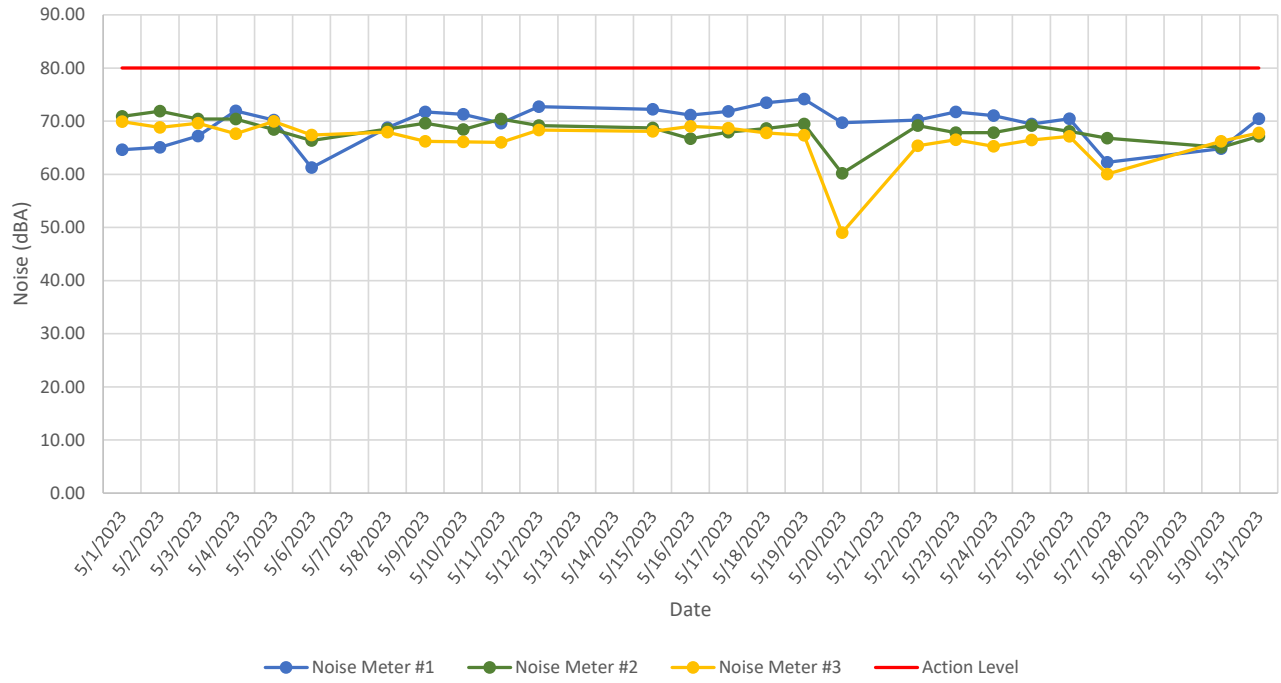
May 2023, Average Equivalent Sound Level Plot (Laeq)

Number of Workdays in a Month	Number of Noise Monitoring Days in a Month	Number of Days with Noise Levels above Action Levels by Month	Comments
25	25	4	There were nine instances of noise levels above the 80 dBA limit on four occasions. These instances occurred on 5/17, 5/18, 5/27, and 5/31 and are detailed below.

Date: Time	Maximum Noise Reading before Corrective Action (dBA)	Maximum Noise Reading after Corrective Action (dBA)	Corrective Action
5/17/23 9:50am	84.64	76.30	Exceedance began at 9:50am and ended at 10:10am due to excavator work near the noise meter on 142 nd St. Excavator work was adjusted to ensure that noise levels were reduced below 80 dBA.
5/17/23 10:00am	83.94		
5/17/23 10:10am	84.57		
5/18/23 7:50am	80.20	79.45	Exceedance began at 7:50am and ended at 8:00am due to rock hammering work. Rock hammering work was adjusted to ensure that noise levels were reduced below 80 dBA.
5/18/23 8:00am	80.16		
5/27/23 7:50am	82.15	63.65	Exceedance was caused by backup alarm for equipment mobilizing near noise meter. Work was stopped in this area.
5/31/23 9:50am	83.99	78.84	Exceedance began at 9:50am

5/31/23 10:00am	84.79		and ended at 10:10am due to unrelated work happening outside construction fence on 141 st Street and Concord Ave.
5/31/23 10:10am	81.65		
<p>Narrative Summary of Air Monitoring, Excursions and Corrective Actions: <i>In May 2023, construction-related levels of noise did surpass the limits of Local Law 113 of 2005 during nine instances on four occasions. On every occasion, the daily average was below the limits and did not cause noise concerns for the community.</i></p>

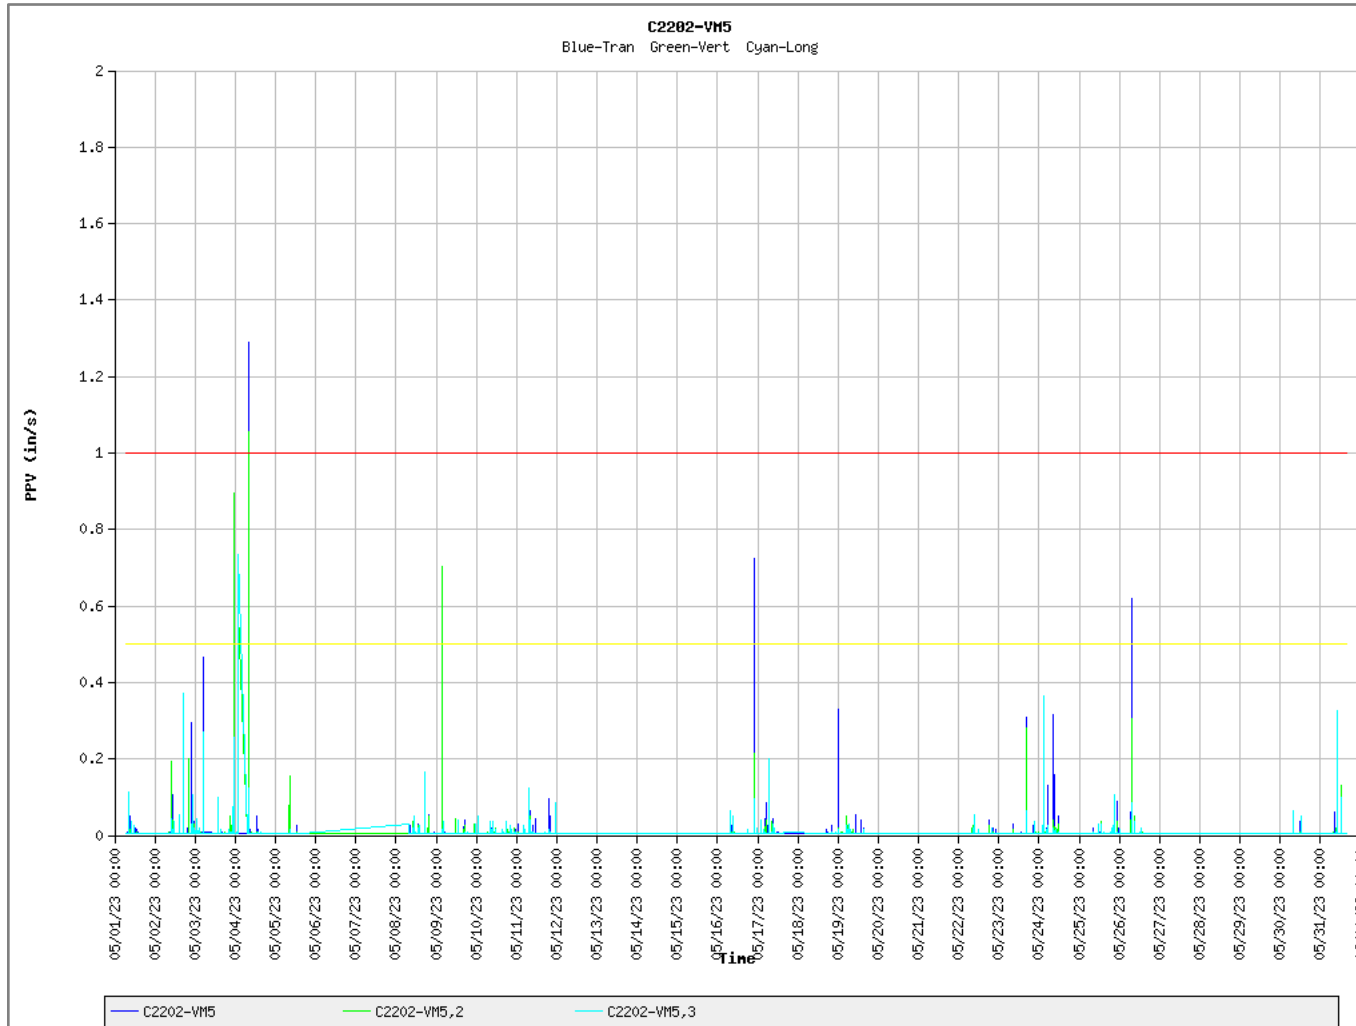
C2202-VM5 Transverse
C2202-VM5,2 Vertical
C2202-VM5,3 Longitudinal

Date: Time	Maximum Vibration Level before Corrective Action (in/sec)	Maximum Vibration Level after Corrective Action (in/sec)	Corrective Action
5/3/2023 23:05	0.895	0.005	Exceedance observed at VM5 was recorded during non-construction hours.
5/4/2023 01:28	0.735	0.065	Exceedance observed at VM5 was recorded during non-construction hours.
5/4/2023 08:09	1.29	0.05	This is an isolated event recorded at VM5 possibly due to non-construction related activities, associated with resident's activities.
5/9/2023 03:12	0.705	0.045	Exceedance observed at VM5 was recorded during non-construction hours.
5/16/2023 22:09	0.725	0.02	Exceedance observed at VM5 was recorded during non-construction hours.
5/26/2023 07:32	0.62	0.05	This is an isolated event recorded at VM5 possibly due to non-construction related activities, associated with resident's activities.
5/5/2023 16:32	1.56	0.025	Exceedance observed at VM6 was recorded during non-construction hours.

In May 2023, three vibration monitors had recorded exceedances. There were exceedances recorded during non-construction hours at VM5 and VM6. There were isolated events recorded at VM5 and VM6, where residents have access to the sensors as they are installed in the basement of residential buildings. There were isolated events recorded at VM5 and VM6 during baseline period as well.

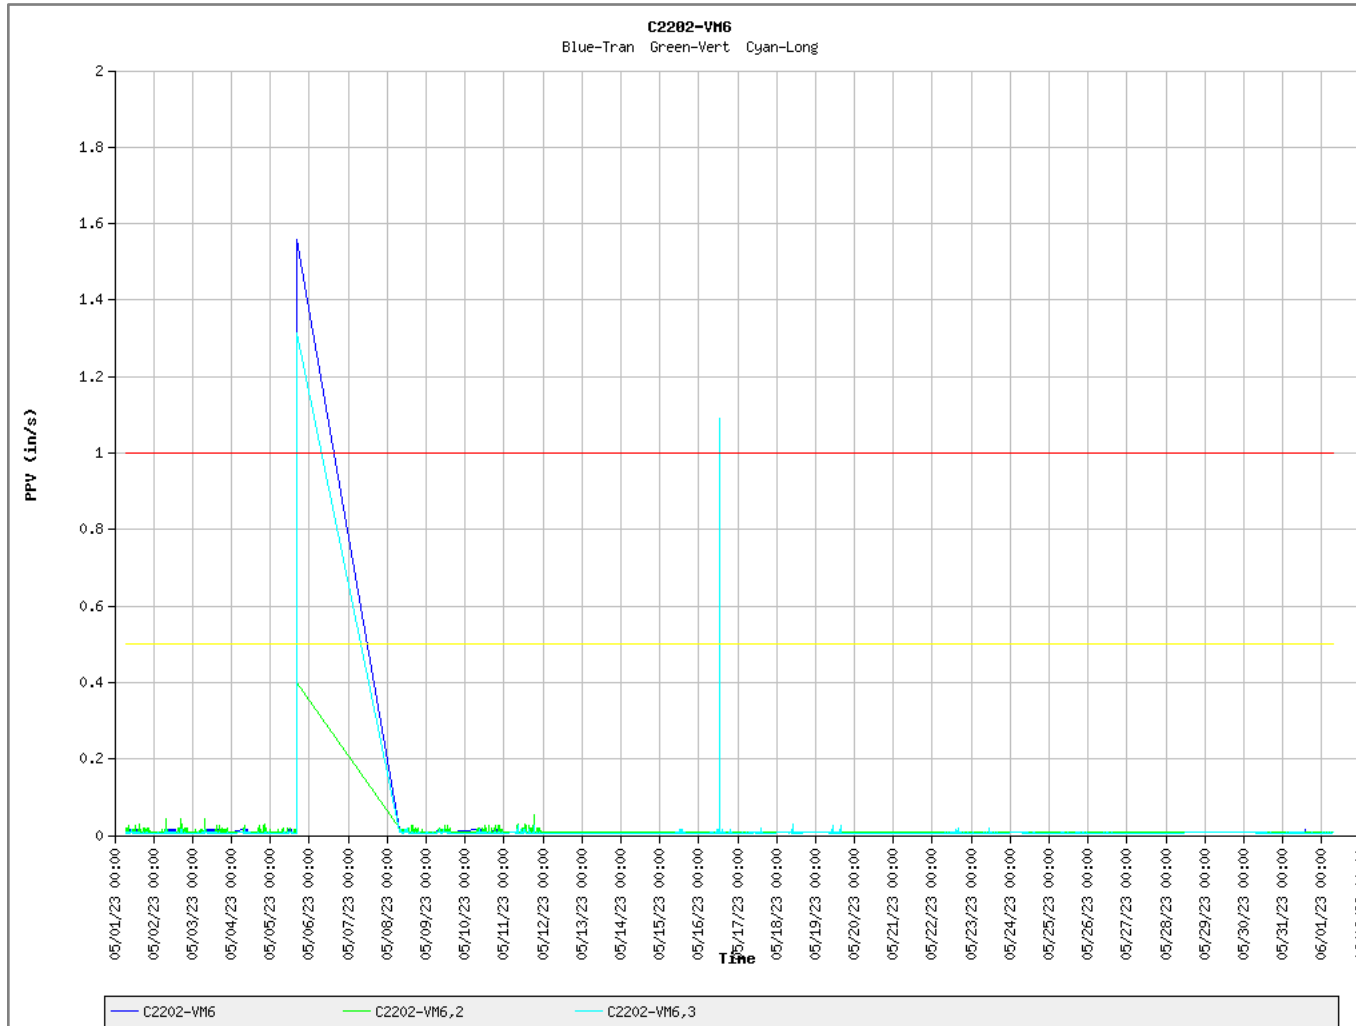
C2202-VM6 Transverse
C2202-VM6.2 Vertical
C2202-VM6.3 Longitudinal

5/16/2023 12:31	1.09	0.015	This is an isolated event recorded at VM6 possibly due to non-construction related activities, associated with resident's activities.
5/23/2023 10:05	0.514	0.4664	Exceedance observed at VM12 was due to accidental disturbance of the sensor cable while loading rock debris off-site.
5/25/2023 06:59 to 11:59	0.718	0.4568	Exceedances observed at VM12 were due to accidental disturbance of the sensor cable while pouring concrete for the button piers.

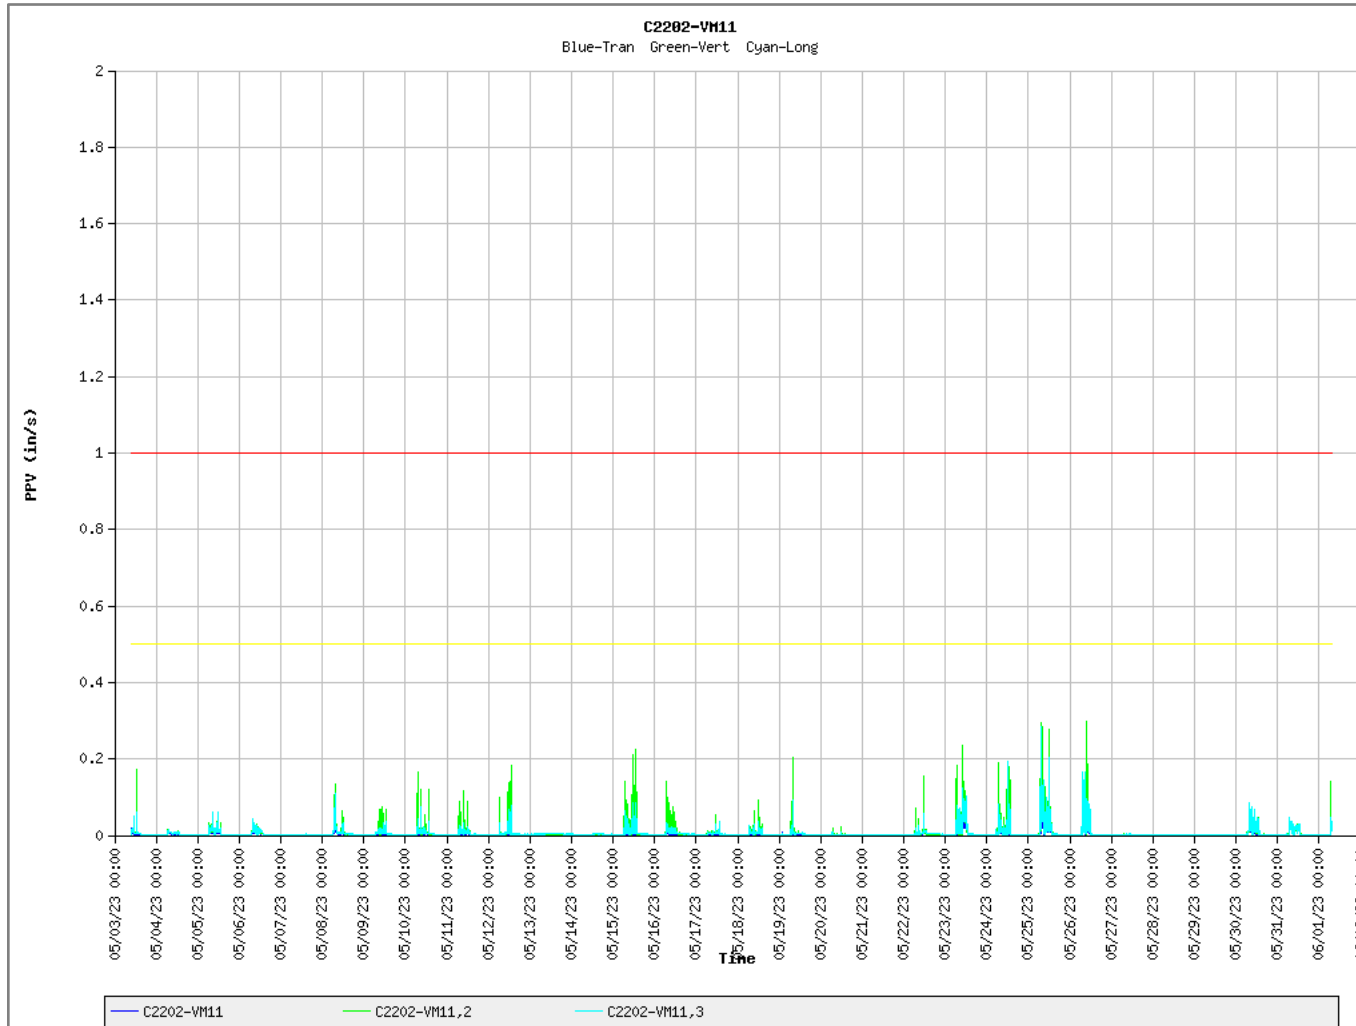
C2202-VM11 Transverse
C2202-VM11,2 Vertical
C2202-VM11,3 Longitudinal

As VM9 and VM10 were experiencing communication issue after the site condition changed, they were replaced by another type of vibration monitors to resolve the communication issue. The units are named as VM11 and VM12.

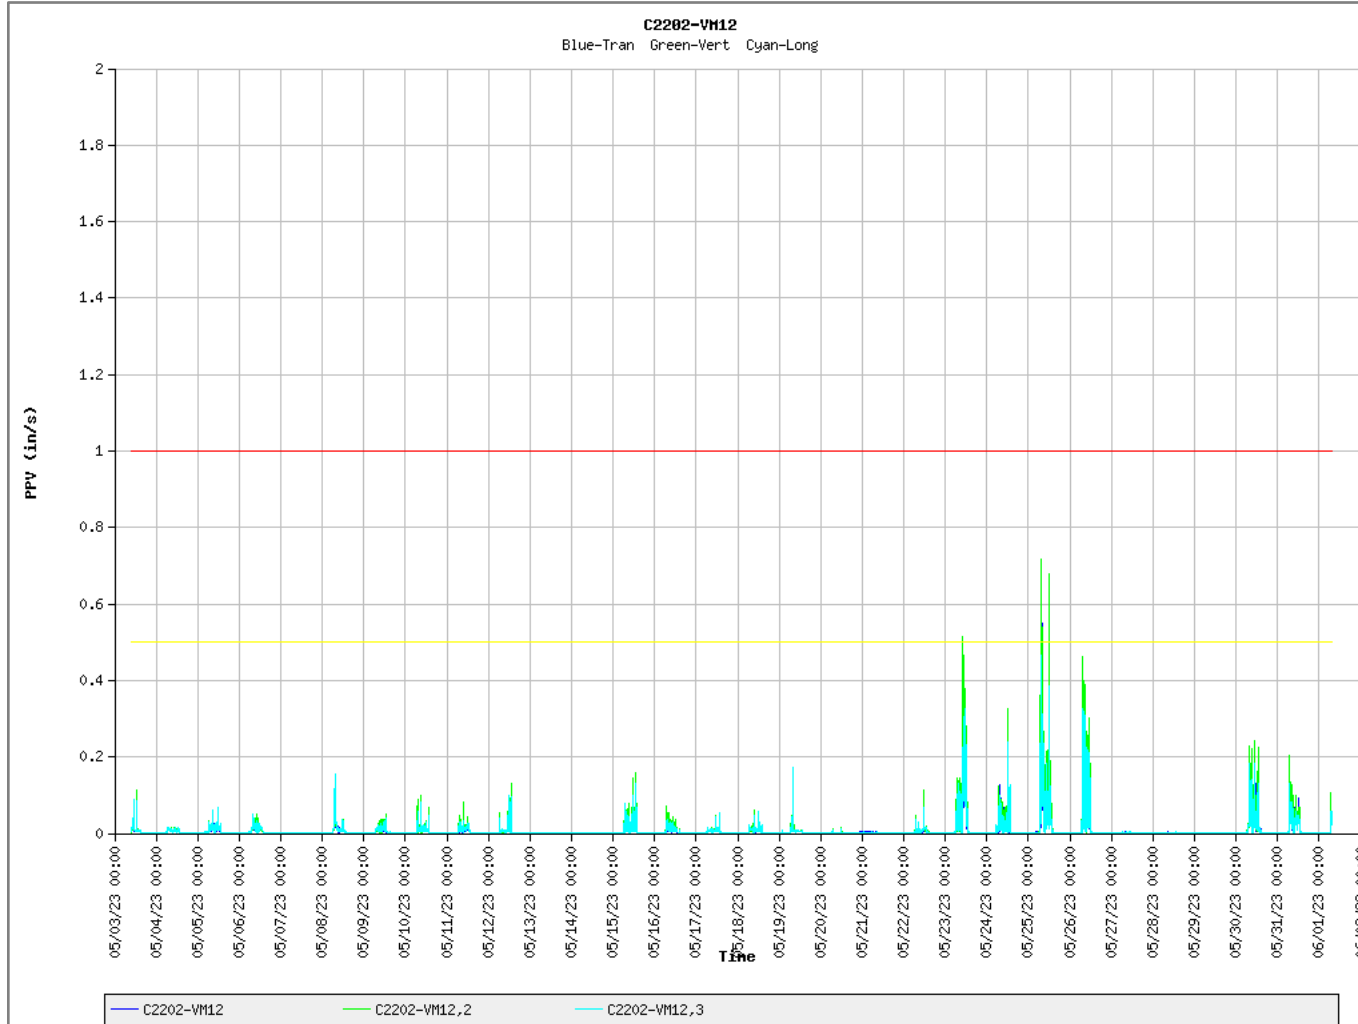
C2202-VM12 Transverse
C2202-VM12,2 Vertical
C2202-VM12,3 Longitudinal

The exceedances recorded at VM12 on May 23rd and May 25th were caused by accidental disturbances of the sensor cable which pulled on the sensor thus causing the exceedances.
