AIR, NOISE AND VIBRATION MONTHLY MONITORING REPORT Number 011

Prepared By: Roux / Wang Technology

DDC Project ID:	BBJ-XSP	BBJ-XSP		Period Start: 6/1/23 End 6/30/23				
Project Name:	NYCDDC – The Bronx	NYCDDC – The Bronx Site Preparation						
DDC Pin No.:	8502021CR0004P-06P	8502021CR0004P-06P

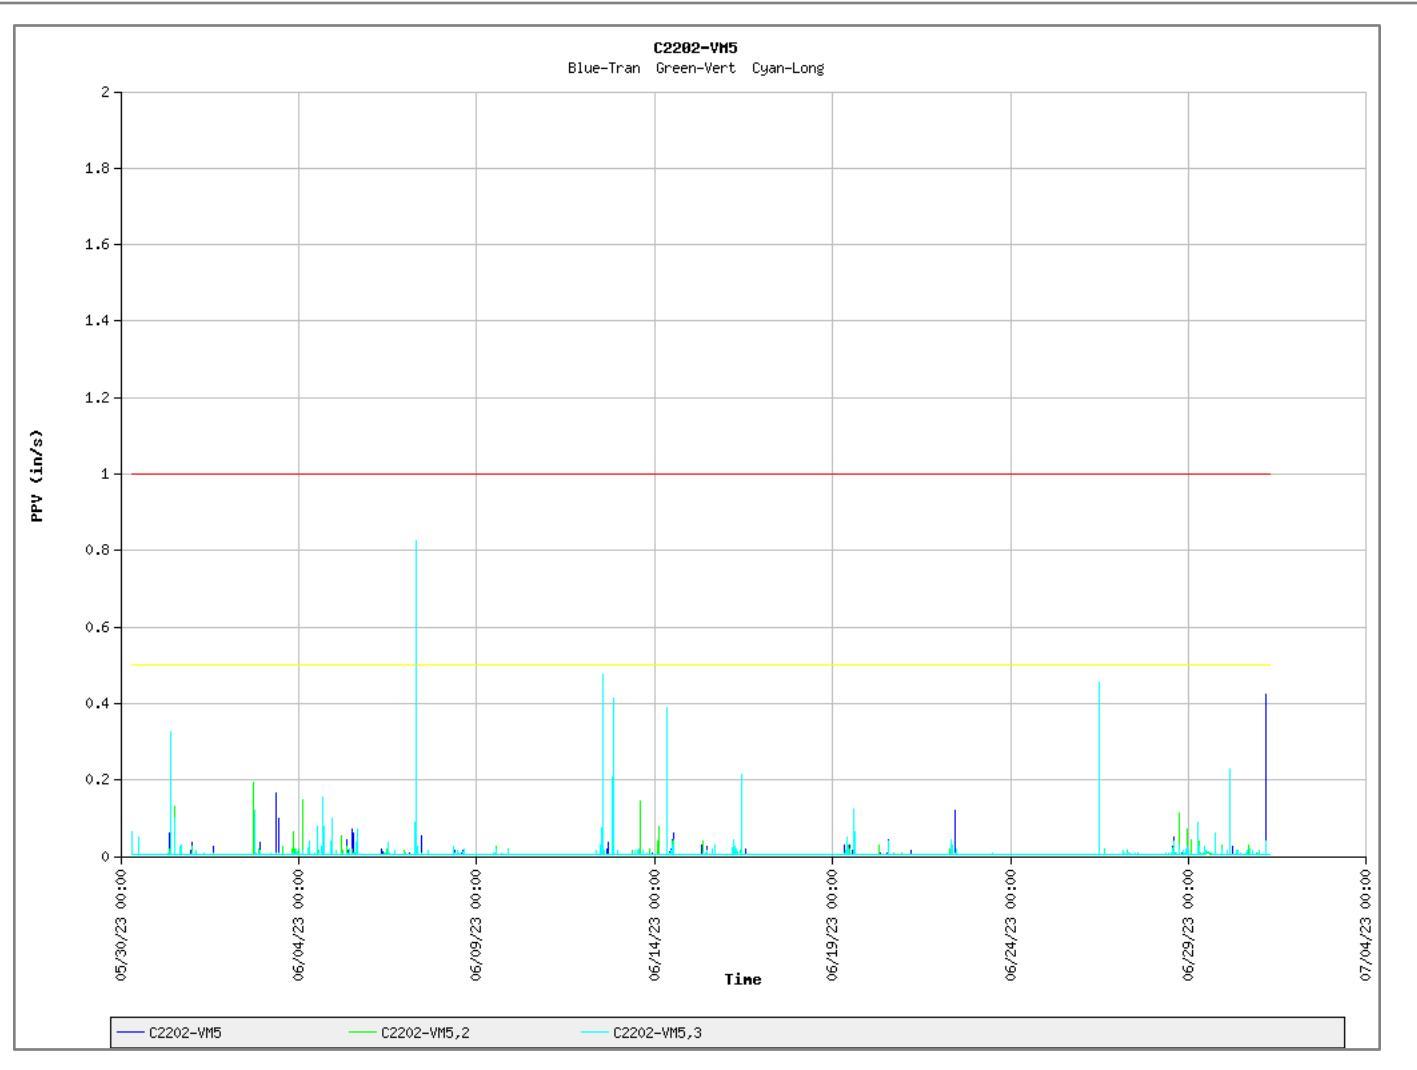
C2202-VM5 Transverse C2202-VM5,2 Vertical C2202-VM5,3 Longitudinal

3) Community Vibration Monitoring Monthly Summary Units: inches per second (in/sec)							
Number of Workdays in a Month	Number of Vibration Monitoring Days in a Month	Number of Days with Vibration Levels above Action Levels by Month	Comments				
26	30	7	Two out of six vibration monitors (VM) recorded a total of fourteen exceedances. These exceedances were isolated events likely not related to construction activities or were recorded during non-construction hours. Detailed information about exceedances is provided in the narrative summary section and plots.				
Community Vibration Monitoring Excursions and Corrective Actions Action Level = 0.5 in/sec above background Stop Work Level = 1.0 in/sec above background							
Date: Time	Maximum Vibration Level before Corrective Action (in/sec)	Maximum Vibration Level after Corrective Action (in/sec)	Corrective Action				
6/7/2023 07:25	0.825	0.055	This is an isolated event recorded at VM5 possibly due to non-construction related activities, associated with resident's activities.

6/3/2023 17:17 & 17:18	0.91	0.01	Exceedances observed at VM6 were recorded during non-construction hours.				
6/6/2023 08:01	3.835	0.08	This is an isolated event recorded at VM6 possibly due to non-construction related activities, associated with resident's activities.				
6/9/2023 15:38, 15:41, 15:42, 15:58, & 16:04	5.61	0.01	Exceedances observed at VM6 were recorded during non-construction hours.				
6/15/2023 10:15	5.12	0.01	This is an isolated event recorded at VM6 possibly due to non-construction related activities, associated with resident's activities.				
6/23/2023 10:14	1.06	0.01	This is an isolated event recorded at VM6 possibly due to non-construction related activities, associated with resident's activities.				
6/23/2023 18:19	1.335	0.01	Exceedance observed at VM6 was recorded during non-construction hours.				
6/29/2023 10:42	1.195	0.49	This is an isolated event recorded at VM6 possibly due to non-construction related activities, associated with resident's activities.

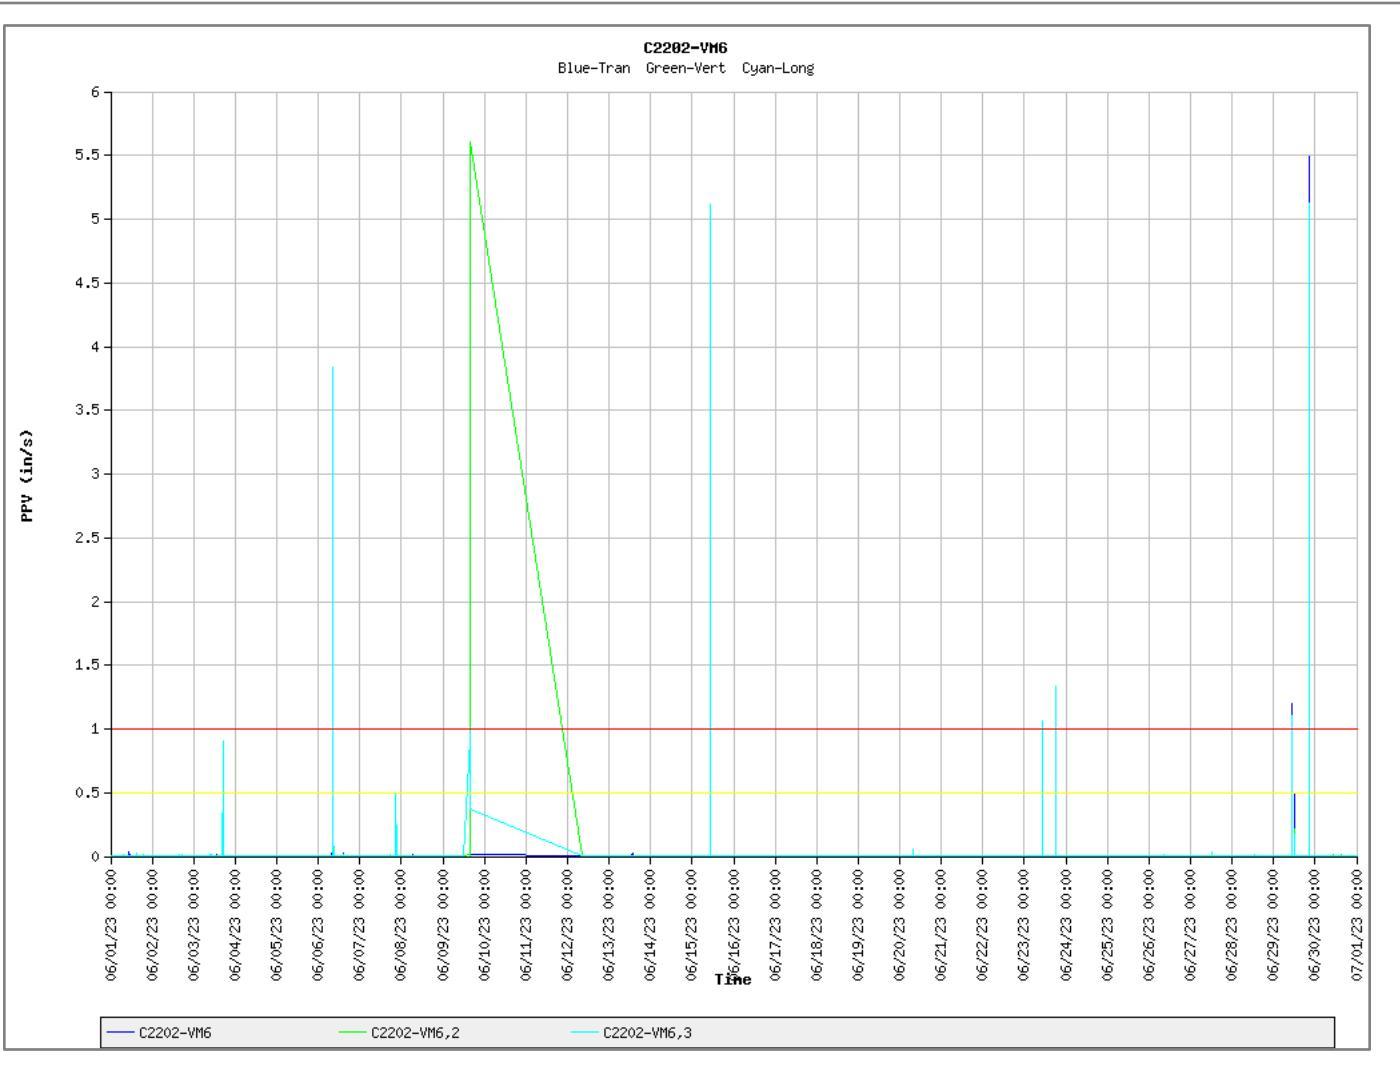
C2202-VM6 Transverse C2202-VM6,2 Vertical C2202-VM6,3 Longitudinal

6/29/2023 20:38	5.495	0.01	Exceedance observed at VM6 was recorded during non-construction hours.
