Borough-Based Jails

# BBJ-BK-DSS Dismantle Construction Impacts Community Meeting

February, 2024

Brooklyn Dismantle

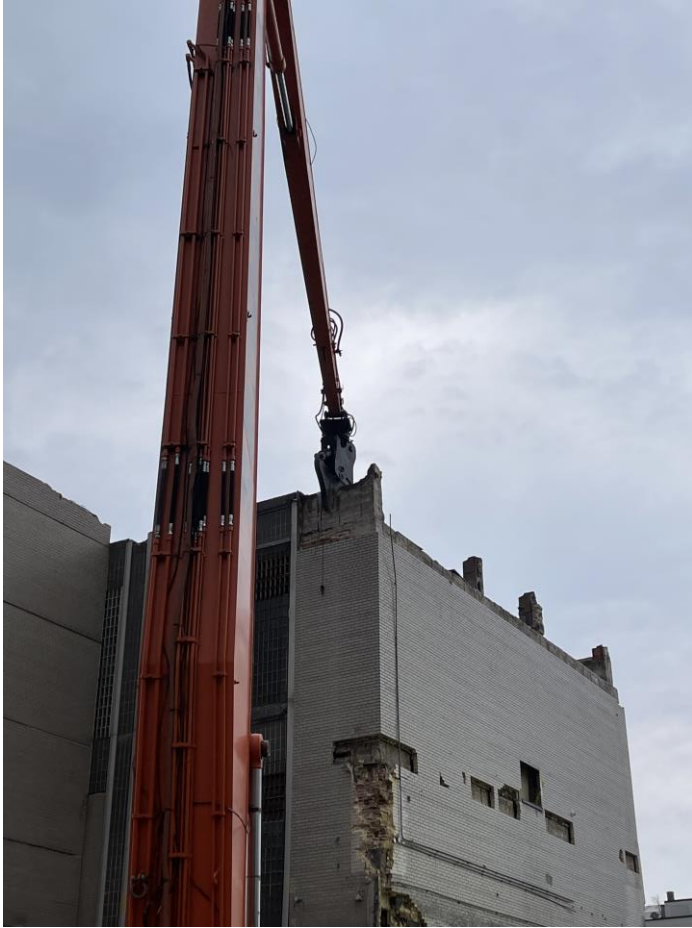
**Long-Reach Excavator**  
(2/28/24)

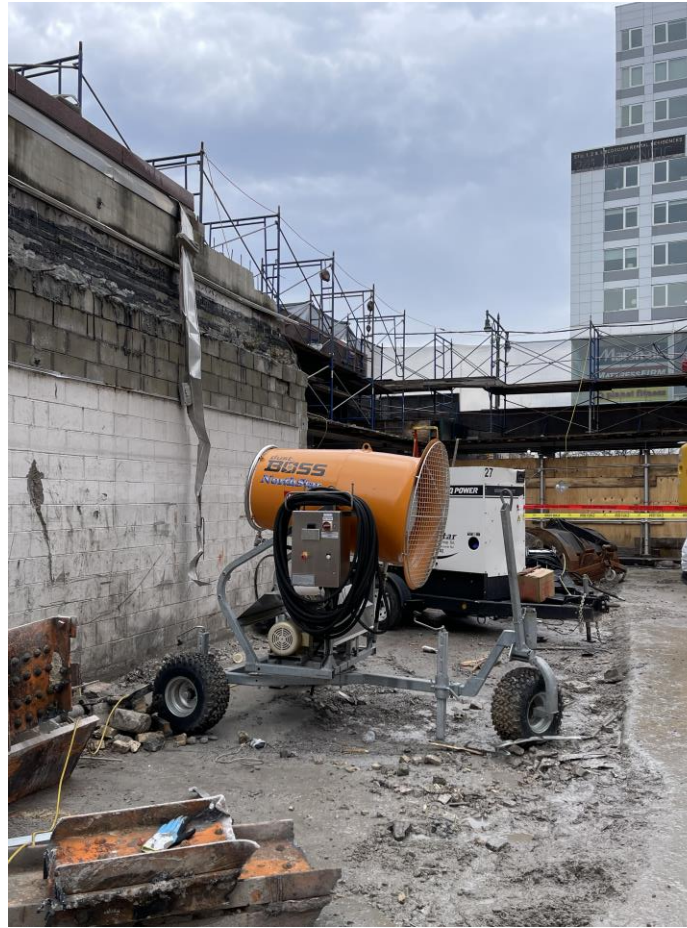
**Dust Mitigation (Dust Boss)**  
(2/28/24)

- 6. Dust Control:** Debris is hosed down to control dust. Water is applied to debris within the chute and may not always be visible from outside the site. Additionally, dust monitors with sensing radii of 200' adequately cover the site perimeter (Monitors are located at each corner of the site. Two monitors along State or Atlantic cover a total length of 400', with a maximum block length of 330')

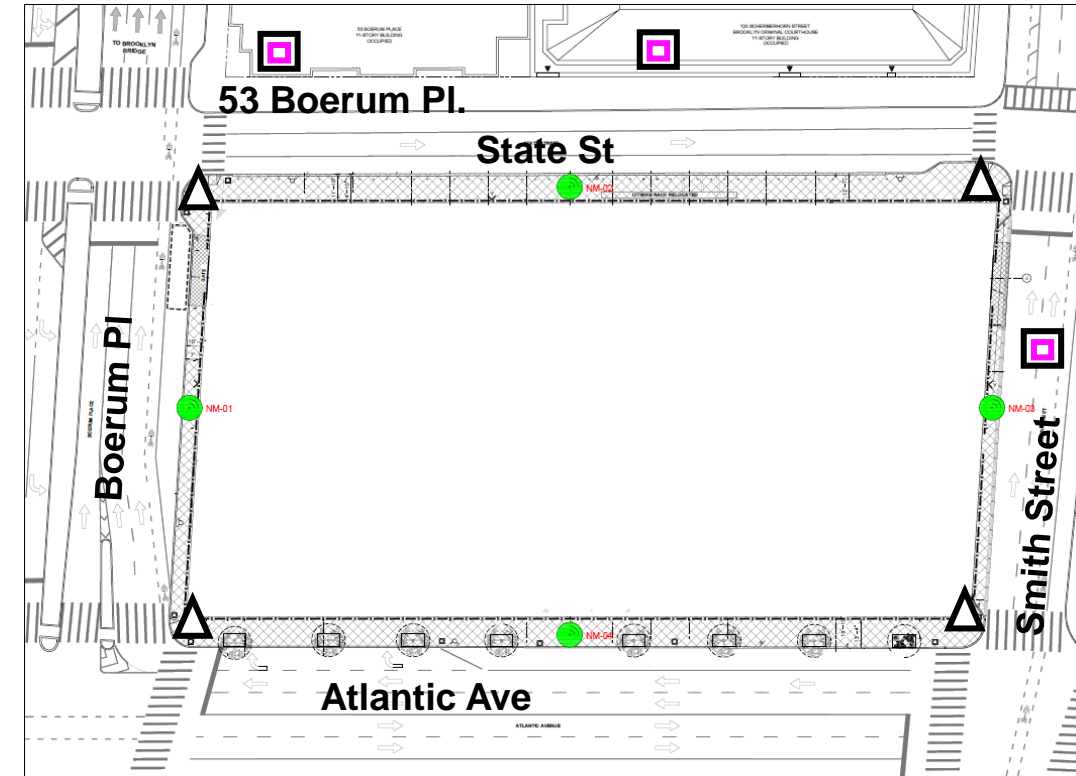
Vibration, Air and Noise monitoring devices installed by Design-Build team.

- Monitor 1 is placed within 120 Schermerhorn Street (Court Building).
- Monitors are placed within the F train subway tunnel under Smith Street.
- Baseline data collection was taken in April 2022.
- **An additional monitor was placed at 53 Boerum Pl. on 1/23/2024**

- 4 Monitors are at the sidewalk bridge locations at the center of Smith Street, Atlantic Avenue, Boerum Place, and State Street.
- Noise monitoring is being performed on a continuous basis.

- 4 particulate monitoring stations are at each corner of the site. Particulate monitoring is performed daily at 15-minute intervals.
- The Action Level is set below the Permissible Exposure Levels (PEL) .  
When Action Levels are reached, the construction activities are assessed, and the contractor immediately acts to apply steps to control dust and emissions before the PEL is reached.
- The BBJ Construction Management Team, Project Contractors and Environmental Specialists receive real time alerts when Particulate Matter (PM), decibels (dBa), or velocity of vibration (ips) number approach and Action Level.

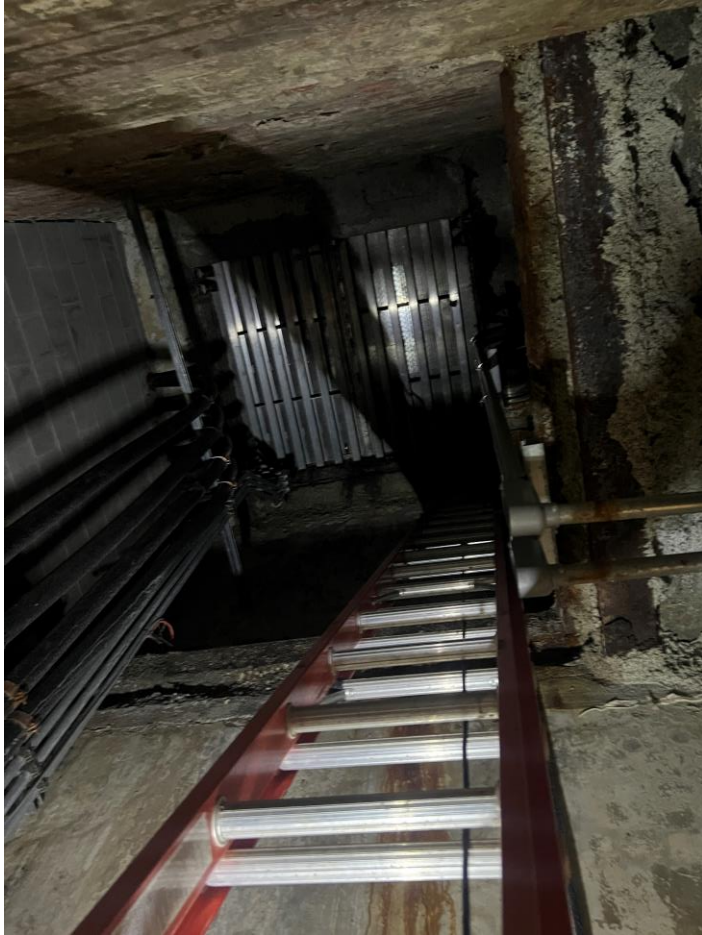
Former location inside shaft  
(1/13/24)

In January, alerts on 6 days recorded by the vibration monitoring occurred during non-working hours or were assessed and determined to be caused by sources other than the construction work. The Central Court Building monitor was relocated to a more stable position within the courthouse as the corrective action due to its original placement in a heavy foot traffic location which caused vibration exceedances. No further corrective actions or mitigation measures were required as the alerts were triggered due to manual disturbance of the sensor during off hours as well as during work hours.

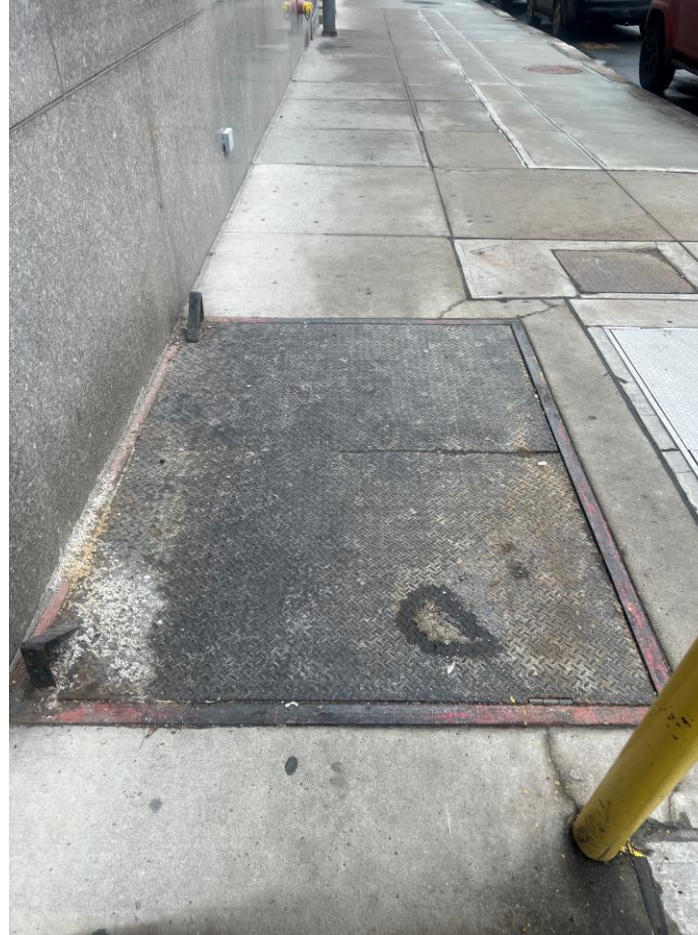
Metal plate covering shaft  
(1/13/24)

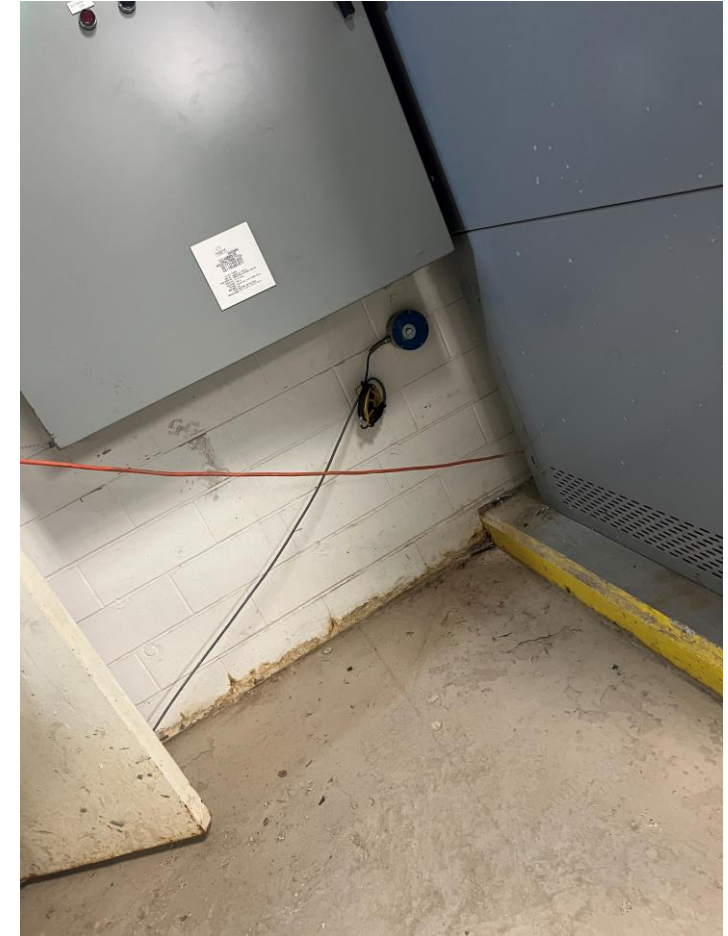
Relocated monitor in mechanical room  
(1/15/24)
