INDEPENDENT COMMUNITY MONITORING

REPORT No. 2

Monitoring Period: Monday, Nov. 11th through Sunday, Dec. 15th, 2024

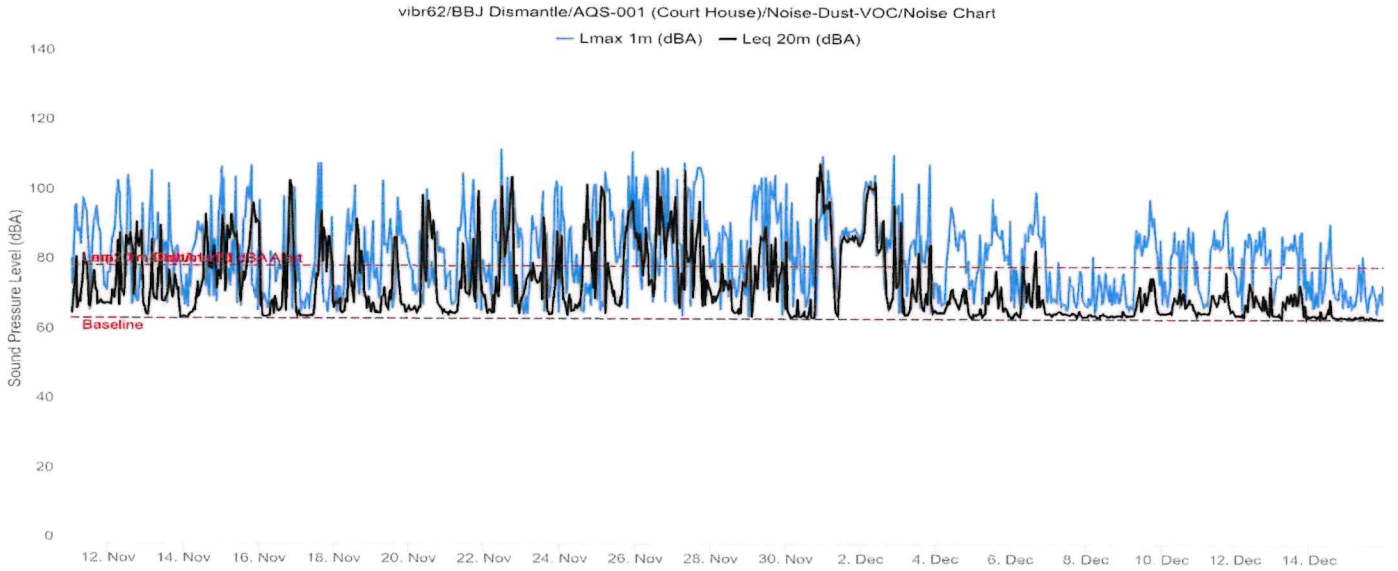
- **AQS-001 (Court House)** - As shown in the noise monitoring graph on Page 7 of 26 of the Data Summary Report, there were multiple Lmax- 1min (blue line) and Leq- 20 min (black line) exceedances of the 80 dBA alert level spread out over the 35-day reporting period.
 - Review of the daily equipment status and excursion reports prepared by Gramercy indicates that most of these exceedances are caused by courthouse activities, except for those on or about November 22nd which were related to Sally Port dismantling and on or about December 6th related to grinding associated with the 3rd Floor Courthouse Infill.
 - In response to the dismantling-related exceedances, work was stopped and corrective action included adding blue skin to the voids. Verification of noise levels confirmed that noise inside the courthouse returned to below threshold levels.

AQS-001 (Court House) Noise Monitor - 11/11/24 to 12/15/24

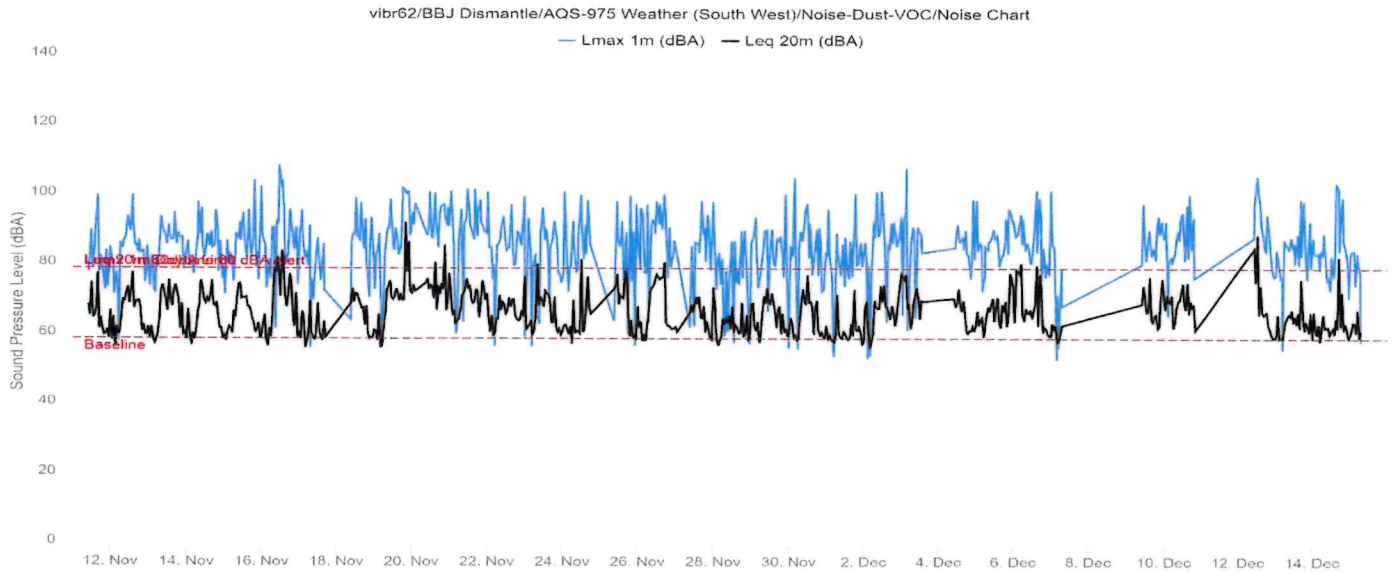
- **AQS-975 (Southwest on Centre St)** – As shown in the noise monitoring graph on Page 8 of 26 of the Data Summary Report, there were multiple Lmax- 1min (blue line) and significantly fewer Leq- 20 min (black line) exceedances of the 80 dBA alert level spread out over the 35-day reporting period.
 - Review of the daily equipment status and excursion reports prepared by Gramercy indicates that the exceedances are caused by traffic on Centre Street, including buses associated with the courthouse and other vehicular activities.

AQS-975 Weather (South West) Noise Monitor - 11/11/24 to 12/15/24

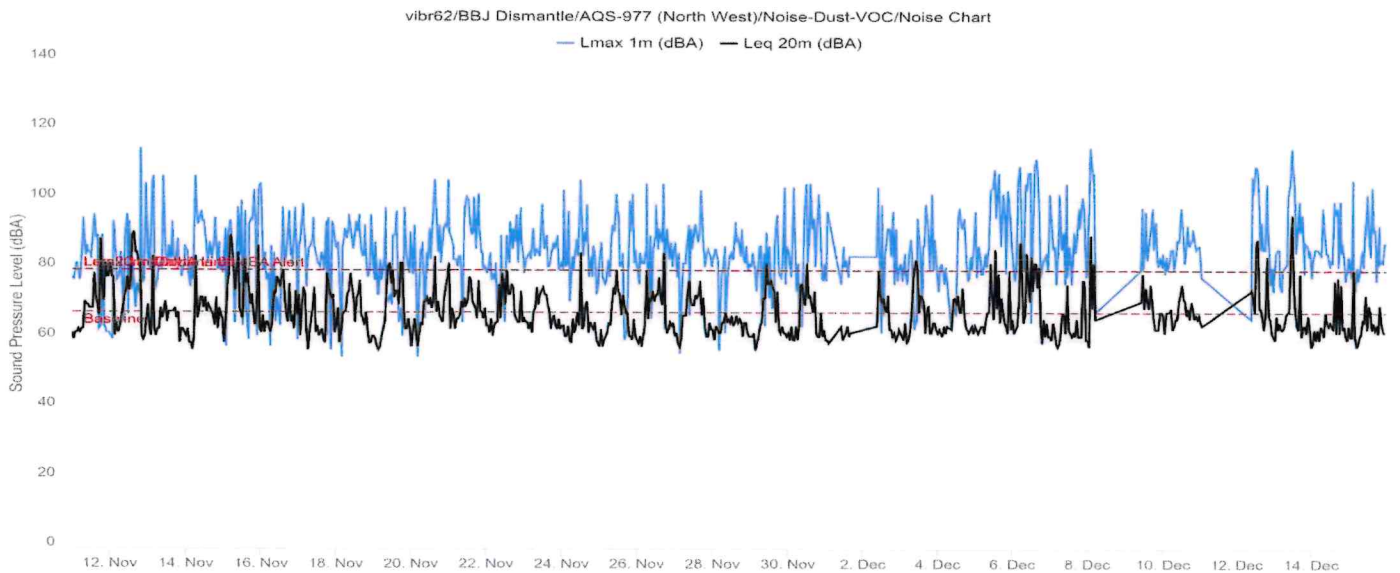
- **AQS-977 (Northwest on Centre St.)** – As shown in the noise monitoring graph on Page 8 of 26 of the Data Summary Report, there were multiple Lmax- 1min (blue line) and significantly fewer Leq- 20 min (black line) exceedances of the 80 dBA alert level spread out over the 35-day reporting period.
 - Review of the daily equipment status and excursion reports prepared by Gramercy indicates that the exceedances are caused by traffic on Centre Street, except for on or about December 3rd when the exceedance was related to dismantling of the North Tower first floor slab.

AQS-977 (North West) Noise Monitor - 11/11/24 to 12/15/24

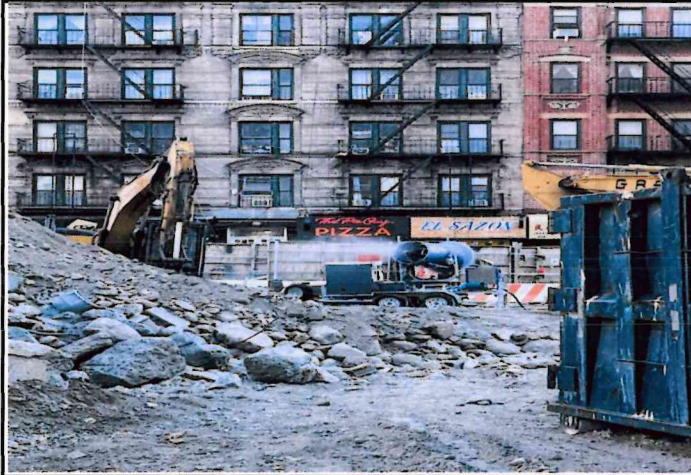
Photo 3: Crushed concrete Stockpile looking east, 11/13/24

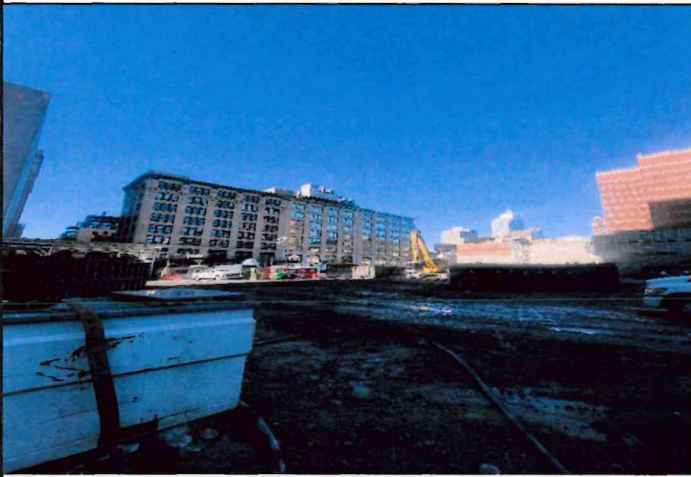
Photo 7: View of site looking northwest showing damp/wet ground due to misting/water suppression activities, 11/13/24

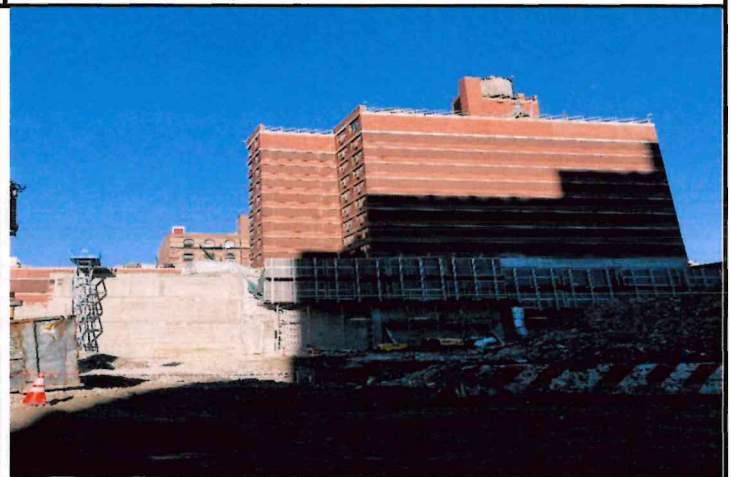
Photo 8: View of North Tower wall removal adjacent to Chung Pak, 11/13/24

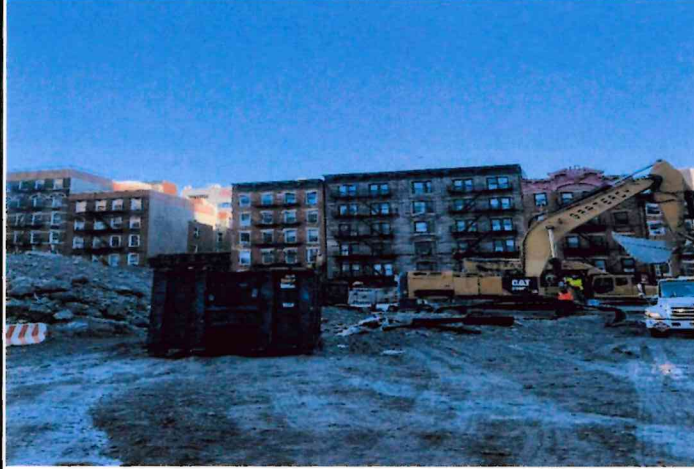
- Dust/particulate BMPs were being implemented, specifically the use of a water cannon to maintain wet conditions and minimize the generation of airborne particulates in the work

areas. The moist/wet ground surface conditions are shown in **Photo 9 provided on Page 23 of 26** of the enclosed Data Summary Report.

Photo 9: View of site looking east showing damp/wet ground due to misting/water suppression activities, 11/13/24

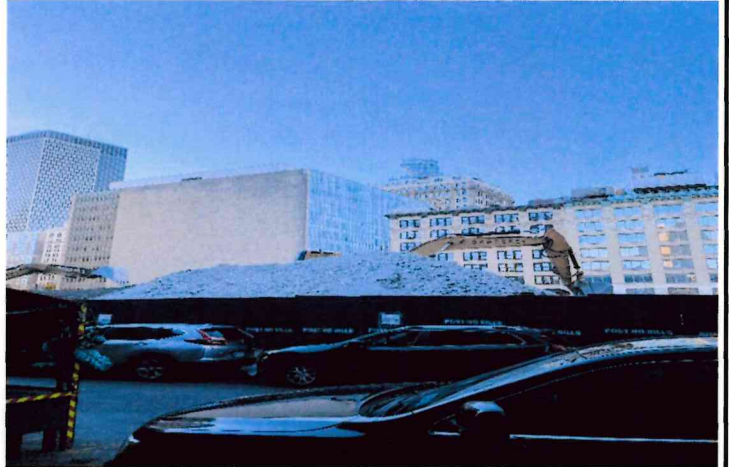
- See the recommendations in Section 8.0 of this Report regarding onsite dust/particulates monitoring.
- At the time of the Kick-off meeting and Site visit, the height of the crushed concrete pile staged onsite for reuse as support of excavation after completion of the North and South Tower basement debris removal remained above the top of construction fence line as shown in Photo 14 provided on Page 24 of 26 of the enclosed Data Summary Report.

Photo 14: View from Baxter St. showing concrete pile, 11/13/24

- As previously recommended in our November 26th, 2024 Weekly Report No. 1, we recommend that Gramercy conduct daily real time monitoring for PM-10 and dust using a hand held instrument calibrated daily before the start of work to periodically verify onsite dust levels, including whenever there is an onsite indication of visible dust, even if it is suspected to be water mist from the water cannon, when heavy equipment is being moved or relocated, strong wind or gusts occur on the Site, and/or there is an offsite dust exceedance recorded during onsite working hours at one or more offsite CAMP stations.

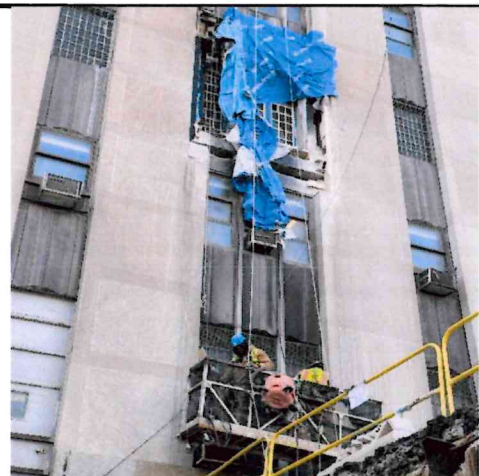
Photo 20: View of Courthouse 3rd Floor Infill, showing "blue skin", 12/6/24

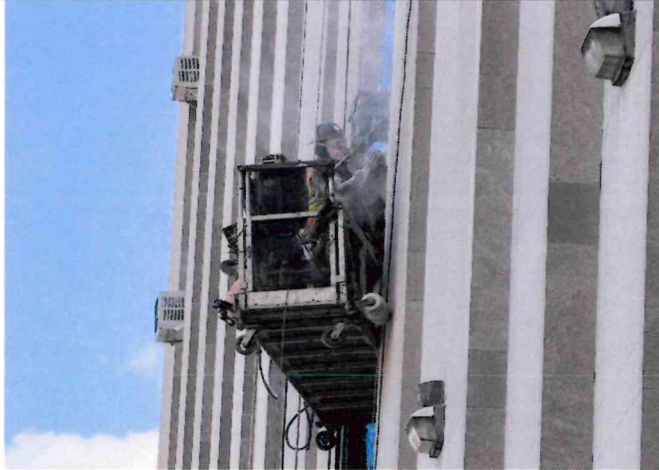
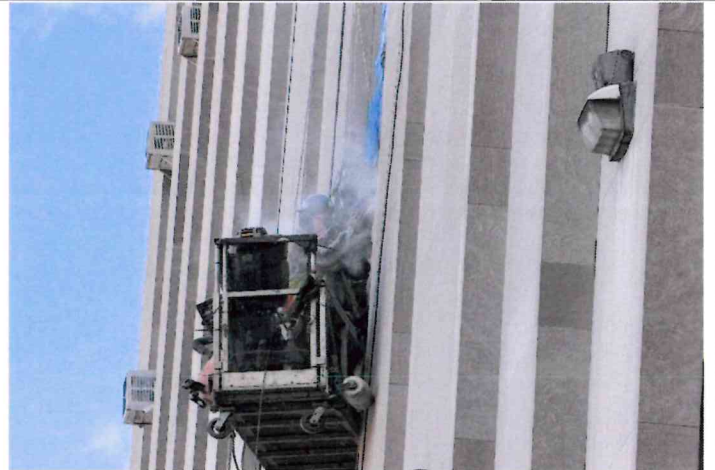
- As discussed in Section 5 below, CAMP Station **AQS-001** is located inside the Courthouse and there were L_{max}-1 min (blue line) and Leq-20 min (black line) exceedances of the 80 dBA action level on December 6th, the date of Excel's Site visit. As noted in Section 5, Gramercy reported the noise level exceedance was related to grinding at the 3rd Floor Courthouse Infill.

- M. DeMatteo accompanied M. Schnurr to where the 3rd Floor Infill work was being conducted and observed workers using a grinder. See **Photos 21 and 22** of the enclosed Data Summary Report No. 2 which show the 3rd Floor Infill grinding in progress.

Photo 21: Courthouse 3rd Floor Infill grinding, 12/6/24

Photo 22: Courthouse 3rd Floor Infill grinding, 12/6/24
