**AIR, NOISE AND VIBRATION
MONTHLY MONITORING REPORT
Number 013 – August 2023**

Prepared By:
Gramercy
Group Inc.

DDC. Project ID:	BBJ M DSS	Period Start: 8/01/23 End 8/31/23	
Project Name:	NYC Borough Based Jails System – Manhattan Dismantle and Swing Space		
DDC Pin No.:	8502021CR0004P-06P

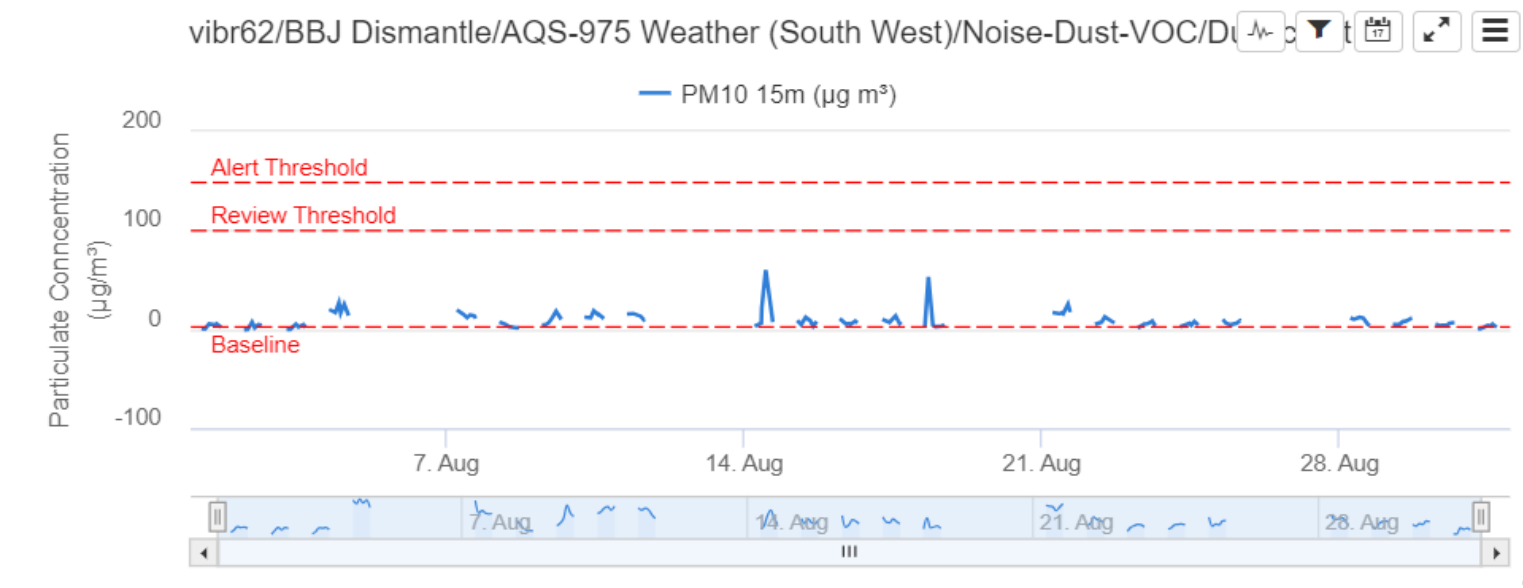
Air Quality Systems #975 – Dust Monitoring Station – August 23:

8/21/23 @ 10:00 AM	184.849	13.165	No corrective action was needed at this time as the spike in the data was a false alarm from reinstallation of the monitor and was not construction related.
8/23/23 @ 2:00 PM	108.072	4.407	No corrective action was needed at this time as the spike in the data was a false alarm from reinstallation of the monitor and was not construction related

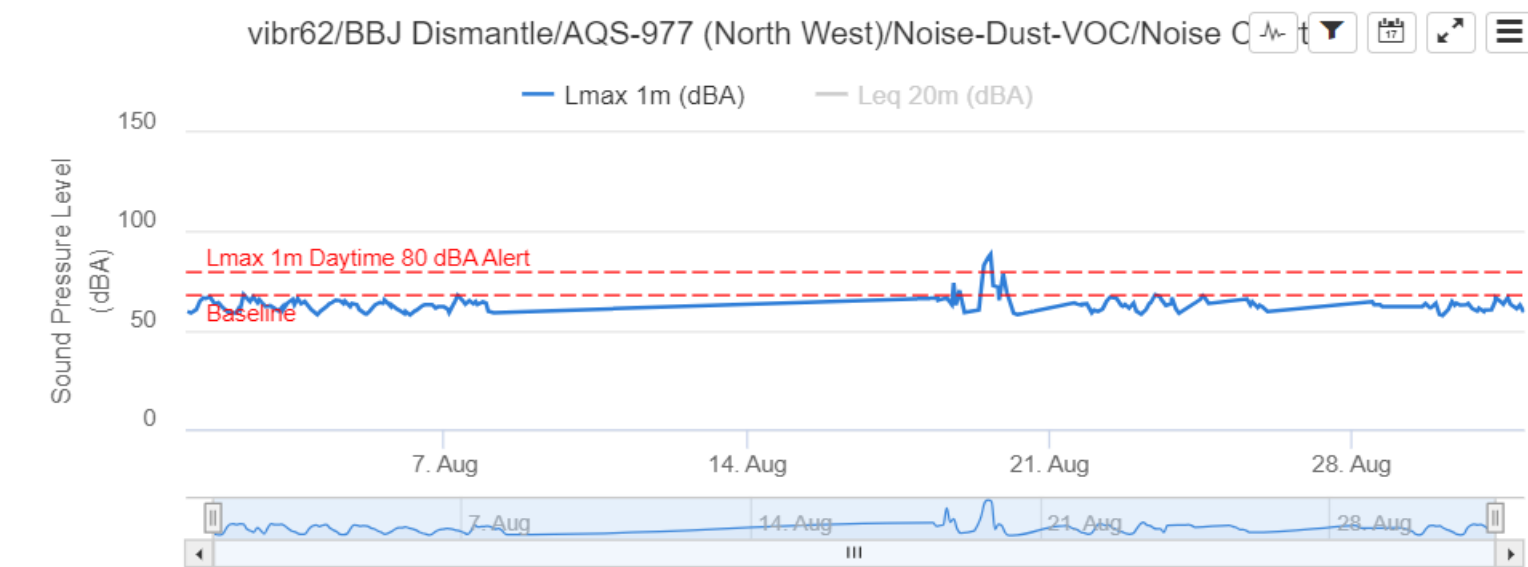
Air Quality Systems #977 – Noise Monitoring Station – August 23:

During the month of August, we experienced noise levels greater than the alert threshold AQS monitor #998, #993, #977, & #997. After investigation of the cause of these spikes in noise in this area, it was noted that these alerts were not caused by construction activity. As stated in the last report, AQS #998 was to be relocated from inside of our site to across the street on the residential side of Baxter to get more accurate readings. (see data below) This monitor experienced an exceedance but it was during the crews lunch break I was unable to pin point the exact cause of the exceedance but its safe to say probably caused by traffic or sirens as our site was not active at 12:21 PM. The additional exceedance shown for the month of August from AQS #993 was also a false reading. The exceedance shown was caused during a recalibration / service for a faulty piece of equipment that needed to be replaced. This was confirmed when we got the alert I went out and was able to make contact with the technician from Vibranalysis and he said it was due to him servicing the microphone of the monitor. For AQS #977, as stated above, this exceedance did happen on a Saturday that we were working. However, it was at 5:30 PM and the site closed at 3:30 PM. AQS #997 was mobilized onto Baxter Street on 8/23/23, the installation of this monitor was the reason there is an initial spike as shown on the graph.
