#### AIR, NOISE AND VIBRATION MONTHLY MONITORING REPORT Number 001

DDC. Project ID:		BBJ-XSP		Period Start: 11/1/22 End 11/30/22						
Project Name:		NYCDDC D&B – The Bronx Site Preparation								
DDC Pin No.:		8502021CR0004P-06P

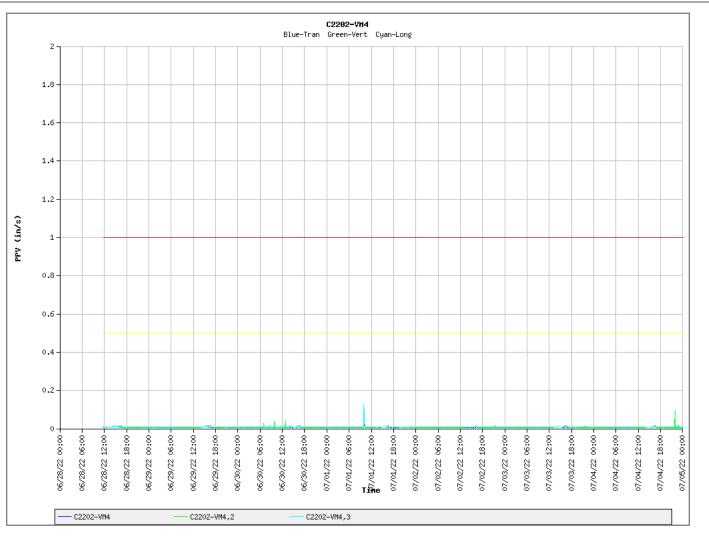
C2202-VM4 Transverse C2202-VM4,2 Vertical C2202-VM4,3 Longitudinal

11/2/2022 10:05	0.535	0.11	This is an isolated event recorded at VM4 location. Laborers installing water misters along fence near sensor this isolated event.					
11/22/2022 17:40	0.545	N/A	Exceedance observed at VM4 was recorded during non-construction hours.					
11/25/2022 21:59	0.51	N/A	Exceedance observed at VM4 was recorded during non-construction hours.					
11/30/2022 03:23	0.57	N/A	Exceedance observed at VM4 was recorded during non-construction hours.					
11/4/2022 12:23	0.525	0.485	This is an isolated event recorded at VM5 location. Residents have access to the sensor.					
11/9/2022 22:23	0.575	N/A	Exceedance observed at VM5 was recorded during non-construction hours.					
11/11/2022 06:37	0.525	N/A	Exceedance observed at VM5 was recorded during non-construction hours.					
11/15/2022 12:34	0.91	0.11	This is an isolated event recorded at VM5 location. Residents have access to the sensor.

There was exceedance recorded at VM4 on November 1<sup>st</sup> and 2<sup>nd</sup>. Laborers were installing water misters along the fence located near sensor which caused the exceedances. Once completed, the readings returned to be within the project threshold afterwards.

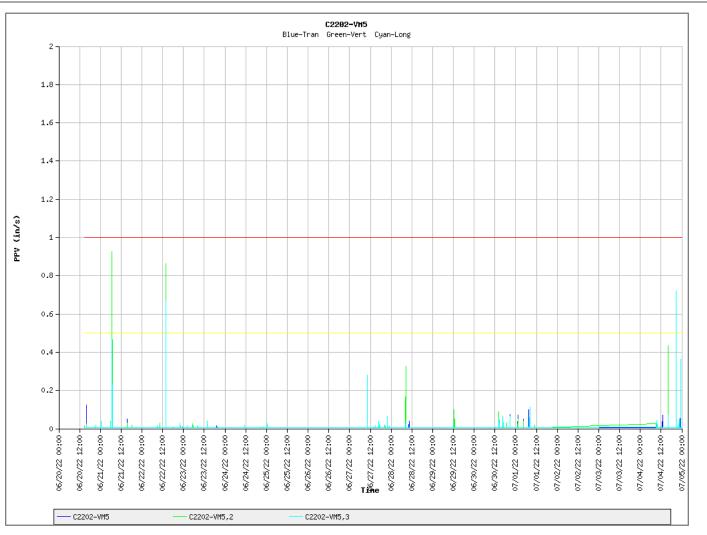
C2202-VM5 Transverse C2202-VM5,2 Vertical C2202-VM5,3 Longitudinal

11/19/2022 19:13 & 19:49	2.06	N/A	Exceedances observed at VM5 were recorded during non-construction hours.					
11/22/2022 09:25	0.6	0.02	This is an isolated event recorded at VM5 location. Residents have access to the sensor.
