**AIR, NOISE AND VIBRATION
MONTHLY MONITORING REPORT
Number 015**

Prepared By: Roux / Wang Technology

DDC Project No.:	BBJ-XSP	Period Start: 10/1/23 End 10/31/23	
Project Name:	NYCDDC D&B – The Bronx Site Preparation		
DDC Pin No.:	8502021CR0004P-06P		
1) Community Air Monitoring Monthly Status Summary			
TWA – Time Weighted Average ug/m ³ - micrograms per cubic meter			
Number of Workdays in a Month	Number of Air Monitoring Days in a Month	Number of Days with Dust Concentrations above Action Concentrations by Month (100 ug/m ³ 15 minute TWA)	Comments
22	21	1	There were three 15-minute readings over the dust action concentration on 10/26 that are detailed below. Dust monitoring not performed on 10/20 due to rain.
Community Air Monitoring Weekly Excursions and Corrective Actions			
Action Concentration = 100 ug/m ³ 15 minute TWA above background concentration Stop Work Concentration = 150 ug/m ³ 15 minute TWA above background concentration			
Date: Time	Maximum Dust Reading Before Corrective Action 15 Minute TWA (ug/m ³)	Maximum Dust Reading After Corrective Action 15 Minute TWA (ug/m ³)	Corrective Action

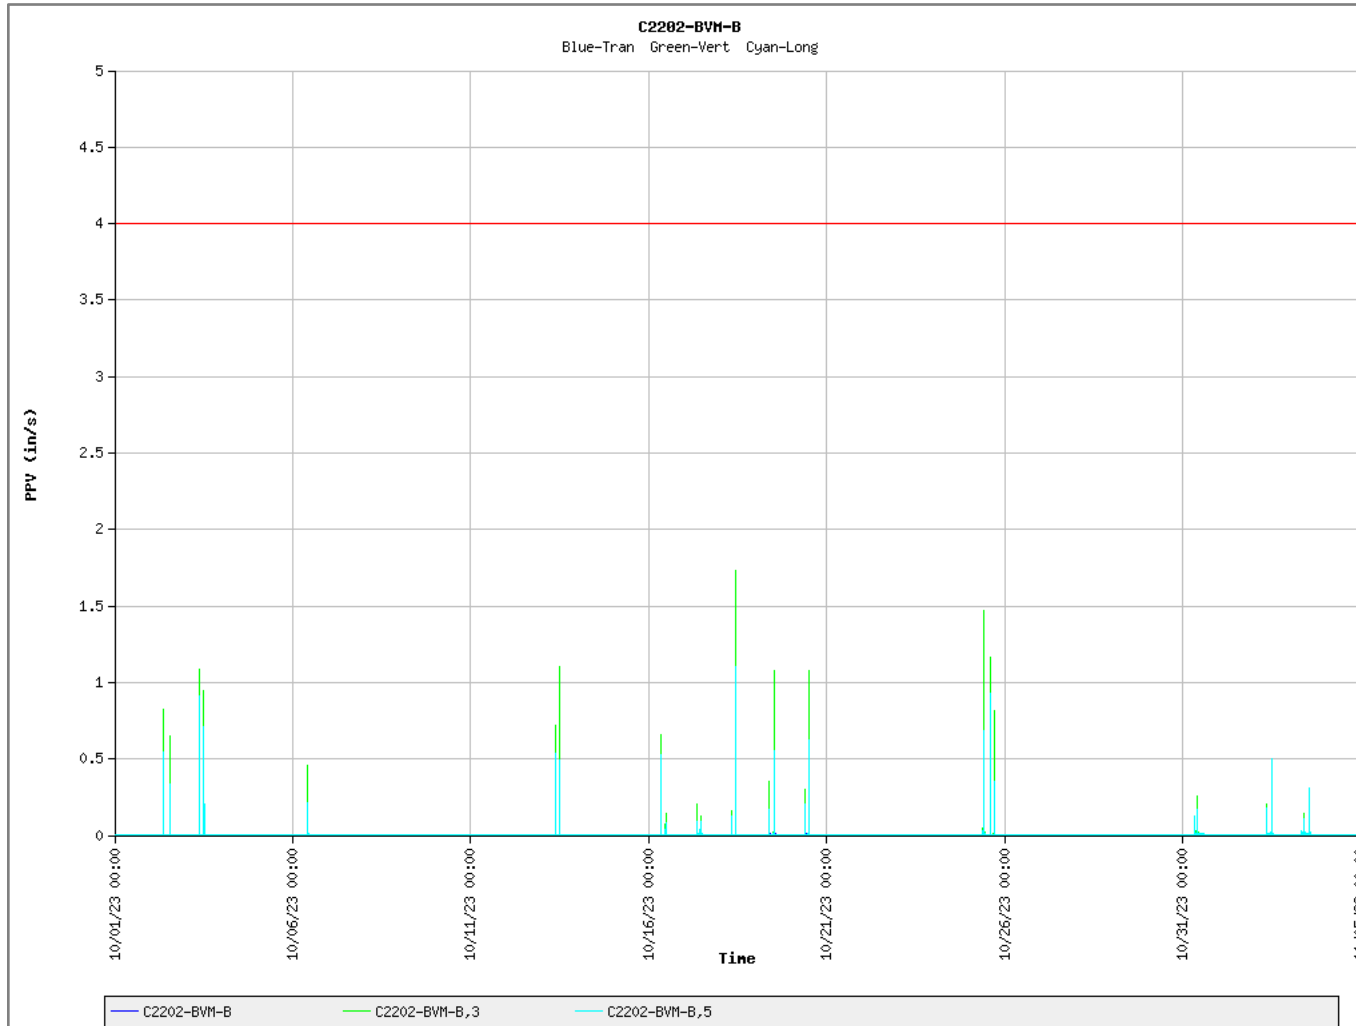
The Bronx Site Preparation October 2023 Vibration Monitoring Data Plots

Exceedance level: 4 in/sec
10/1/2023-10/30/2023 at location# 2
10/31/2023 at location# 3

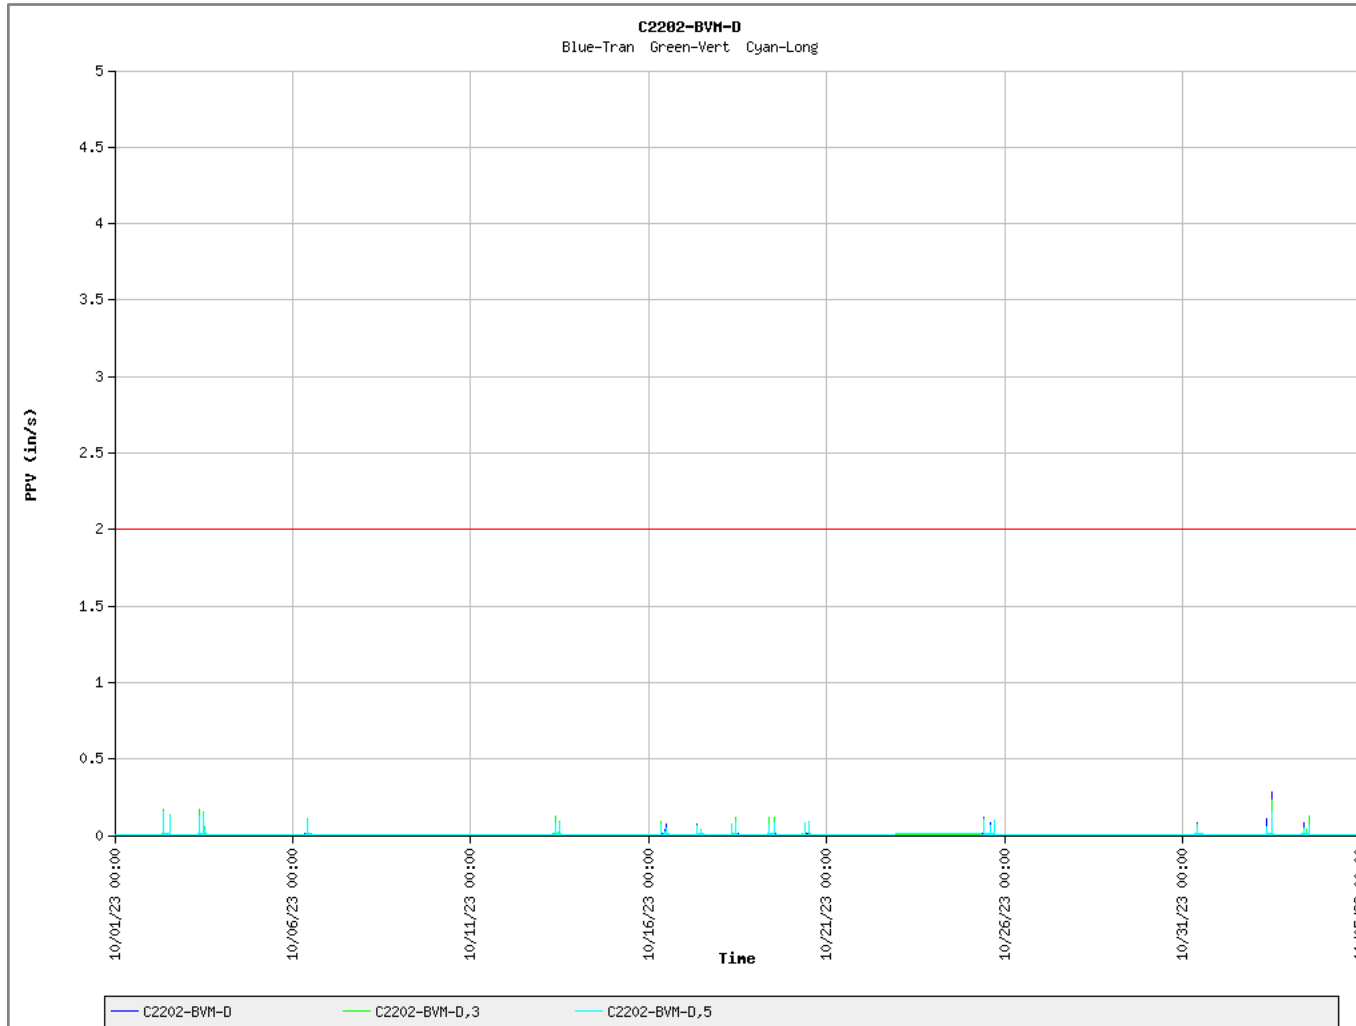
The Bronx Site Preparation October 2023 Vibration Monitoring Data Plots

Exceedance level: 2 in/sec
10/1/2023-10/31/2023 at location# 5
