**AIR, NOISE AND VIBRATION  
MONTHLY MONITORING REPORT  
Number 017**

Prepared By: Roux / Wang Technology

<b>DDC Project No.:</b>	BBJ-XSP	<b>Period Start:</b> 12/1/23 <b>End</b> 12/22/23	
<b>Project Name:</b>	NYCDDC D&B – The Bronx Site Preparation		
<b>DDC Pin No.:</b>	8502021CR0004P-06P		
<b>1) Community Air Monitoring Monthly Status Summary</b>			
TWA – Time Weighted Average ug/m <sup>3</sup> - micrograms per cubic meter			
Number of Workdays in a Month	Number of Air Monitoring Days in a Month	Number of Days with Dust Concentrations above Action Concentrations by Month (100 ug/m <sup>3</sup> 15 minute TWA)	Comments
16	15	1	There was one 15-minute reading over the dust action level on 12/15 that is detailed below.  Air Monitoring not performed on 12/18 due to inclement weather.  Air monitoring was only set up on work days.
<b>Community Air Monitoring Monthly Excursions and Corrective Actions</b>			
Action Concentration =100 ug/m <sup>3</sup> 15 minute TWA above background concentration Stop Work Concentration = 150 ug/m <sup>3</sup> 15 minute TWA above background concentration

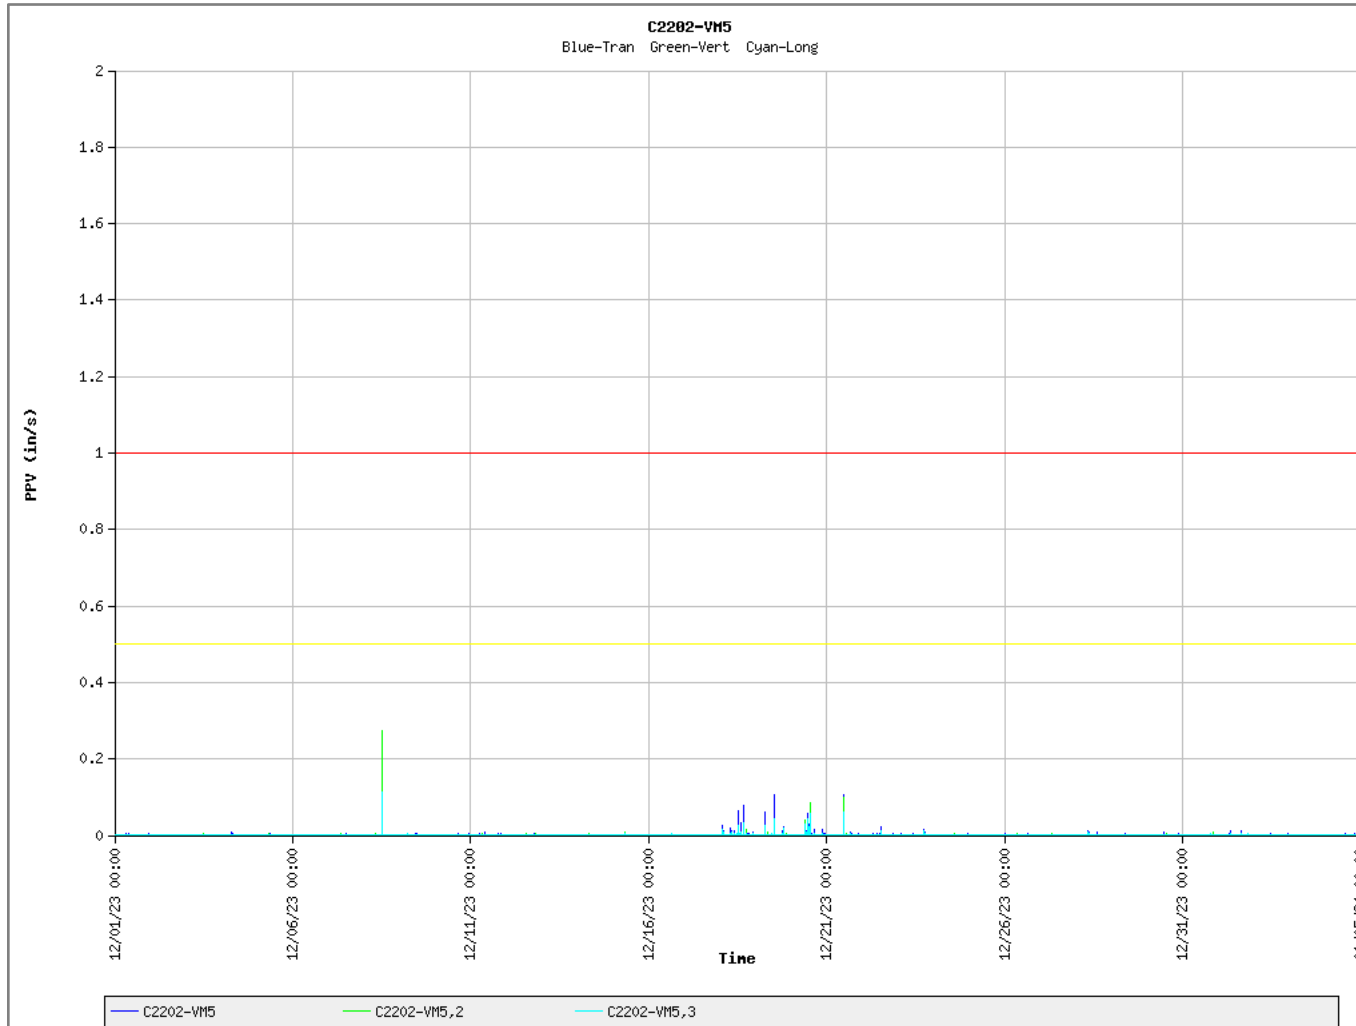
C2202-VM5 Transverse  
C2202-VM5,2 Vertical  
C2202-VM5,3 Longitudinal

Exceedance level: 1 in/sec  
Warning level: 0.5 in/sec

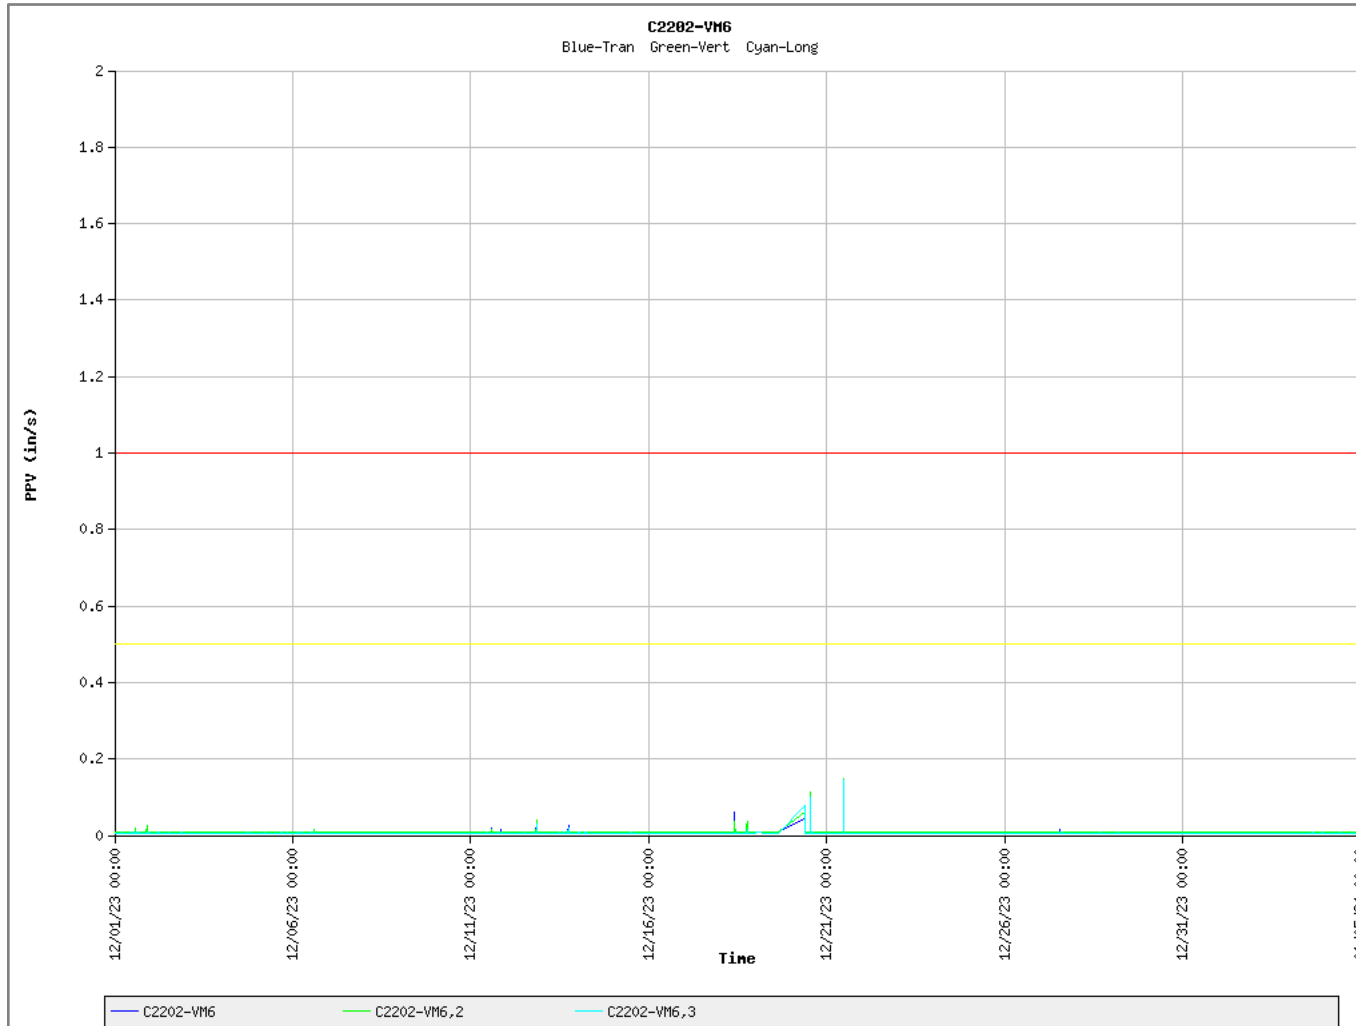
C2202-VM6 Transverse  
C2202-VM6,2 Vertical  
C2202-VM6,3 Longitudinal

Exceedance level: 1 in/sec  
Warning level: 0.5 in/sec

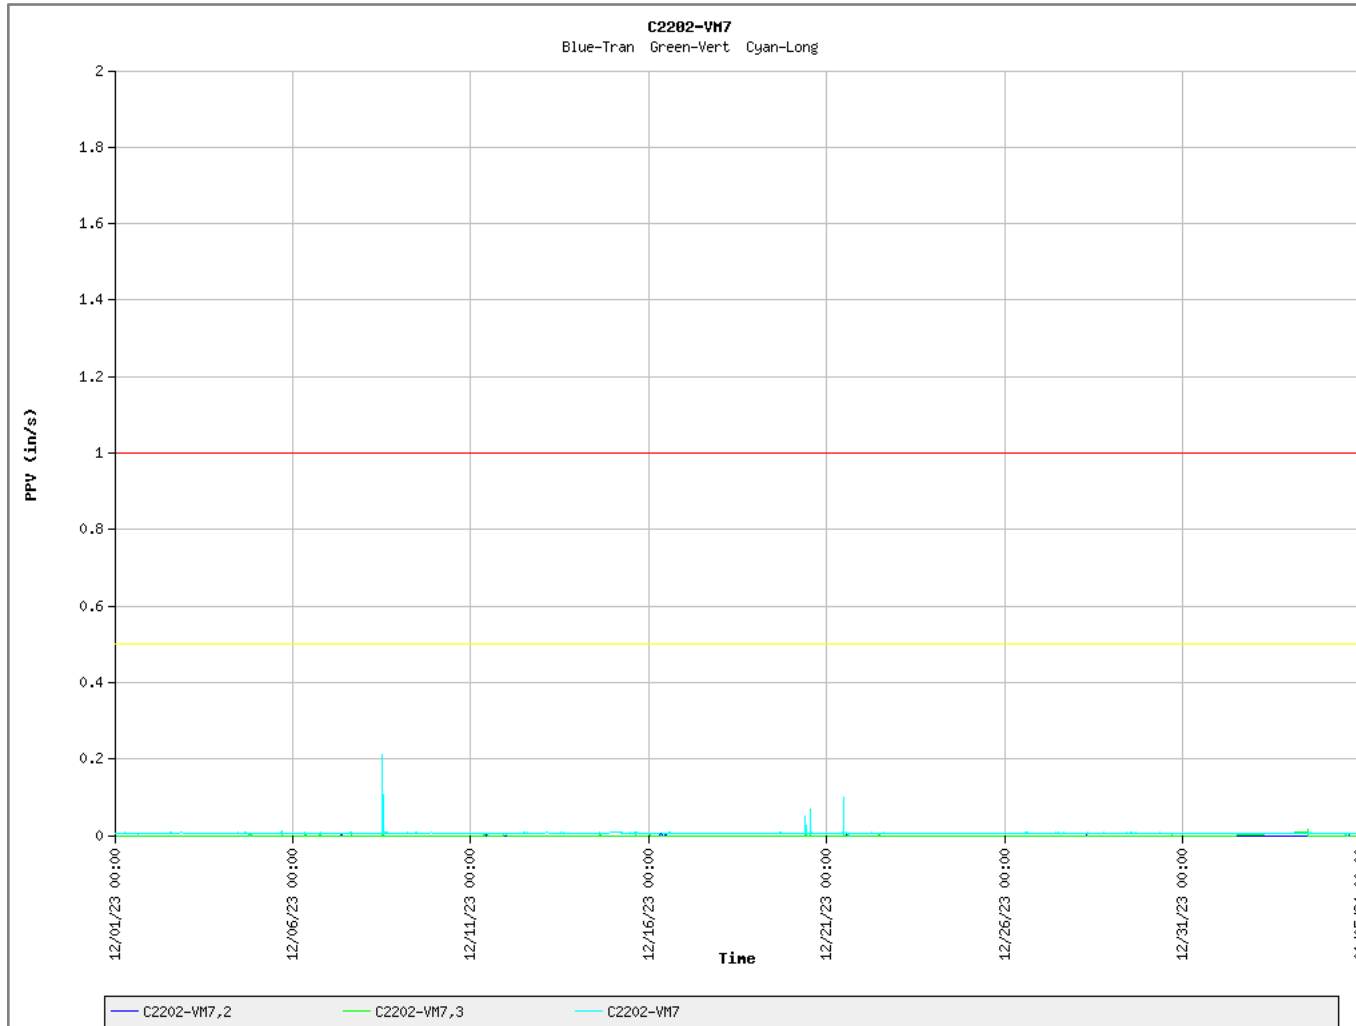
C2202-VM7 Longitudinal  
C2202-VM7,2 Transverse  
C2202-VM7,3 Vertical

Exceedance level: 1 in/sec  
Warning level: 0.5 in/sec

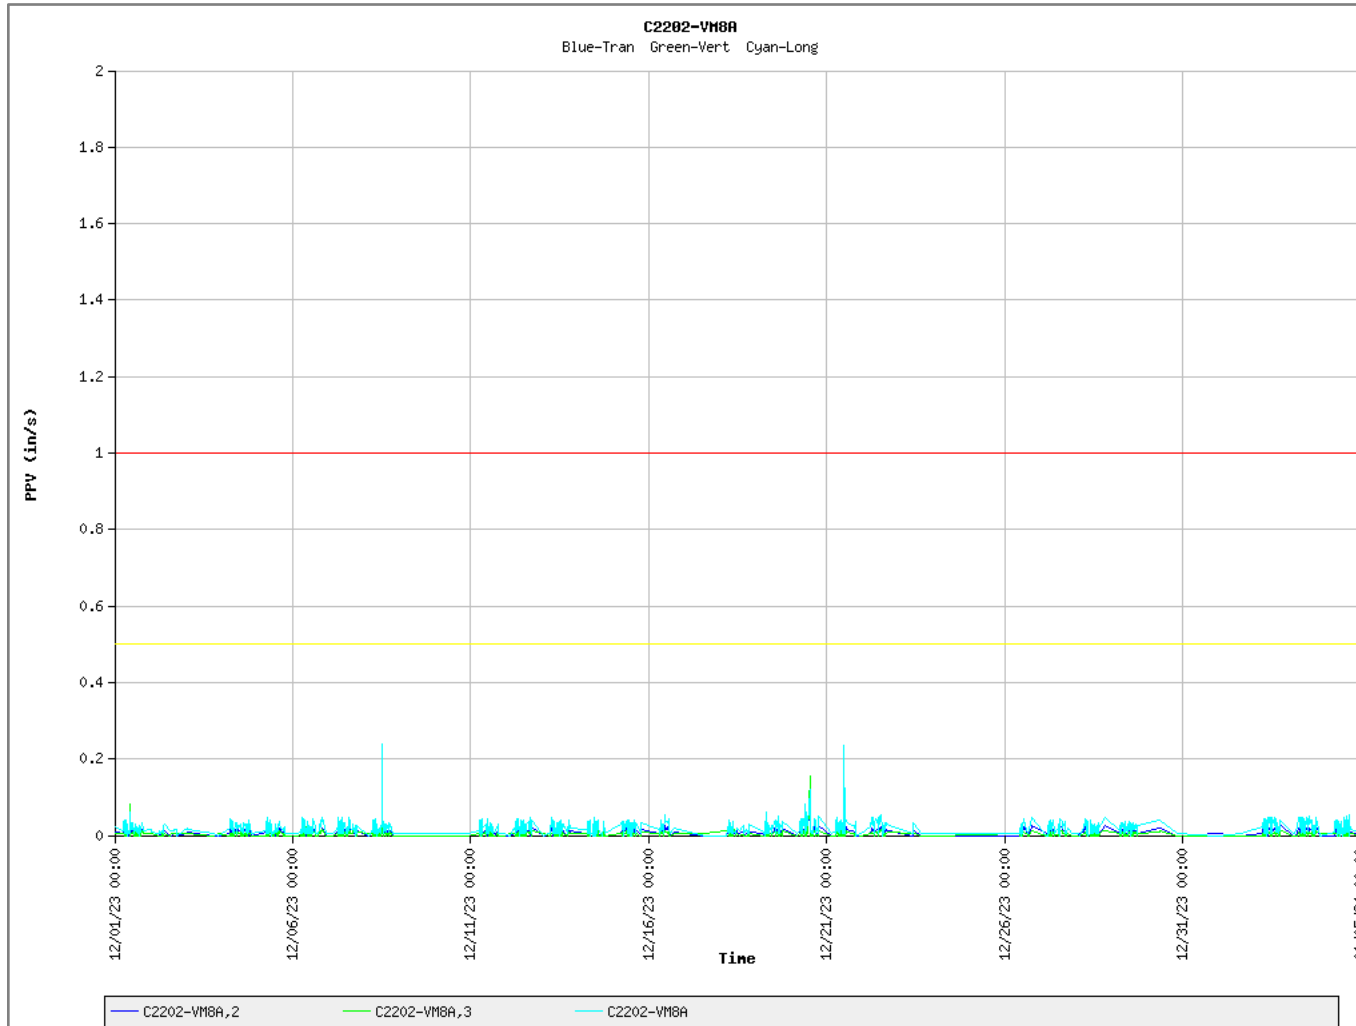
C2202-VM8A Longitudinal  
C2202-VM8A,2 Transverse  
C2202-VM8A,3 Vertical

Exceedance level: 1 in/sec  
Warning level: 0.5 in/sec

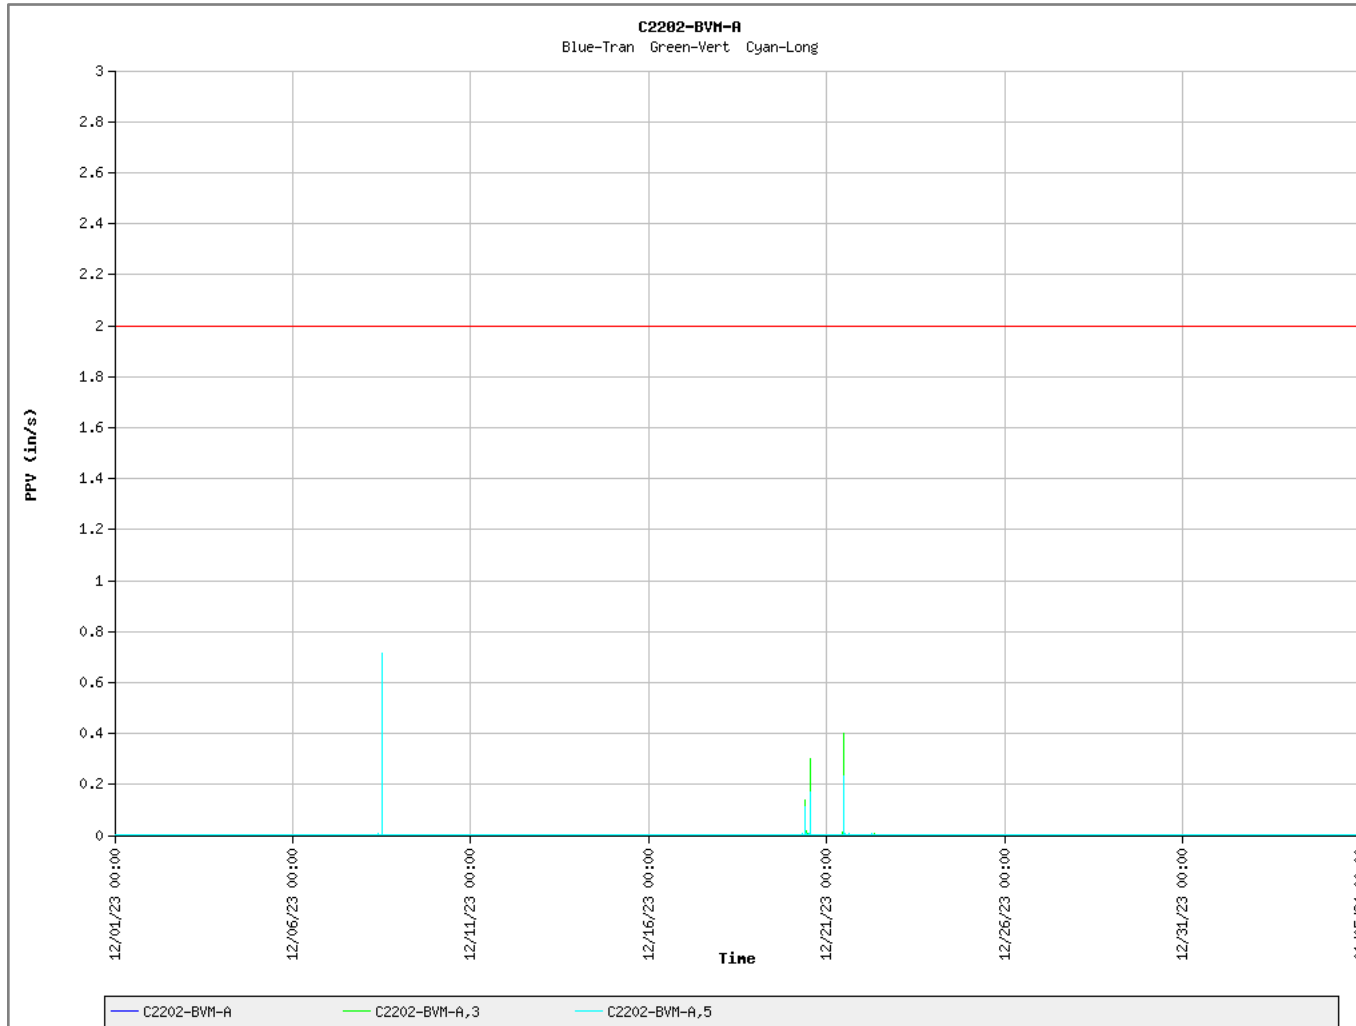
C2202-BVM-A Transverse  
C2202-BVM-A,3 Vertical  
C2202-BVM-A,5 Longitudinal

There are two sets of project limits for vibration, one for general onsite construction activities and another specifically for blasting activities. No vibration exceedance related to the blasting activities was observed in December.

Exceedance level: 2 in/sec  
12/1/2023-12/31/2023 at location# 10

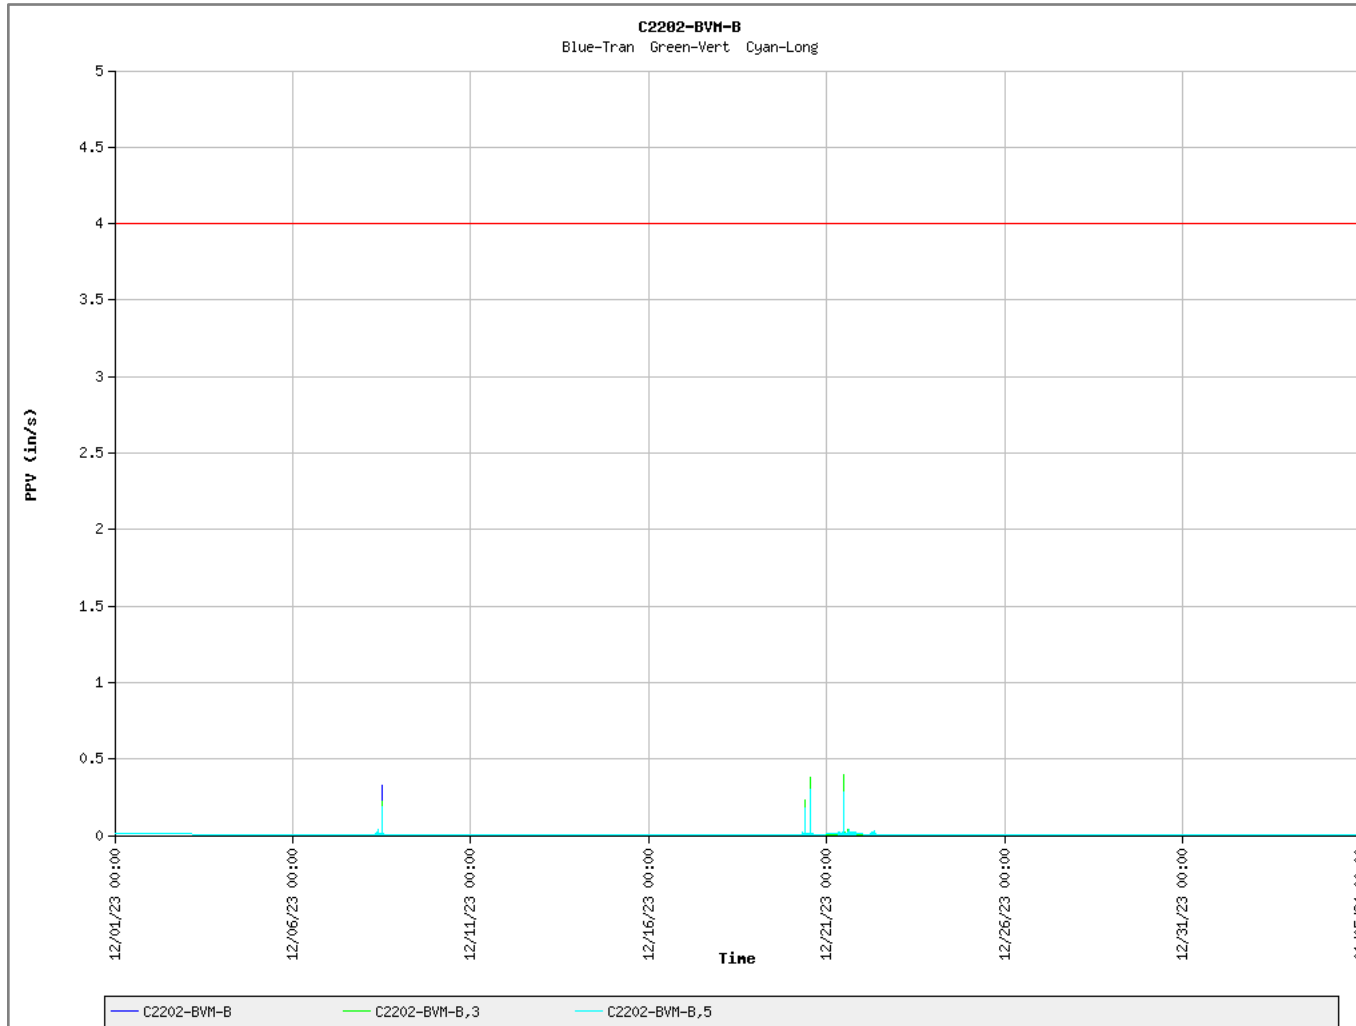
C2202-BVM-B Transverse  
C2202-BVM-B,3 Vertical  
C2202-BVM-B,5 Longitudinal

Exceedance level: 4 in/sec  
12/1/2023-12/31/2023 at location# 3

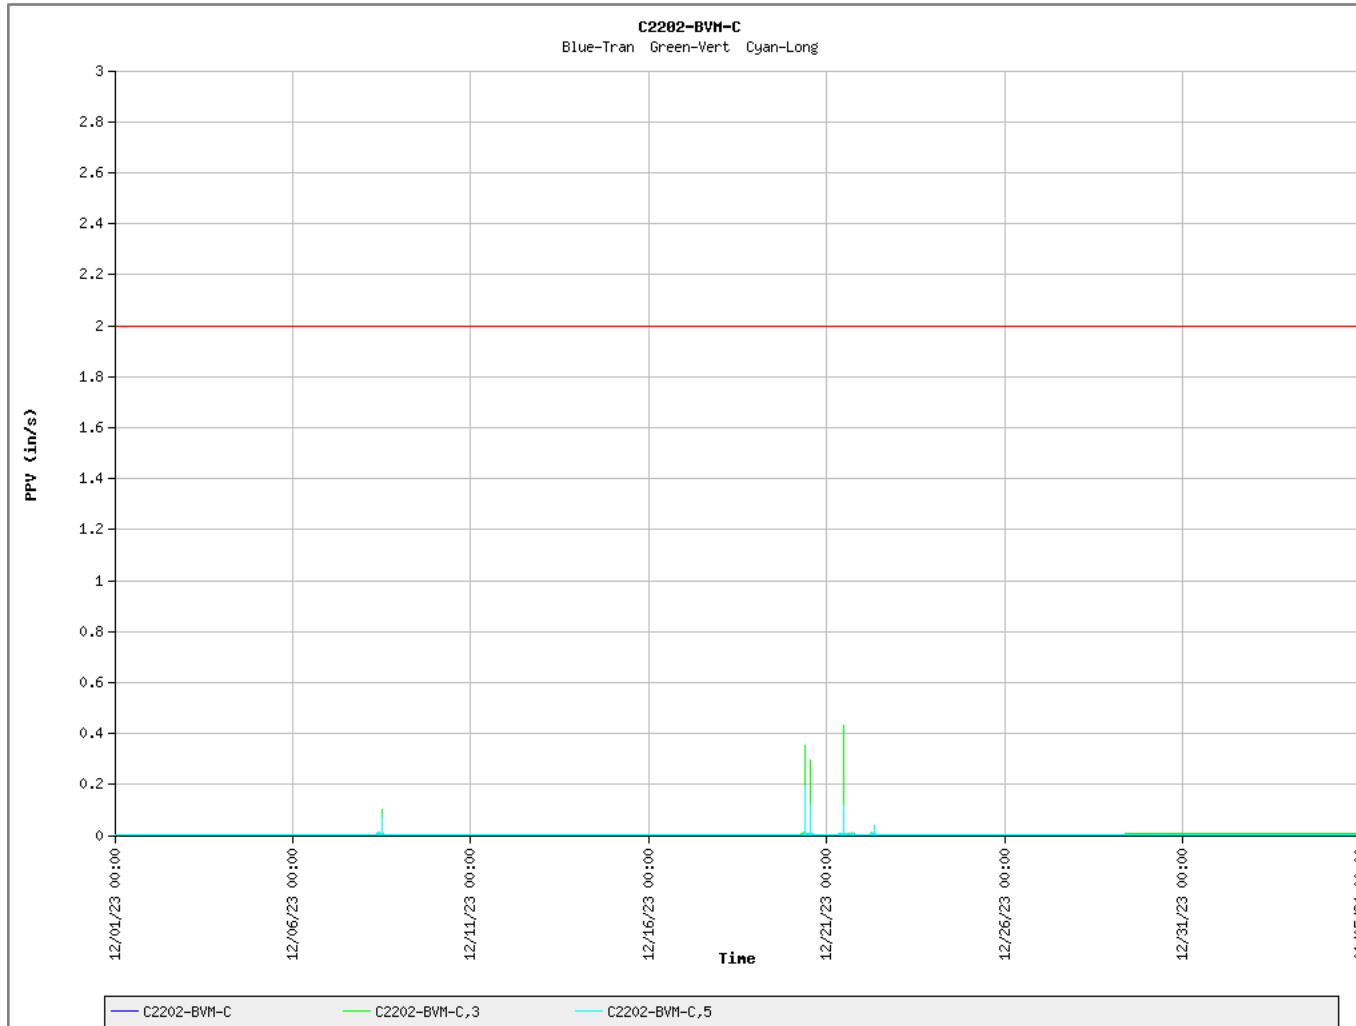
C2202-BVM-C Transverse  
C2202-BVM-C,3 Vertical  
C2202-BVM-C,5 Longitudinal

Exceedance level: 2 in/sec  
12/1/2023-12/31/2023 at location# 7

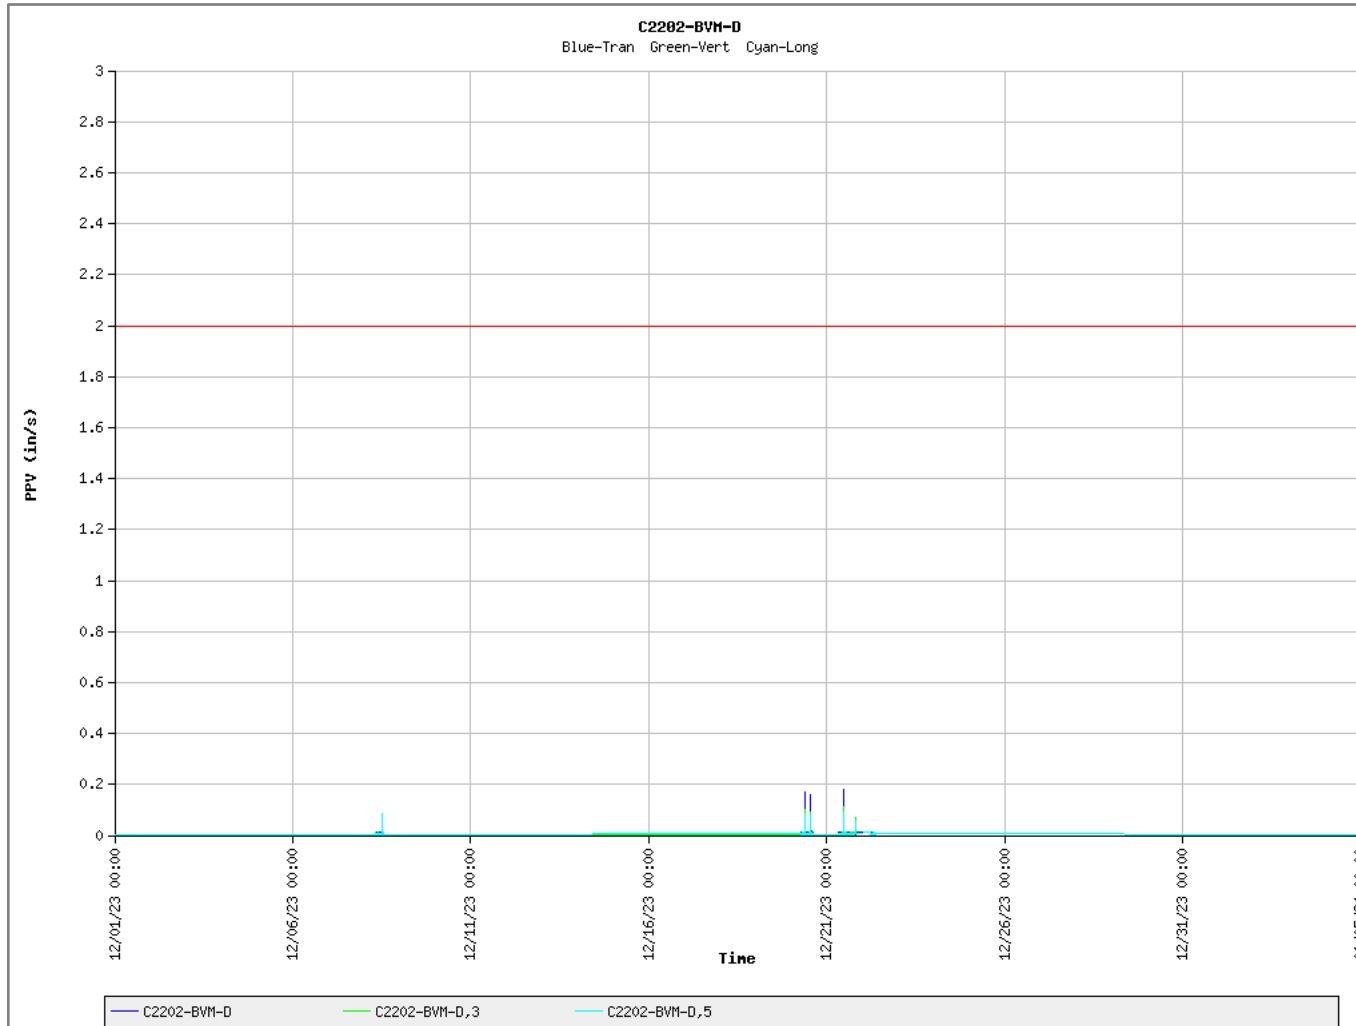
C2202-BVM-D Transverse  
C2202-BVM-D,3 Vertical  
C2202-BVM-D,5 Longitudinal

Exceedance level: 2 in/sec  
12/1/2023-12/31/2023 at location# 5
