**AIR, NOISE AND VIBRATION
MONTHLY MONITORING REPORT
Number 018**

Prepared By: Roux / Wang Technology

DDC Project No.:	BBJ-XSP	Period Start: 1/2/24 End 1/31/24	
Project Name:	NYCDDC D&B – The Bronx Site Preparation		
DDC Pin No.:	8502021CR0004P-06P		
1) Community Air Monitoring Monthly Status Summary			
TWA – Time Weighted Average ug/m ³ - micrograms per cubic meter			
Number of Workdays in a Month	Number of Air Monitoring Days in a Month	Number of Days with Dust Concentrations above Action Concentrations by Month (100 ug/m ³ 15 minute TWA)	Comments
21	21	5	Each exceedance was recorded during separate 15-minute readings on 1/03, 1/05, 1/08, 1/09, 1/24, respectively. See details below.
Community Air Monitoring Monthly Excursions and Corrective Actions			
Action Concentration = 100 ug/m ³ 15 minute TWA above background concentration Stop Work Concentration = 150 ug/m ³ 15 minute TWA above background concentration			
Date: Time	Maximum Dust Reading Before Corrective Action 15 Minute TWA (ug/m ³)	Maximum Dust Reading After Corrective Action 15 Minute TWA (ug/m ³)	Corrective Action

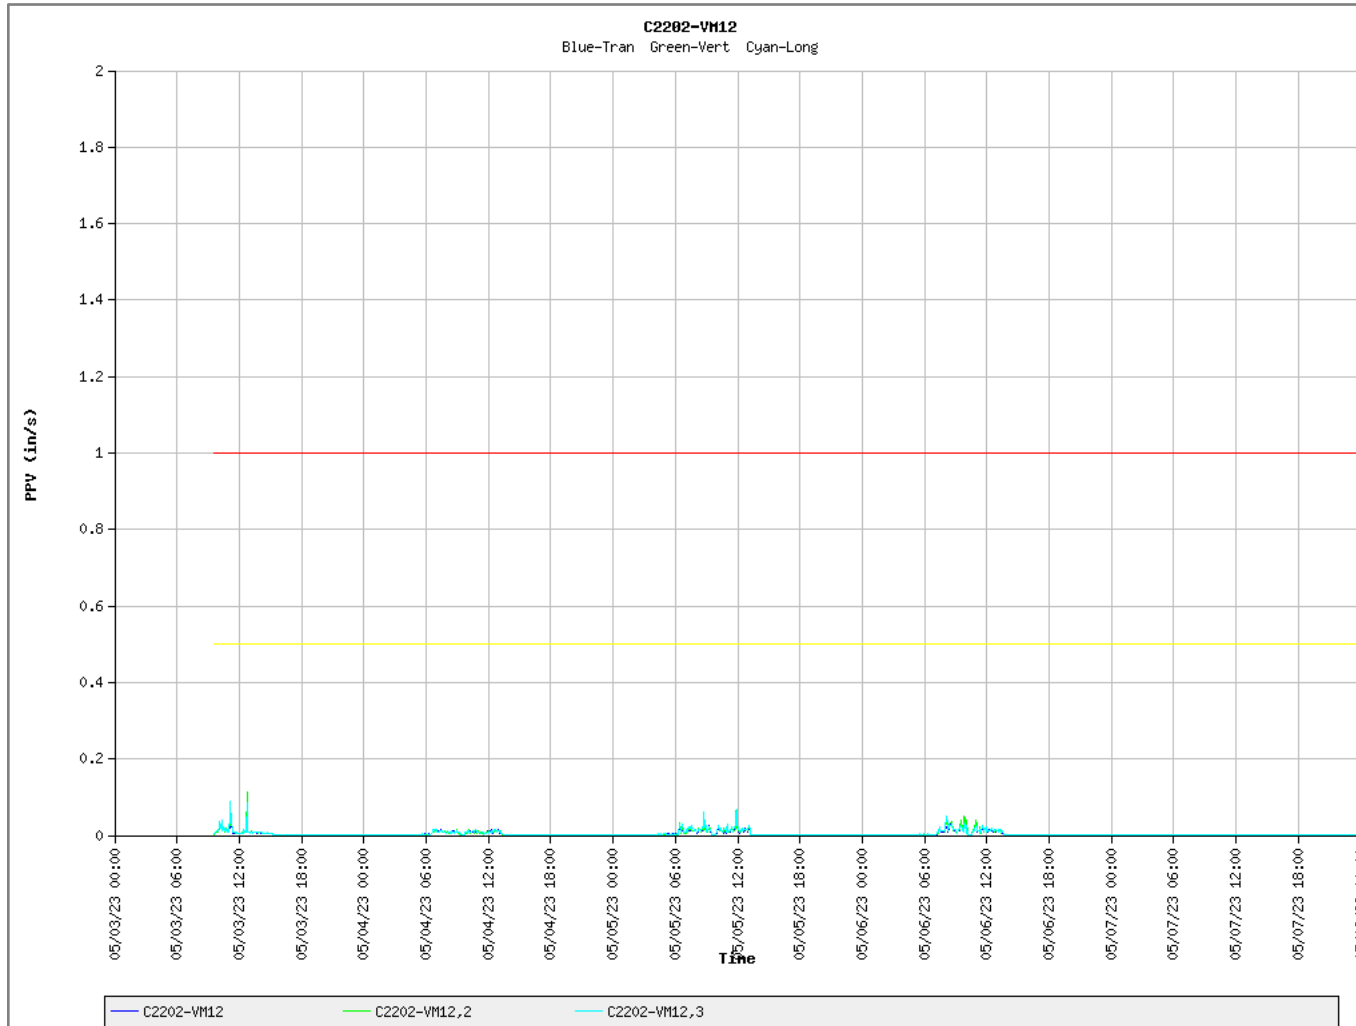
C2202-VM12 Transverse
C2202-VM12,2 Vertical
C2202-VM12,3 Longitudinal

Exceedances recorded at VM11 between January 23rd 12:30 pm and January 26th 6:45 am were due to the sensor failing sensor check and malfunction. The sensor was replaced on post events.
