**AIR, NOISE AND VIBRATION
MONTHLY MONITORING REPORT
Number 010**

Prepared By: Roux / Wang Technology

DDC Project ID.:	BBJ-XSP	Period Start: 5/1/23 End 5/31/23	
Project Name:	NYCDDC – The Bronx Site Preparation		
DDC Pin No.:	8502021CR0004P-06P		
1) Community Air Monitoring Weekly Status Summary			
TWA – Time Weighted Average ug/m ³ - micrograms per cubic meter			
Number of Workdays in a Month	Number of Air Monitoring Days in a Month	Number of Days with Dust Concentrations above Action Concentrations by Month (100 ug/m ³ 15 minute TWA)	Comments
25	25	2	There were two instances of elevated readings above 150ug/m ³ . These instances occurred on 5/4 and 5/31 and are detailed below.
Community Air Monitoring Weekly Excursions and Corrective Actions			
Action Concentration =100 ug/m ³ 15 minute TWA above background concentration Stop Work Concentration = 150 ug/m ³ 15 minute TWA above background concentration			
Date: Time	Maximum Dust Reading Before Corrective Action 15 Minute TWA (ug/m ³)	Maximum Dust Reading After Corrective Action 15 Minute TWA (ug/m ³)	Corrective Action

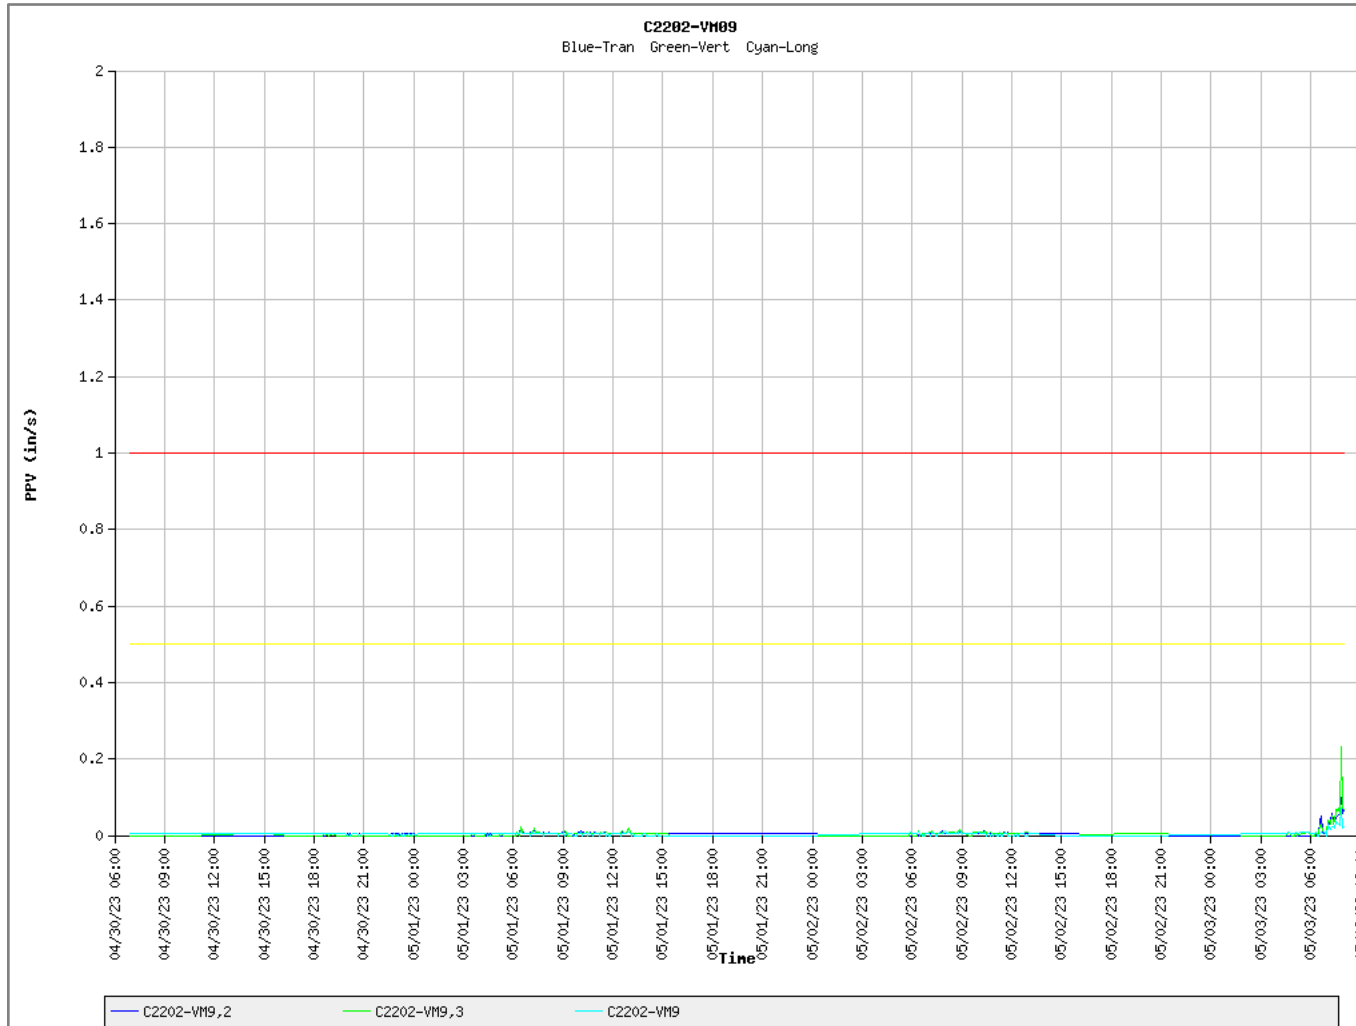
The Bronx Site Preparation May 2023 Vibration Monitoring Data Plots

As VM9 and VM10 were experiencing communication issue after the site condition changed, they were replaced by another type of vibration monitors to resolve the communication issue. The units are named as VM11 and VM12.
