## AIR, NOISE AND VIBRATION MONTHLY MONITORING REPORT Number 016 – November 2023

Prepared By: Gramercy Group Inc.

DDC. Project ID:		BBJ M DSS		Period Start: 11/01/23 End 11/30/23			
Project Name:		NYC Borough Based Jails System – Manhattan Dismantle and Swing Space					
DDC Pin No.:		8502021CR0004P-06P

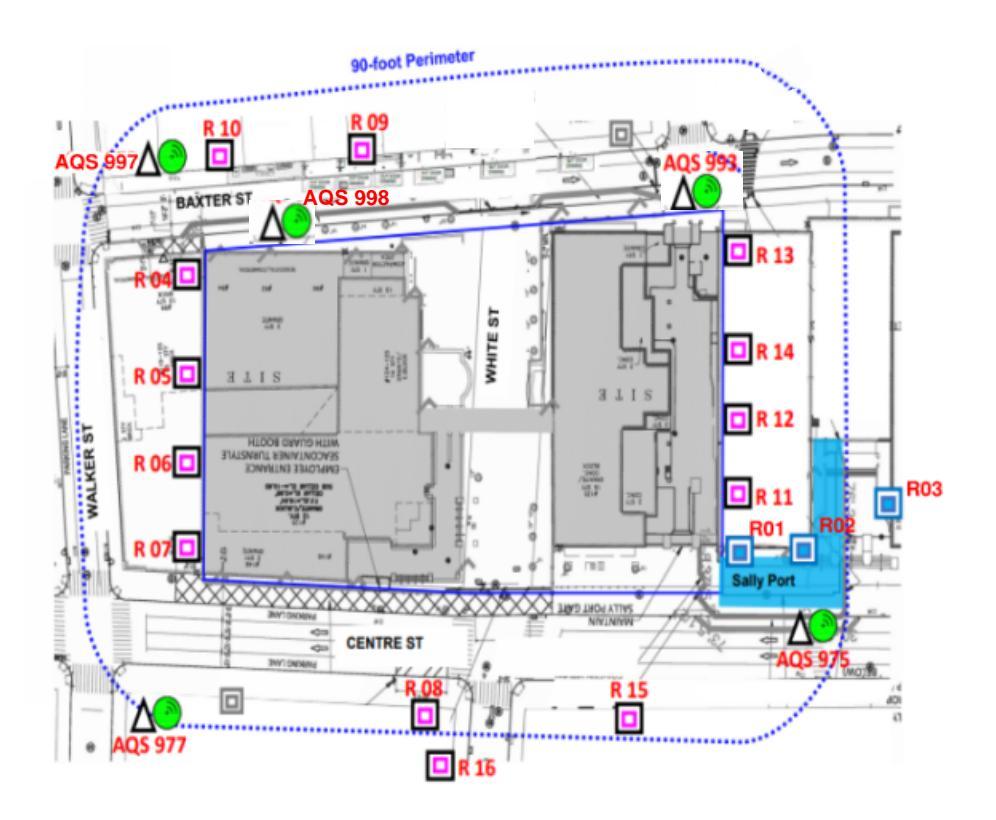
# Map of Monitoring Locations:

Vibration Monitors R01 - R16

Air Quality System (AQS) # 933, 997, 975, 977, & 998.

\* Dismantle project vibration, air and noise monitoring devices are installed by Design-Build team in Phase 2, after sally port construction. A vibration monitoring station was installed in the DCTV Fire house at 87 Lafayette St.

\* The location of monitoring stations presented is referential. Air/Noise Monitoring station located in Sally Port area will be relocated in Phase 2.

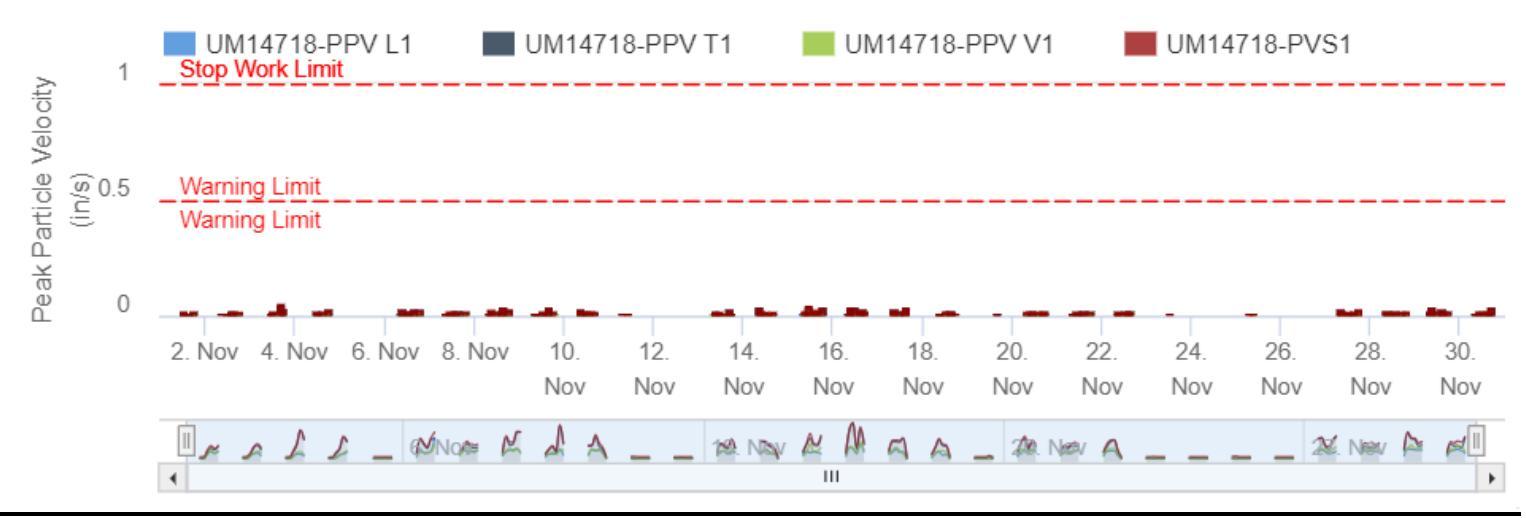
# Vibration Monitor – (R04) November 23:

vibr62/BBJ Dismantle/Vibration/R04-UM14718(96 Baxter St-Basement Maintenan(小文で)(逆)(24hr Chart

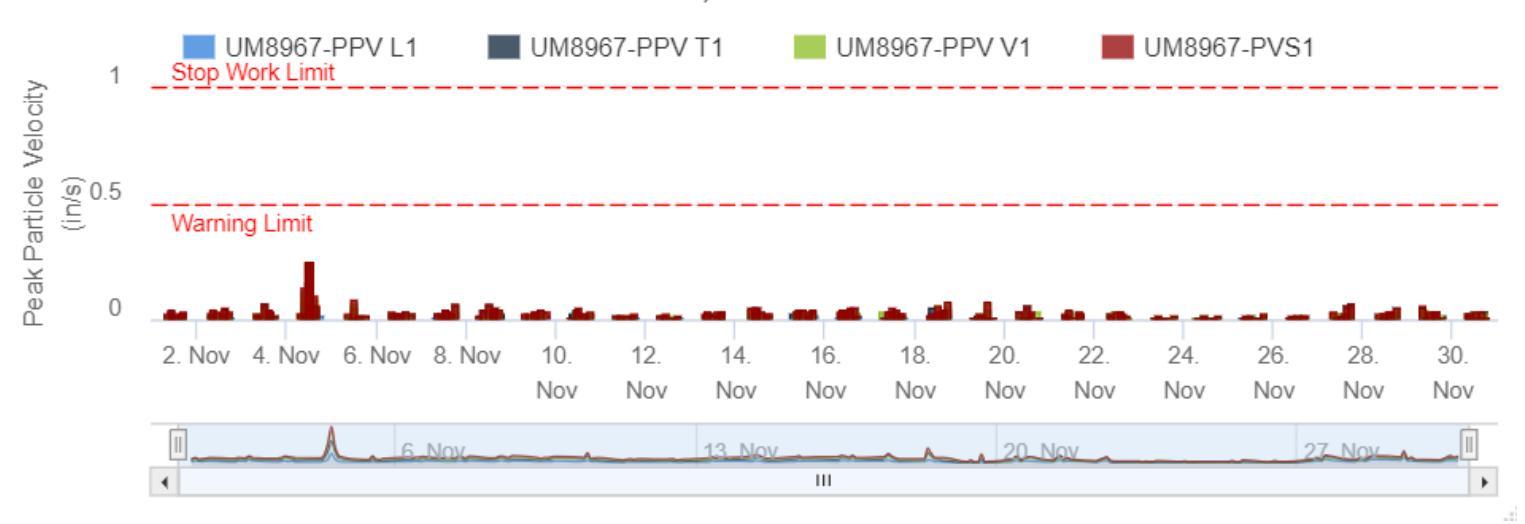
# Vibration Monitor – (R10) November 23:

vibr62/BBJ Dismantle/Vibration/R10-UM8967 (91 Baxter St-Basement Sprinkler Cor Arguing 10/24 hr Chat

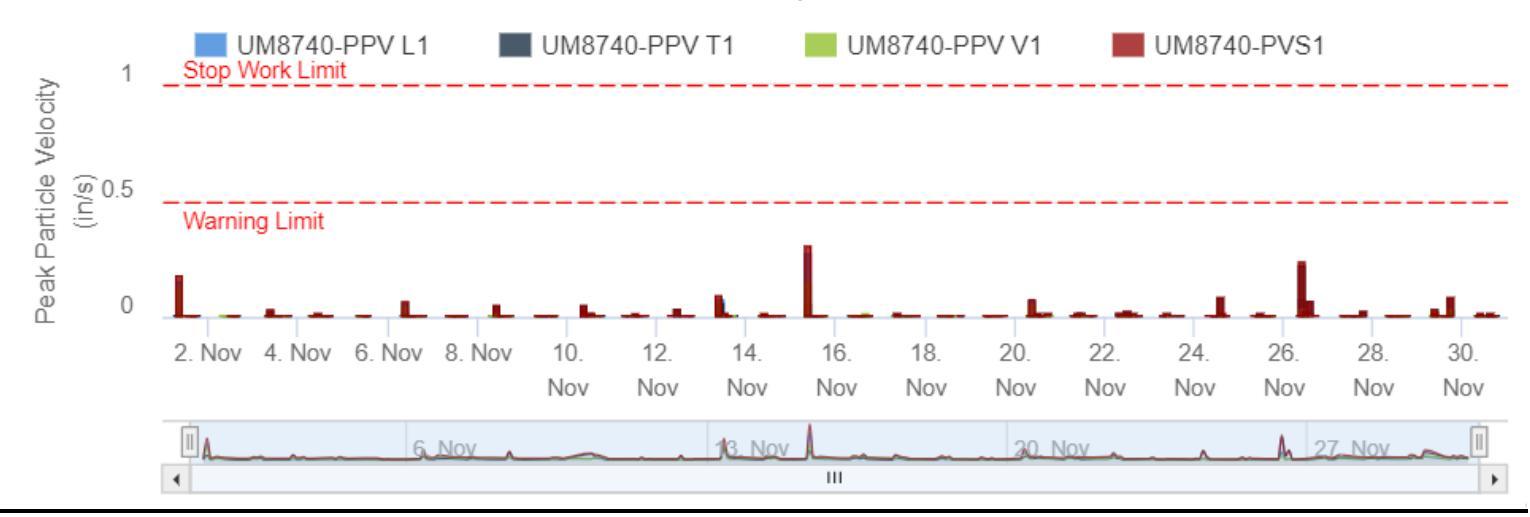
# Vibration Monitor – (R14) November 23:

vibr62/BBJ Dismantle/Vibration/R14-UM8740 (125 White St- NYC Family Court- N 孙 🏹 🗒 🖃 East-CJA Intake)/24hr Chat

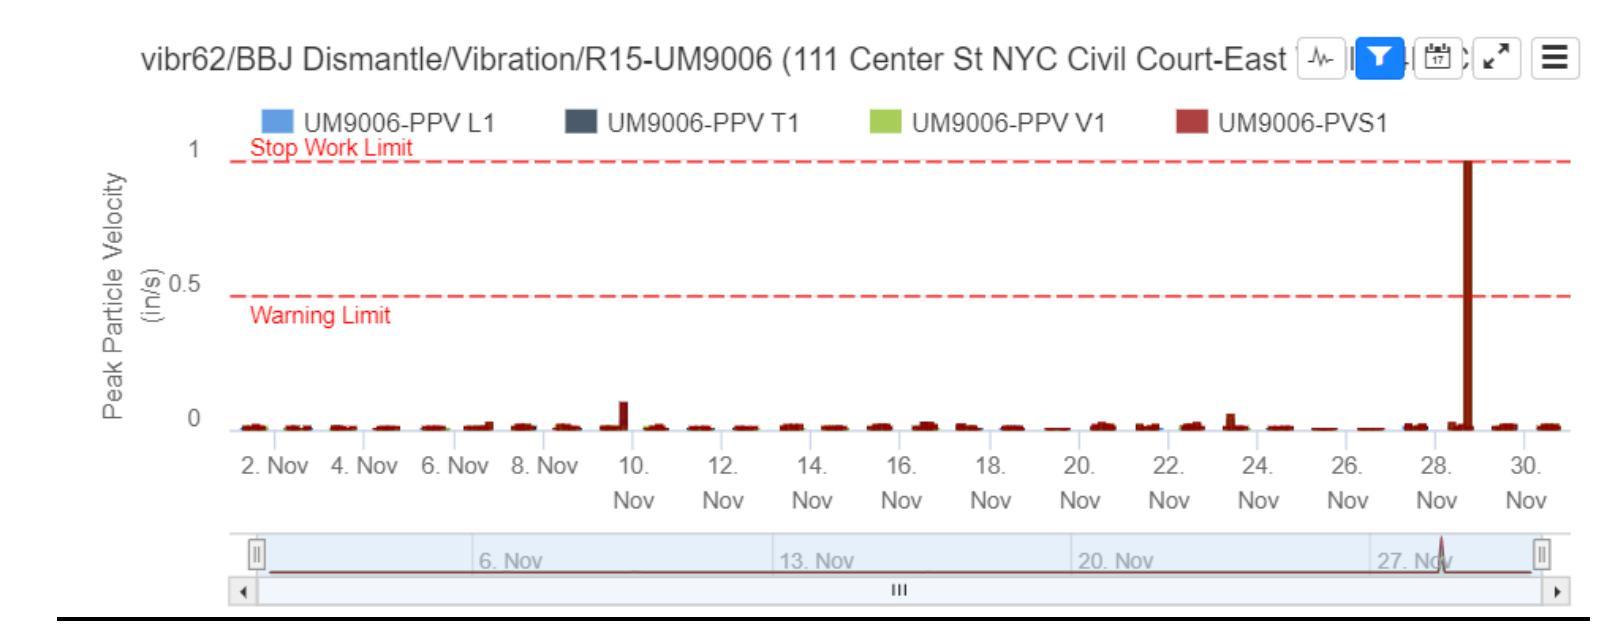
#### Vibration Monitor – (R15) November 23:

Number of Workdays in a Month	Number of Vibration Monitoring Days in a Month	Number of Days with Vibration Levels above Action Levels by Month (in/sec)	Comments
21	30	1	During the month of November, we experienced reading that exceeded vibration level thresholds on unit R15. This was investigated immediately see explanation below.

Stop work Level = 1.0 in/sec			
Date: Time	Maximum Vibration Level before Corrective Action (in/sec)	Maximum Vibration Level after Corrective Action (in/sec)	Corrective Action
R15: 11/28/23 @ 3:54 PM	13.752 in/sec	0.018 in/sec	This monitor is located at 111 Center Street. The monitor is taped off but someone accidentally bumped into it causing it to trigger an alert. Unrelated to construction activities. No corrective action at this time. Monitoring was continued everyday of the week even on weekends.

During the Month of November 2023, there was 1 vibration monitor exceedances. When we got this alert, we investigated immediately. This exceedance was unrelated to construction activity. Below you will see a few days with gaps in the data for vibration monitors R01, R02, R03, R05, R07, & R12. This happens when batteries die, or the unit loses connection. When this happens, we have act Vibranalysis as quickly as possible to get these back up and running. Even though there is missing for data couple of days, the monitors are places in areas that even when they are down, the adjacent monitor covers that area as a back up to ensure we are within our limits.

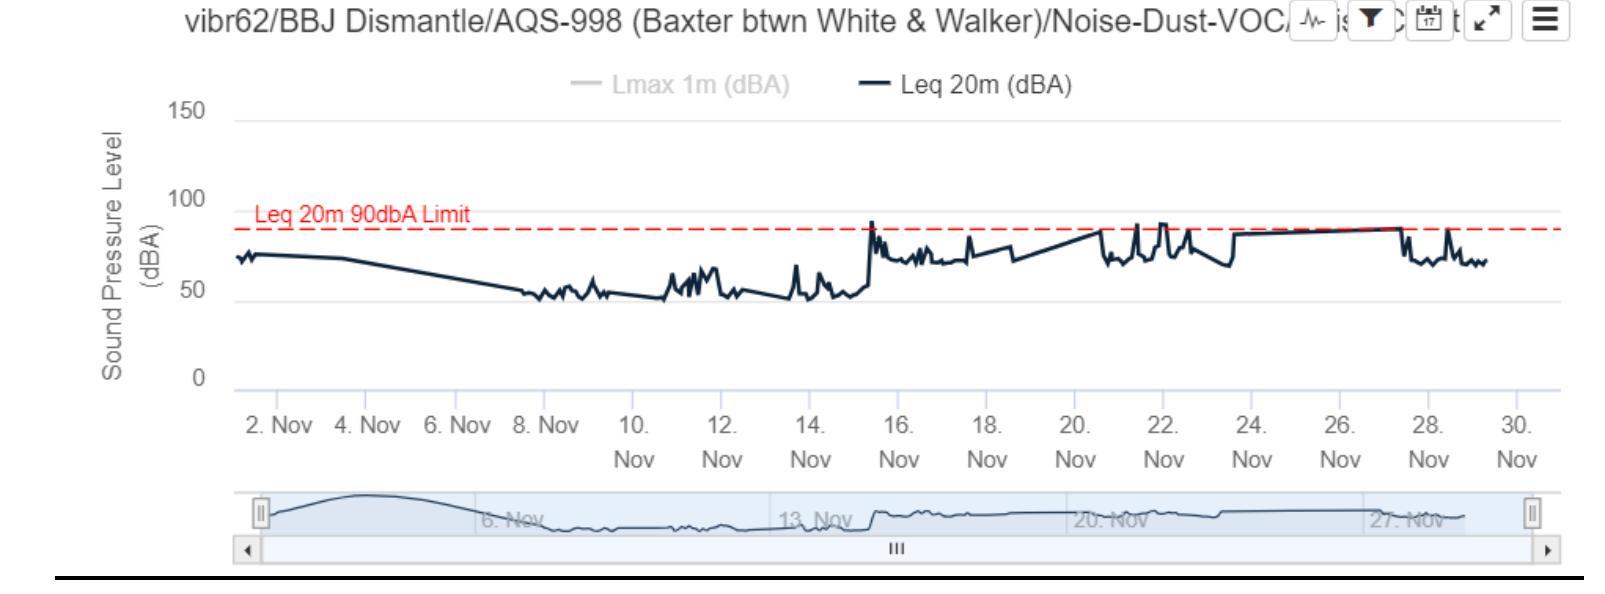
#### Air Quality Systems #998 – Noise Monitoring Station – November 23:

NYPD sallyport entrance.
AQS #998: 11/21/23 @ 9:41 AM	93.1 dBA	72.2 dBA	Upon alert we immediately investigated the cause of the exceedance. This was due to us sorting debris in our yard near Baxter Street directly where this monitor is located. We spoke to our operator and told him to be more cautious when sorting the debris. The noise level was then within the threshold.
AQS #998: 11/21/23 @ 10:22 PM	92.8 dBA	74.5 dBA	No corrective action was feasible at this time as tis alert happened after hours while no work was being performed.
AQS #998: 11/22/23 @ 1:41 PM	90.1 dBA	76 dBA	Upon alert we immediately investigated the cause of the exceedance. This was due to us sorting debris in our yard near Baxter Street directly where this monitor is located. Even though the exceedance was very minor, we take this seriously and remediated the issue immediately.
AQS #997: 11/10/23 @ 3:30 PM	94.24 dBA	69.7 dBA	No corrective action was feasible as we went to investigate, this was caused by vehicle horns where there was traffic build up on the corner of Baxter and Walker Street.

During the month of November 2023, we experienced noise levels greater than the alert threshold at times. Above you will see the monitors that had alerted us with dates and times. As you can see from the corrective action explanations, most of the alerts were not caused by construction activity. AQS #975 is located on Centre Street right near the traffic light / DOC sallyport where the DOC buses use their sirens to signal that they are outside the gate. Depending on how close they are to the monitor this siren will set it off and cause an alert. The graph for AQS #975 shows a flat line from the dates 11/15/23 – 11/28/23 and a gap in the data for air quality. This is because we had to relocate the unit due to construction fence reconfigurations. The monitor was back up and running as soon as we were able to have it reinstalled. With that being said, the other monitors serve as coverage and this monitor specifically is not located near the dismantlement. AQS #998 experiences noise levels above threshold 4 times. Two of which were not caused by construction activity see explanations above. AQS #997 had one instance during the month of November where noise levels exceeded threshold. After investigation this alert was not caused by construction activity see explanation above. You will also see in the graph below for AQS #997 that there is a gap in the data for the same time frame as AQS #975. We also had to relocate this monitor and as soon as we reinstalled it. We had it back up and running. As stated previously for AQS #975, the adjacent monitors serve as back up coverage. Overall, the noise levels for an A-weighted average 8-hour workday were below the threshold.
